Service Bulletin

Subject: Malfunction Indicator Lamp (MIL) ON, Reduced Power Mode and DTCs

Brand:	Model:	Model Year:		VIN:		Engine:	Transmission:
		from	to	from	to		
Chevrolet, GMC	Equinox, Terrain	2010	2015			All	All

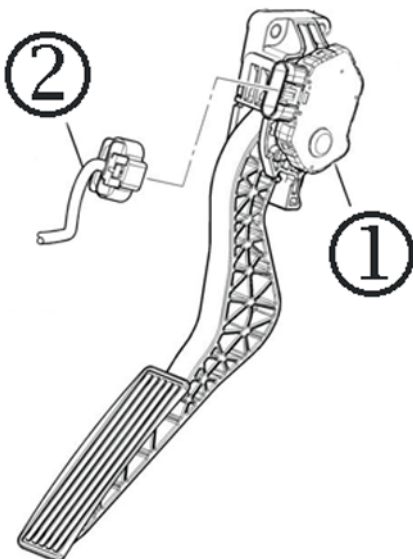
Accelerator Pedal Position (APP) Sensor assembly (1) and APP harness (2)

1. Inspect the Accelerator Pedal Position (APP) Sensor harness connector B104 (2) for fretting or damage and for proper routing. If damage found, proceed to Step 2. If no damage found, follow normal SI diagnostics.
2. Replace the Accelerator Pedal Position (APP) Sensor assembly (1). Refer to *Accelerator Pedal with Position Sensor Assembly Replacement* in SI.
3. Replace the Accelerator Pedal Position (APP) Sensor harness (2) and ensure the correct routing (4). The harness must be routed below the Onstar® coax cable. Refer to *Splicing Copper Wire Using Splice Sleeves* in SI.
4. Verify the repair. Refer to *Diagnostic Repair Verification* in SI.

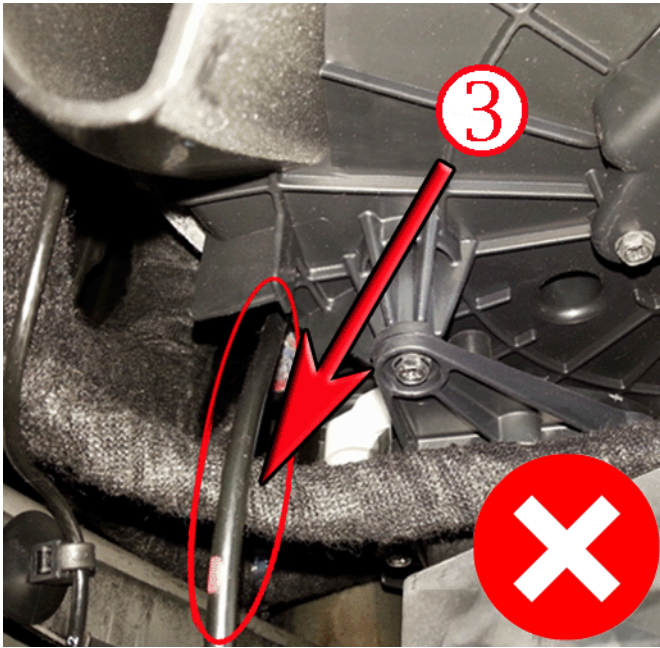
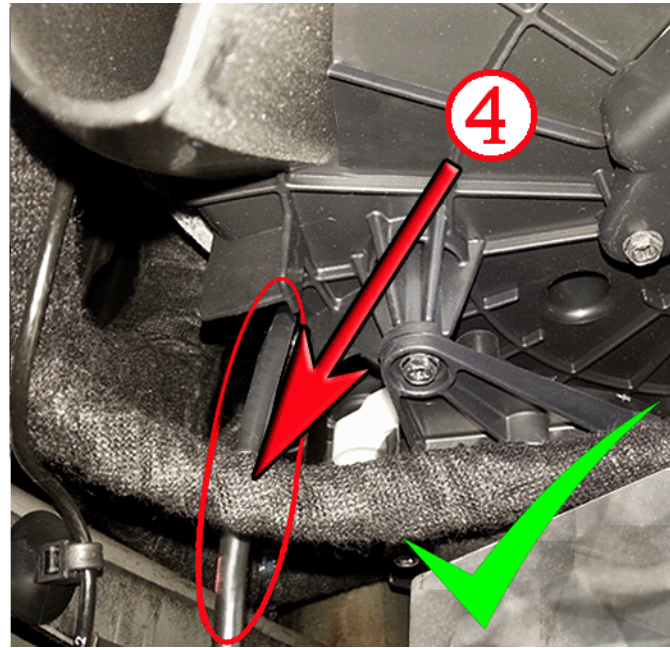
Condition	Some customers may comment that the Malfunction Indicator Lamp (MIL) is ON, Reduced Power Mode active, along with DTCs.
Cause	The Accelerator Pedal Position (APP) Sensor wiring harness may be mis-routed and under tension, damaging the connector, causing a poor connection.

Incorrect APP harness (3) routing / Correct APP harness (4) routing (Viewed from under instrument panel)

Replace Accelerator Pedal Position (APP) Sensor assembly part number 25798449, and APP harness part number 13584094. Reroute the harness.
