Reference	SSM72326
Models	Discovery Sport / L550 LR2 / L359 Range Rover Evoque / L538
Title	L538 & L359 12MY Onwards 2.0 GTDi - Coolant leak from Radiator
Category	Engine
Last modified	07-Jun-2017 00:00:00
Symptom	402000 Cooling System Concerns
Attachments	11Fit Cable Tie.pdf (11Fit Cable Tie.pdf)

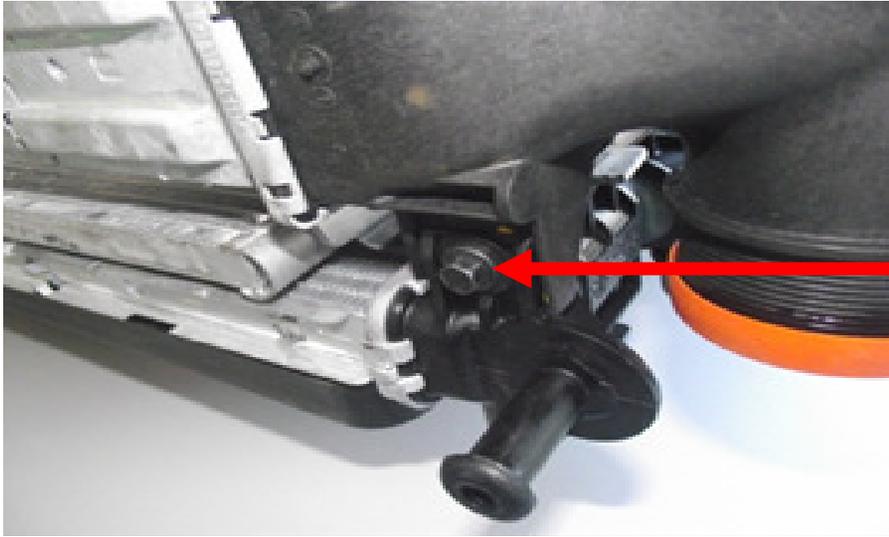
Concern:
L359 and L538, 12MY onwards with 2.0GTDi engines, a warning indicator may illuminate on the IP (Instrument Pack) for low coolant level and coolant visible on the ground at the front area of the engine bay. On inspection, the coolant leak is from the radiator.

Do not install 不要安装

- Do not install the 2 bolts that hold the Radiator and the Intercooler together
- Install 2 service cable ties (part number UKC6684L) in place of the bolts - see attached photo of the cable tie location

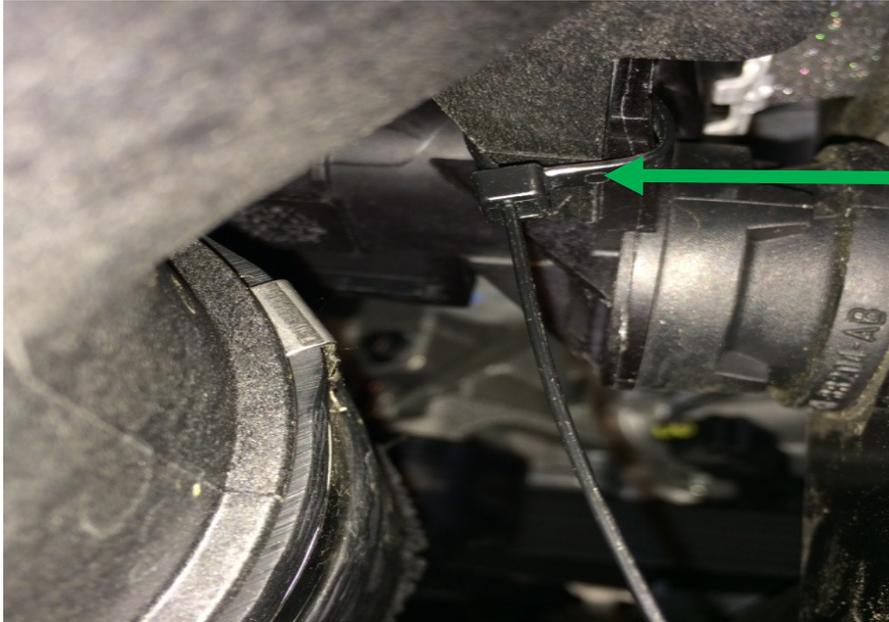
Fit 适合
