TECHNICAL BULLETIN
LTB00998NAS1
01 NOV 2016

'Chirp' Noise From Second Row Seat(s)

Discovery Sport (LC)

Model Year: 2015-2016
VIN: 501001-544577
Assembly Plant: Halewood

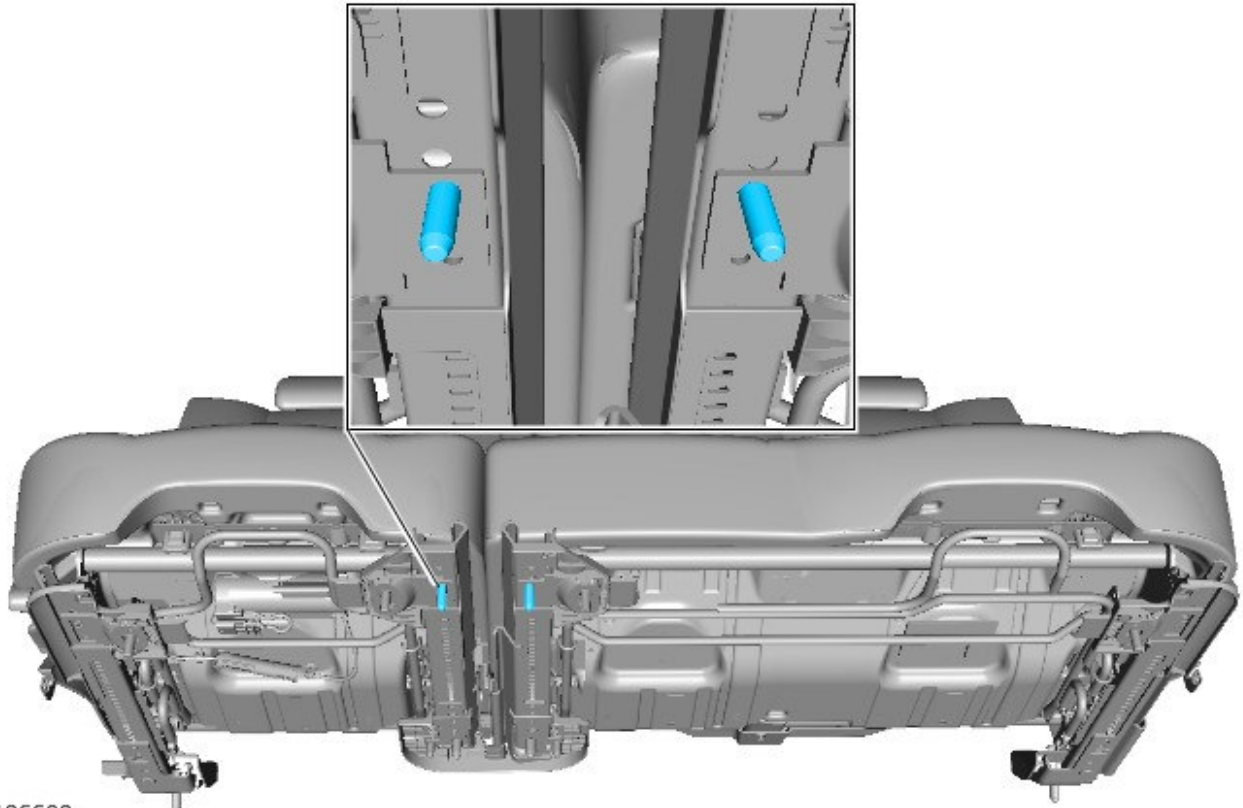
E196609

Locate the areas shown.

**CAUTION: Place the seats on a flat and clean surface to avoid damage.**

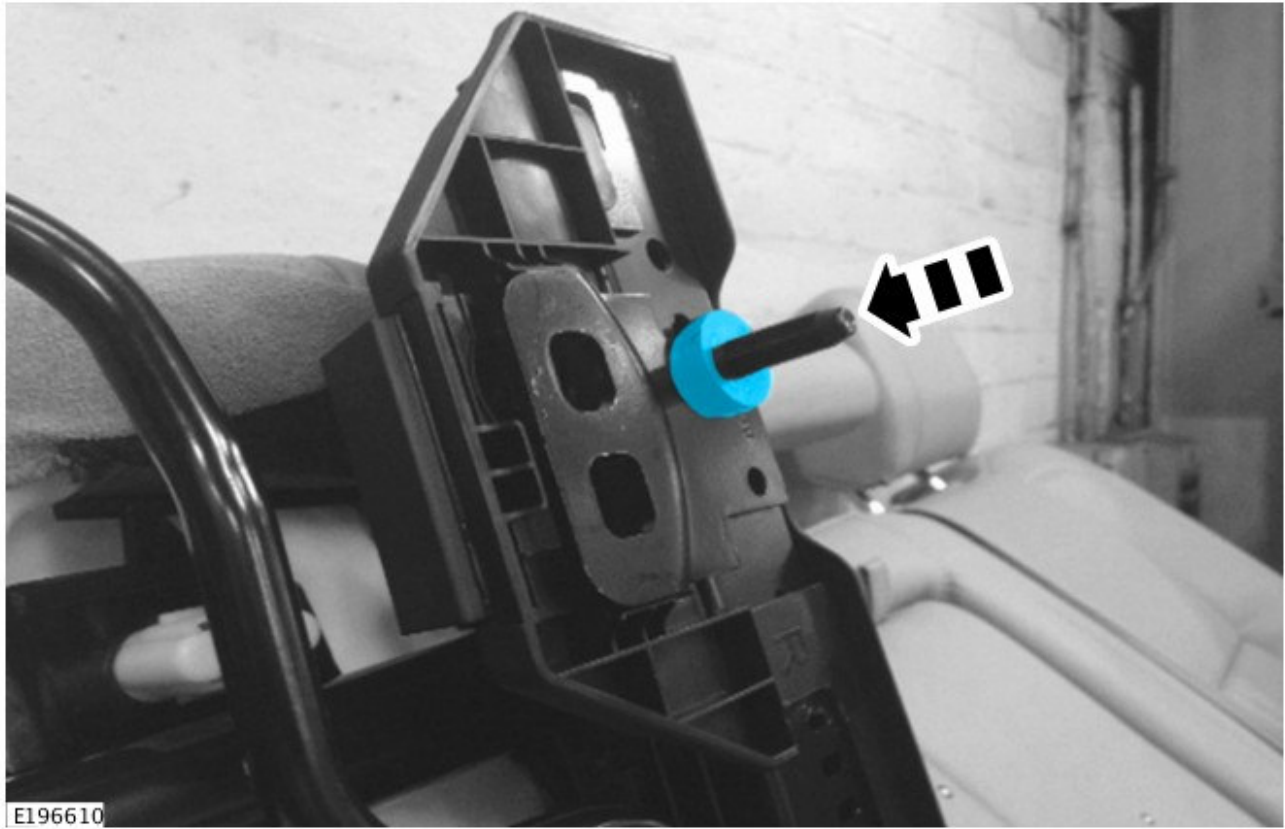
**NOTE: The existing metal washers should still be installed.**

**NOTE: Single seat shown; repeat for double seat as shown in Step 2.**

Install the new nylon spacers.
