Reference	SSM73065
Models	Discovery Sport / L550 Range Rover Evoque / L538
Title	9HP Transmission Internal Differential Seal Plug Missing
Category	Driveline
Last modified	27-Jan-2017 00:00:00
Symptom	501000 Automatic Transmission Concerns
Attachments	SSM73065 Differential Sealing Plug.pdf (SSM73065 Differential Sealing Plug.pdf)
Content	Issue: Oil leakage from the joint of 9 HP transmission and front differential following a repair in and around the Transmission internal differential right output half shaft.
	<u>Cause:</u> Transmission internal differential right output half shaft sealing plug missing.
	<u>Action:</u> When removing or refitting the automatic transmission and/or the front differential please check the integrity and fitment of the transmission internal differential right output half shaft sealing plug.
	Please see attachment "SSM73065 Differential Sealing Plug" for examples. Images A1 and A2 show the differential sealing plug intact (Differential cross pin not visible)

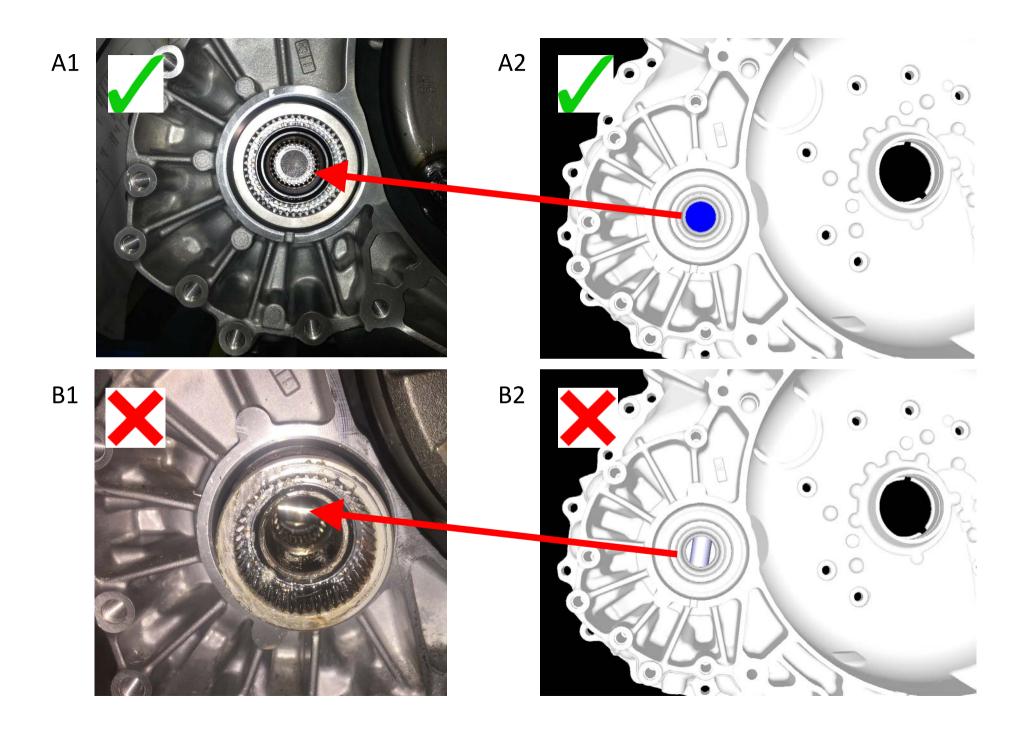
Images B1 and B2 show the differential sealing plug missing (Differential cross pin visible)
	<u>Under no circumstances must any tooling be used to remove the halfshafts</u> by attempting to push the halfshafts out through the transmission as this will dislodge the sealing plug.
	<ul> <li>If the sealing plug is in place please carry on with the repair.</li> <li>If the sealing plug is missing and cannot be located there is a chance the plug may be within the automatic transmission unit. In this case please escalate to the recommended department and also please raise an EPQR.</li> </ul>
