Service Bulletin No. 445

MODEL J4500	TYPE Field Change Program	SECTION/GROUP 7-Electrical	DATE Mar. 24, 2017
SUBJECT TRANSMISSION HARNESS ROUTING			
CONDITIONS

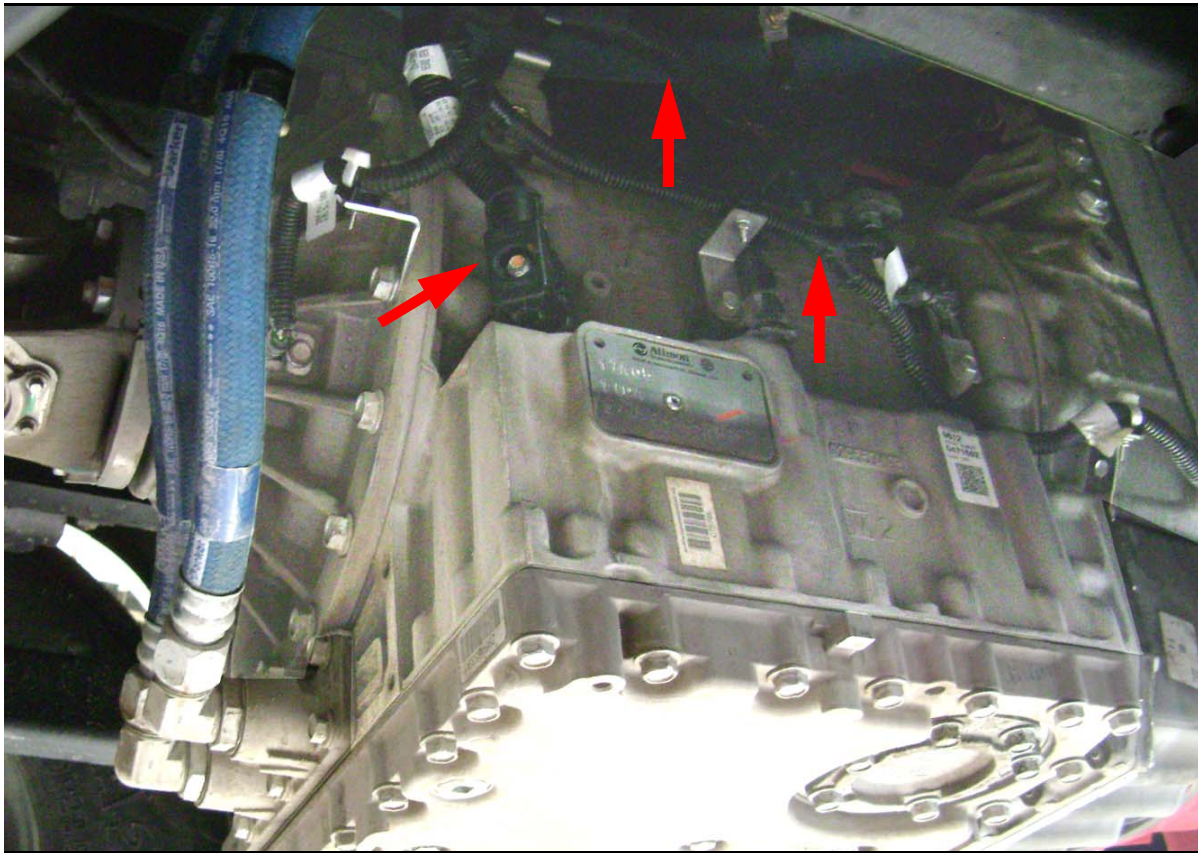
3. Locate the transmission harness connector, behind the roadside, tag axle wheel (refer to Figure 2).

Figure 2. Transmission harness routing.

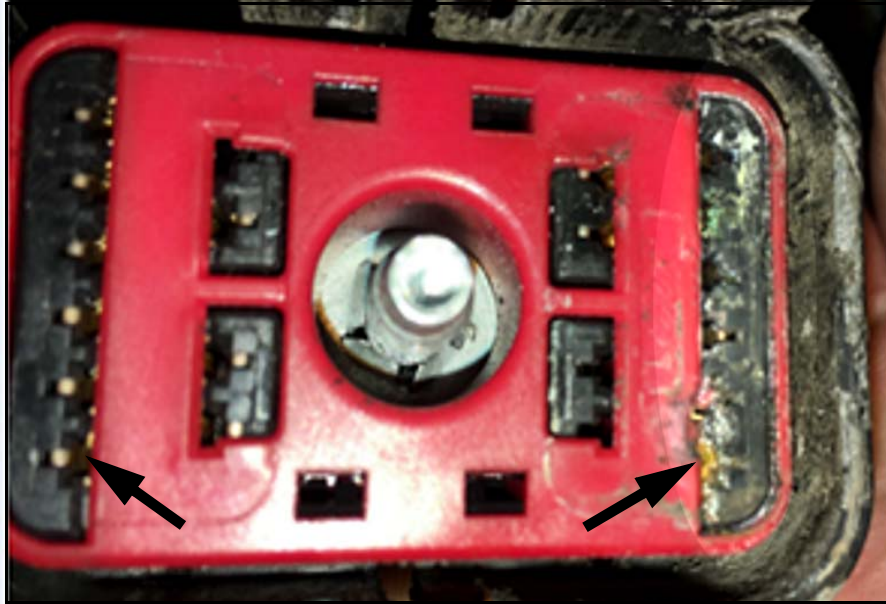
6. Visually inspect the transmission harness connector and the transmission interface port for corrosion buildup on the internal pins (refer to Figures 6 and 7)

Figure 6. Evidence of corrosion on the transmission harness connector pins.

If upon visible inspection there is corrosion buildup on the internal pins as shown in Figures 6 and 7, contact the MCI Fleet Support Technical Center at 1-800-241-2947 for further information.

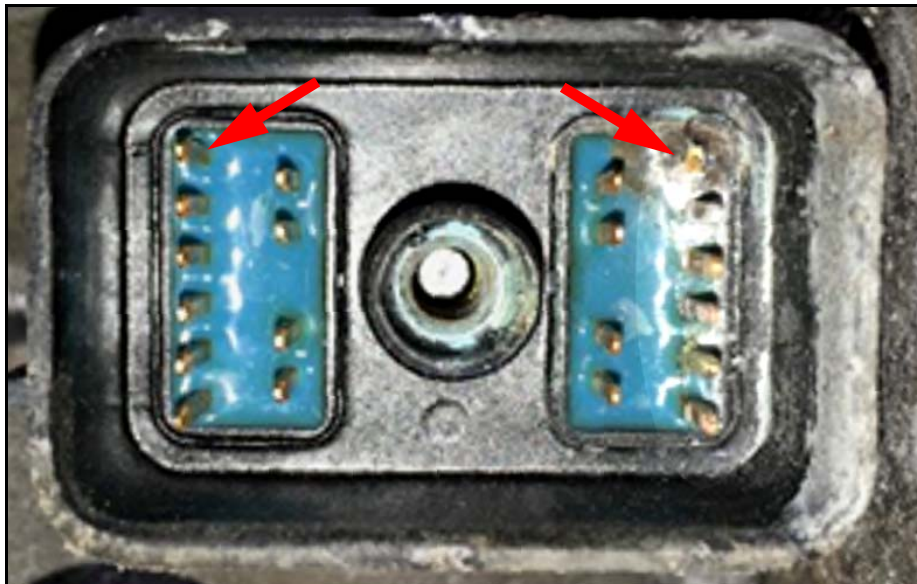
Figure 7. Evidence of corrosion on the transmission interface port.

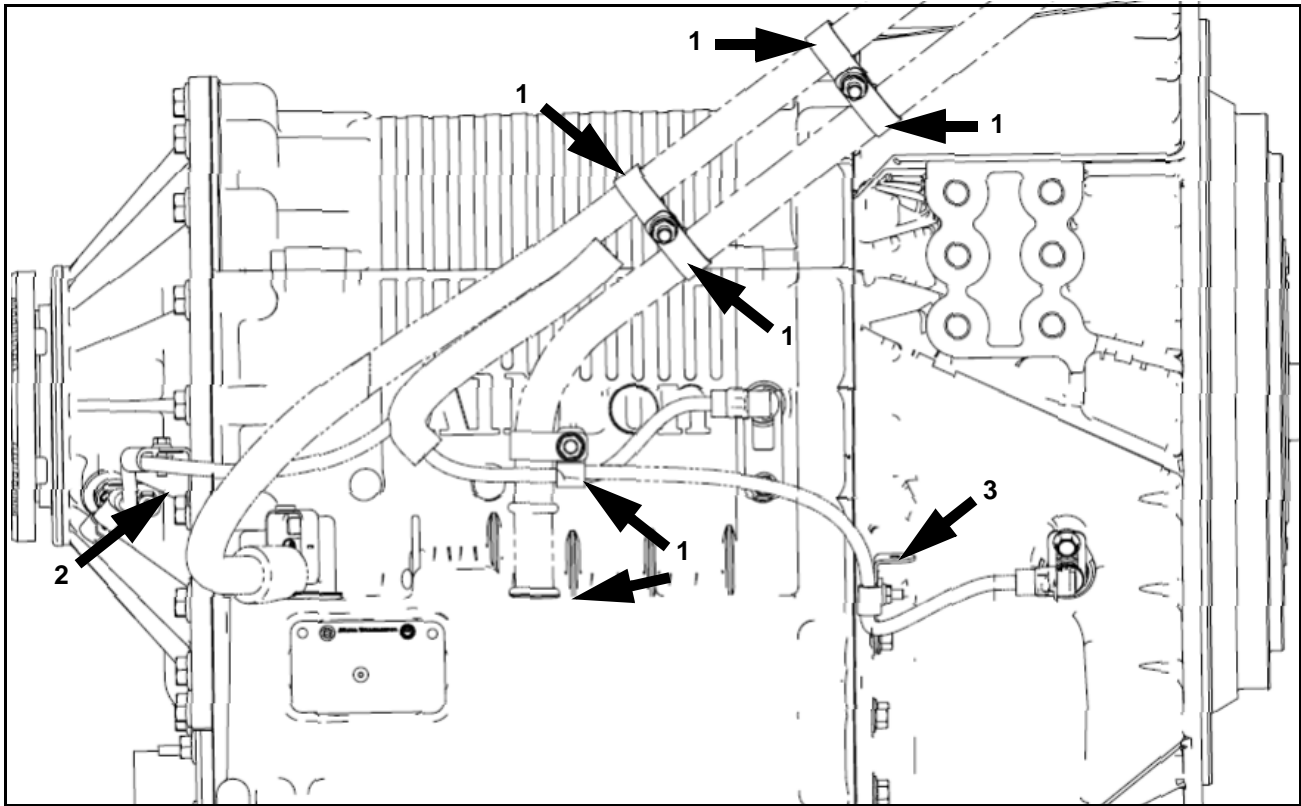
Figure 8. Removal of p-clamps from transmission.

7. Locate the existing p-clamps shown as Item 1 in Figure 8.
8. Remove and discard the eight (8) existing p-clamps shown in Figure 8, as well as the p-clamps on the dipstick.

Item	Figure 8 Description
1	Remove and discard existing eight (8) p-clamps
2	Front bracket location
3	Rear bracket location

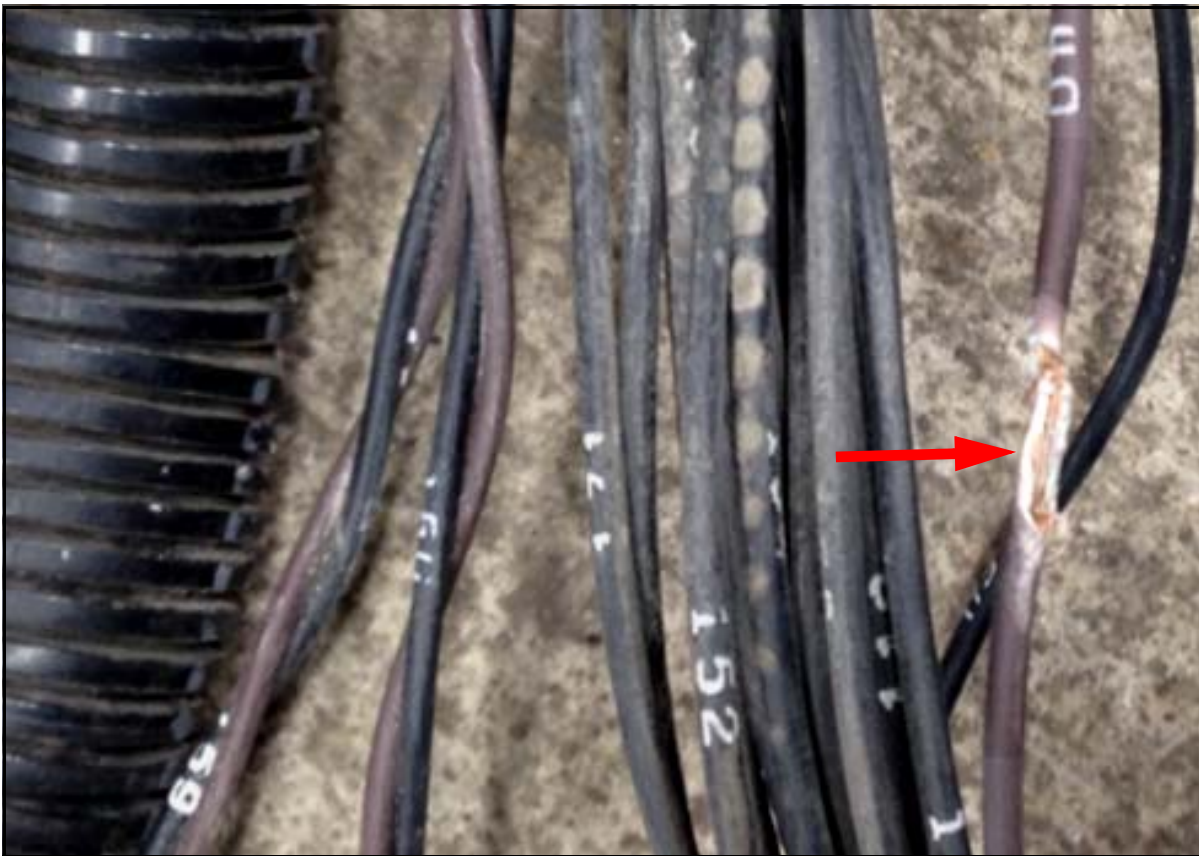
9. Visually inspect the transmission harness loom at the intersection point of the removed p-clamps. Open the loom at the intersection point of the removed p-clamps and inspect the wrap, wire harness and individual wires for damage (refer to Figure 9).

Figure 9. Damaged wire in transmission harness.

If upon visible inspection there is damage or corrosion to the wire(s), contact the MCI Fleet Support Technical Center at 1-800-241-2947 for further information.

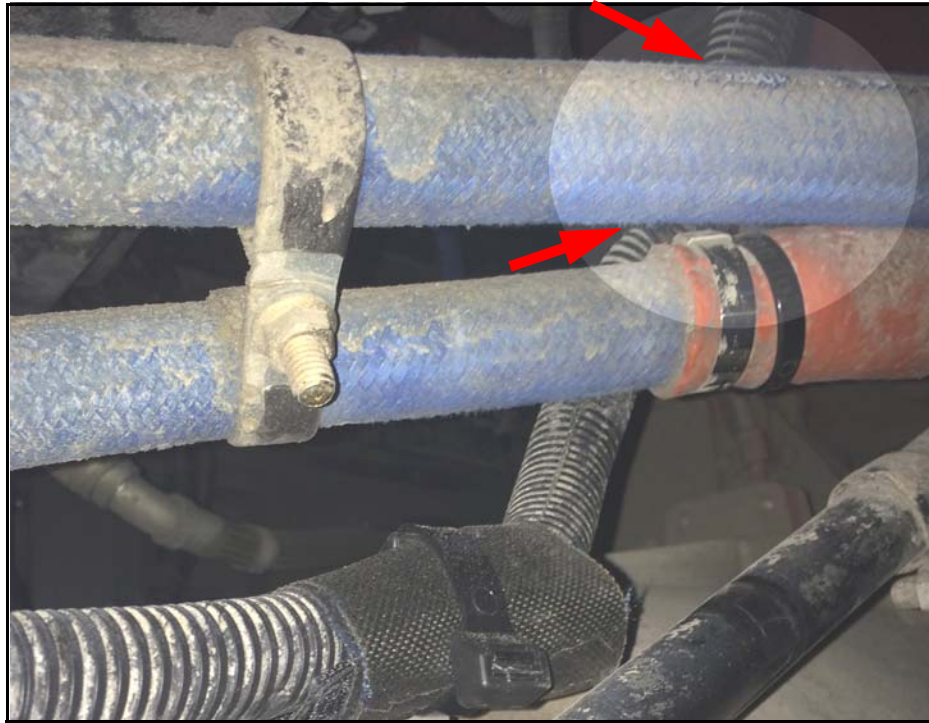
30. Follow the routing of the transmission harness rearwards to the intersection area of the coolant hoses. Visually inspect for contact between the transmission harness and the hoses as shown in Figure 24.

Figure 24. Visual inspection area of contact.

Upon visual inspection, if the transmission harness is contacting the coolant hoses in the area shown in Figure 24, proceed to Step 31.

Upon visual inspection, if the transmission harness is not contacting the coolant hoses in the area shown in Figure 24, proceed to Step 32.

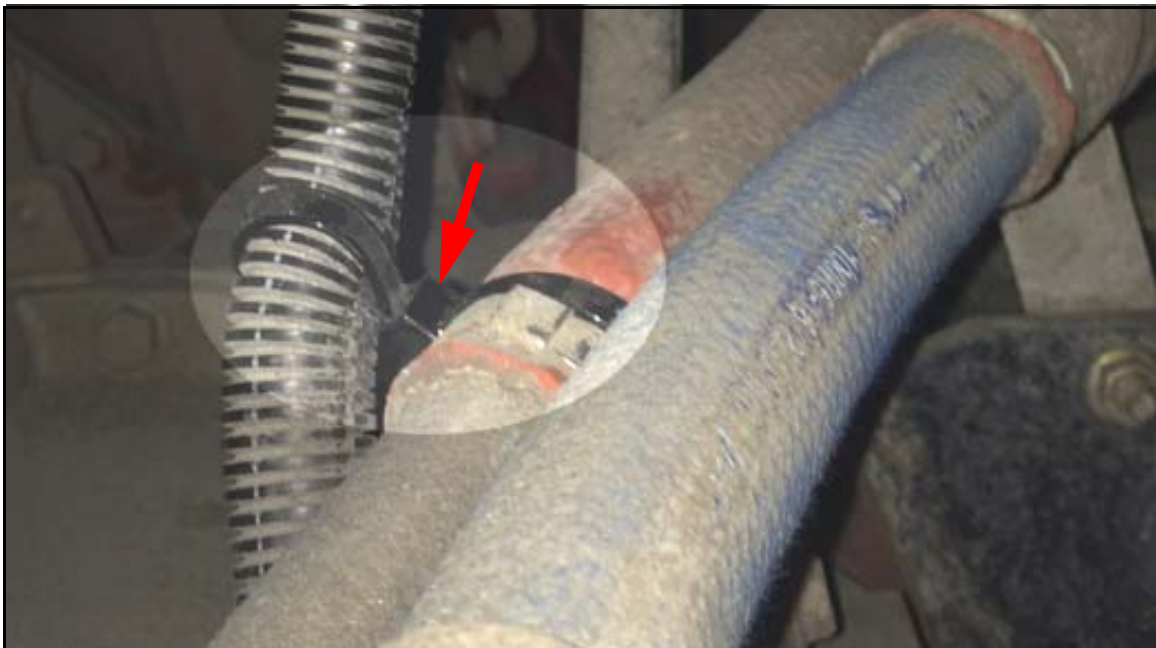
Figure 25. Double loop cable installed with base positioning.

31. Orient and install the double loop cable, p/n 19-11-3078, over the transmission harness and coolant hose as shown in Figure 25, with the cable base positioned in the middle.
