WE66 - Tightening Clamp for Rubber Sleeve on Pressure Pipe (Workshop Campaign)

Vehicle Type: **911 Turbo (991)/911 Turbo S (991)**

Model Year: **As of 2014 up to 2015**

Concerns: **Rubber sleeve between pressure pipe and throttle housing**

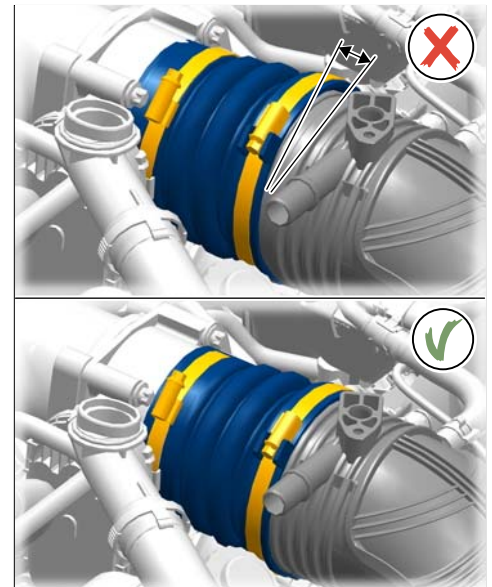
Checking that rubber sleeve is fitted securely

- 3 Check that the **rubber sleeve** is fitted securely on the pressure pipe.
Also make sure that the rubber sleeve is fitted correctly on the pressure pipe all the way around ⇒ *Checking that rubber sleeve is fitted securely*.
 - If the rubber sleeve is **not fitted correctly** on the **pressure pipe** or has already **slipped off the pressure pipe** ⇒ *Checking that rubber sleeve is fitted securely -top-*, the rubber sleeve must be replaced ⇒ Continue with **Step 4**.
 - If the rubber sleeve is fitted correctly on the pressure pipe ⇒ *Checking that rubber sleeve is fitted securely -bottom-* ⇒ Continue with **Step 5**.
- 4 Replace rubber sleeve.
