SERVICE BULLETIN

APPLICABILITY: 2016-2017MY Crosstrek Models with SRVD

SUBJECT: DTC B2327 / B2328- Diagnosis and Repair

NUMBER: 07-118-17R

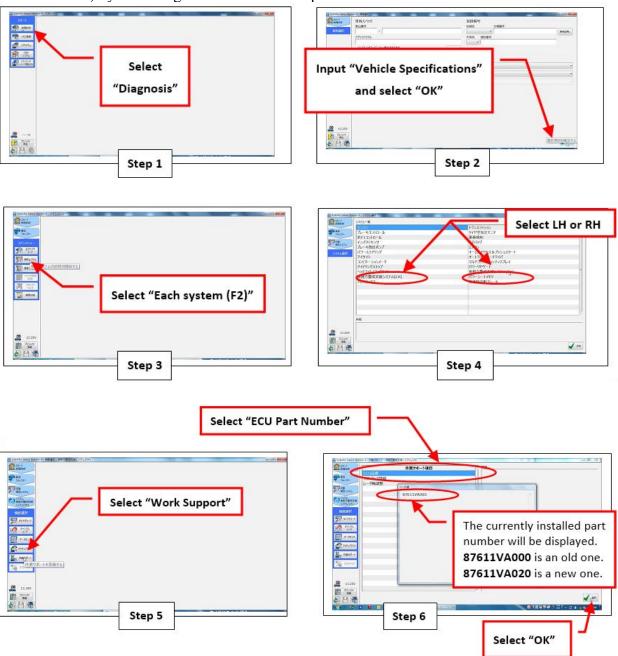
• Using the SSM4, determine the part number of the currently installed SRVD units (both I/ hand and r/ hand) by following the screen shot / steps shown below.

• Once the SRVD unit part numbers have been determined, proceed to the B2327 diagnosis and repair table below.
