TECHNICAL SERVICE BULLETIN

Group:	0-GENERAL
Bulletin No:	SB-15-031
Issue Date:	8-26-2015
Vendor Ref.:	HMM-150707-J1

STRAINER FOR DEF TANK FILLER INLET

SUBJECT VEHICLES: 11MY-14MY Conventional Trucks (238, 258, 268, or 338) and 12MY-16MY COE (Cab over Engine) Trucks (195, 195h)

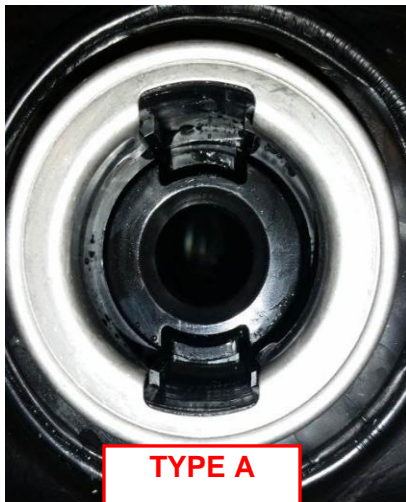
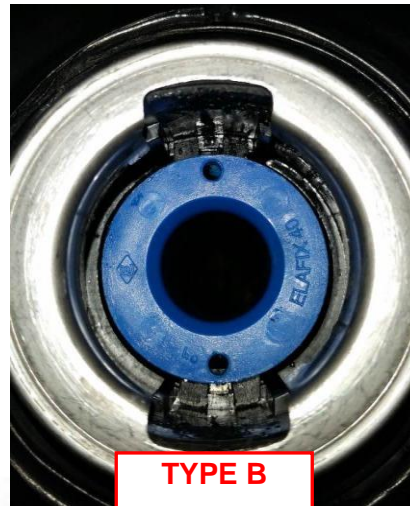
2. To install the inlet strainer, the existing inlet restrictor will need to be removed. There are two different types of inlet restrictors used on Hino vehicles. Refer to the images below to determine if Type A or Type B is present. Follow the appropriate removal process indicated in step 3A or 3B.
