Group:	SERVICE MANUAL UPDATE
Bulletin No:	SB-15-032
Issue Date:	10-21-2015

**Subject: CORRECTION OF WORKSHOP MANUAL FOR 2011~2014 MY**  
Troubleshooting information and inspection procedure of the DTC/P2030 were revised

**RELEVANT MODEL:** 11MY-14MY Conventional Trucks (238, 258, 268, or 338)

**DTC: P2030 Burner abnormal combustion (Burner misfire, Lost flame, Burner outlet temperature too high, Unable to achieve target temperature)**  
INFORMATION

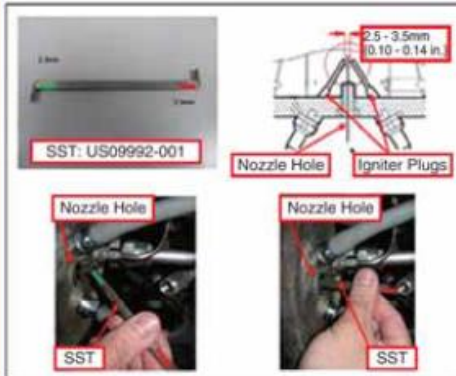
P2030-01-05

1. Check igniter plug gap.  
The SST is a "Go - No-Go" gauge to check the igniter gap at the tips. The tool has a 2.5 mm (0.10 in.) gauge on one end and a 3.5 mm (0.14 in.) gauge on the other end. The 2.5 mm (0.10 in.) end should be able to pass between the igniter tips while the 3.5 mm (0.14 in.) end should not.

Remove both blue ceramic igniter plugs from the combustor. And carefully cleaned up by break cleaner and wire brush.  
Switch igniter positions side to side. Reinstall both igniter plugs and torque to the specified torque.  
Specified Torque: 22.0 lb-ft (29.8 N-m). Check the gap again. If the gap is still out of spec, remove one (1) igniter from the combustor and exchange it with another new one. Due to manufacturing variability of igniters it may be necessary to replace one of the two igniters to bring the gap within specification and then go to step 5.

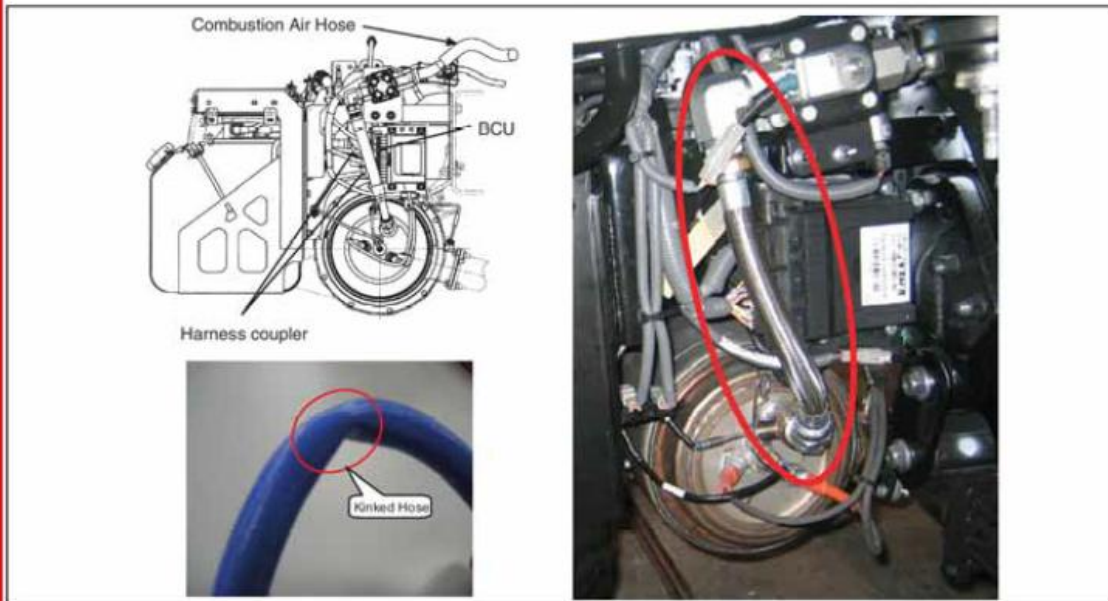
P2030-n22

Standard value
Not kink, not loose, not leaks, not restriction

Repair/Replace.  
And then go to step 6.

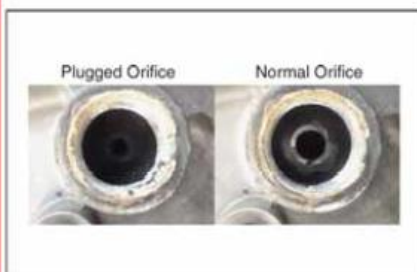
step2-15

Combustor orifice must be periodically replaced every 150,000 miles.

Measurement condition	Measurement site
Starter switch: LOCK	Combustor
Standard value	
11.25 - 11.75 mm (0.44 - 0.46 in.)

Clean the hole by brake cleaner / wire brush and then go to step 7.

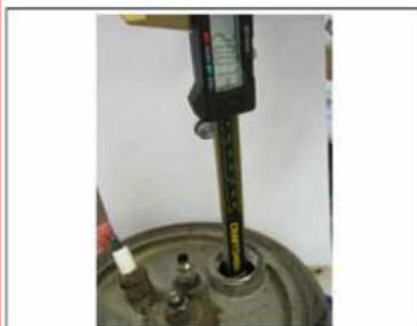
Step2-16

Measurement condition	Measurement site
Starter switch: LOCK	Combustor
Standard value	
Depth is 20 mm (0.78 in.) or less

Replace the combustor and then go to step 8.

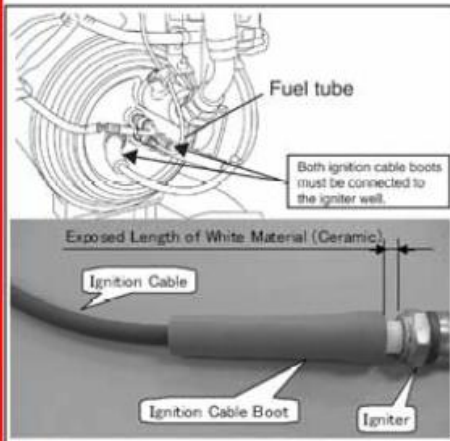
p2000-18

Is the exposed length 7mm (0.28 in.) or less?  
Is there no loose?

Repair and then go to step 3.

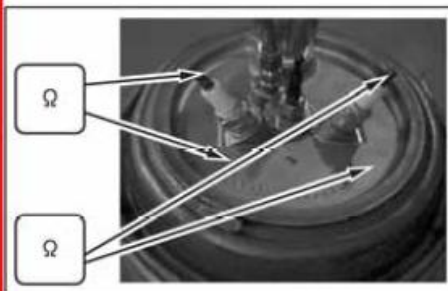
P2000-20

The insulation resistance of the igniter decreases with excessive deposit of soot and/or fuel on the igniter surface. In this case, the spark is not generated at the tip of the igniter, and there is leakage at the combustor.

Perform step 3 again. If no spark, replace the ignition coil and then go to step 3.

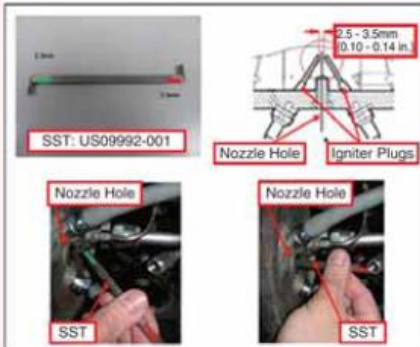
P2030-01-05

#### 1. Check igniter plug gap.

Remove both blue ceramic igniter plugs from the combustor. And carefully cleaned up by break cleaner and wire brush. Switch igniter positions side to side. Reinstall both igniter plugs and torque to the specified torque. Specified Torque: 22.0 lb-ft (29.8 N·m). Check the gap again. If the gap is still out of spec, remove one (1) igniter from the combustor and exchange it with another new one. Due to manufacturing variability of igniters it may be necessary to replace one of the two igniters to bring the gap within specification and then go to step 3.

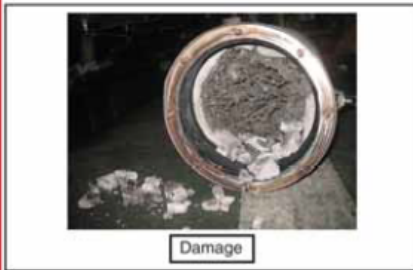
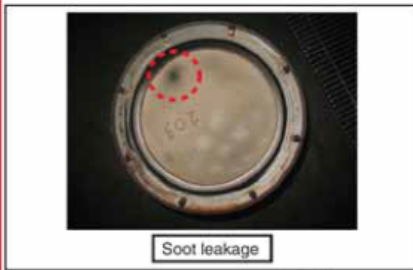
step17-01

When DPR filter is melted, the combustion air cannot be supplied correctly.

Damage / soot leakage found on DPR filter outlet surface?

DPR replacement.  
Clean the igniters, and then go to step 3.

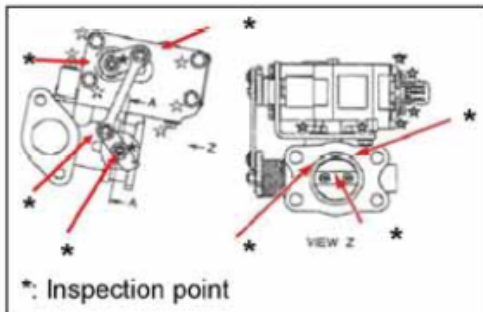
P2030-36

No shaft rattle?, No butterfly valve screw loose?, No link rod rust?

Replace the EGR valve.  
And then go to step 11.
