Technical Information Bulletin

ECM Mount Modification{7000}

Media Number -TIBU7306-00

CT660 (S/N: TRK1-UP; TKL1-UP; TJS1-UP; TGT1-UP; TSW1-UP; TSY1-UP)

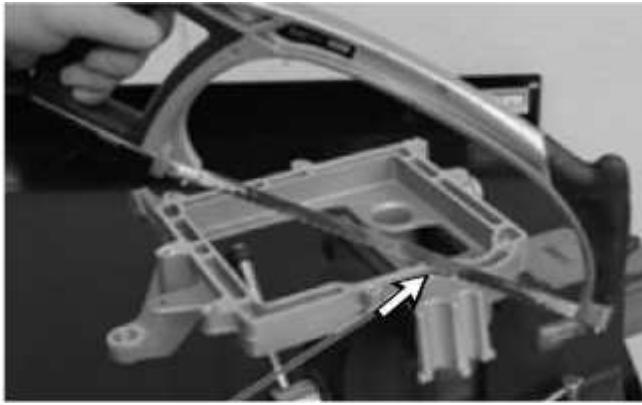
Illustration 1

The engine harness can rub on the harness mounting location of the ECM mount.

1. Using a hack-saw or other acceptable method, cut off harness support bracket from bottom of ECM bracket.
