K452NAS1

TECHNICAL BULLETIN

08 MAR 2017

Service Action: Track Rod End Adjusting Locking Nut

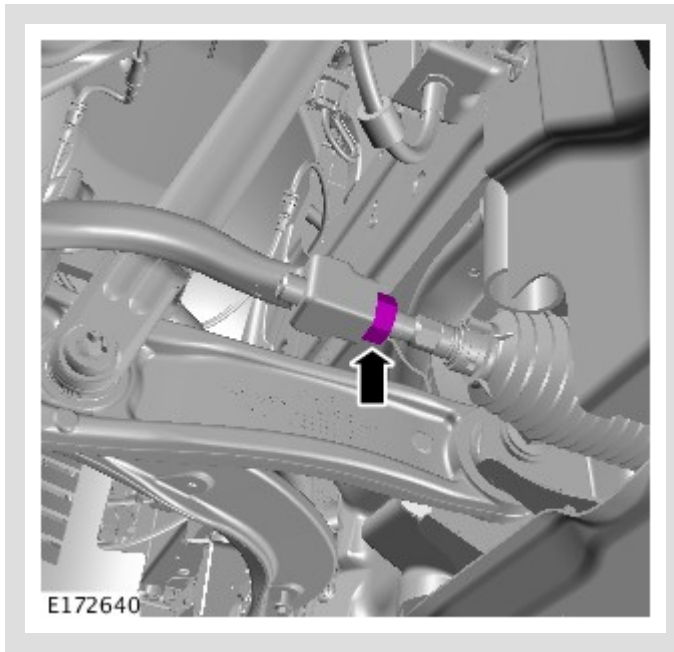
2

An issue has been identified on certain vehicles within the listed Affected Vehicle Range which have had an incorrect torque applied to the front left and right tie-rod adjustment lock nut.

Tighten the front left tie-rod adjustment lock nut using tool JLR-211-347.

Torque: **100 Nm** .
