Preliminary Information

PIP5191B Engine Ticking Noise or oil pressure fluctuation On Cold Start

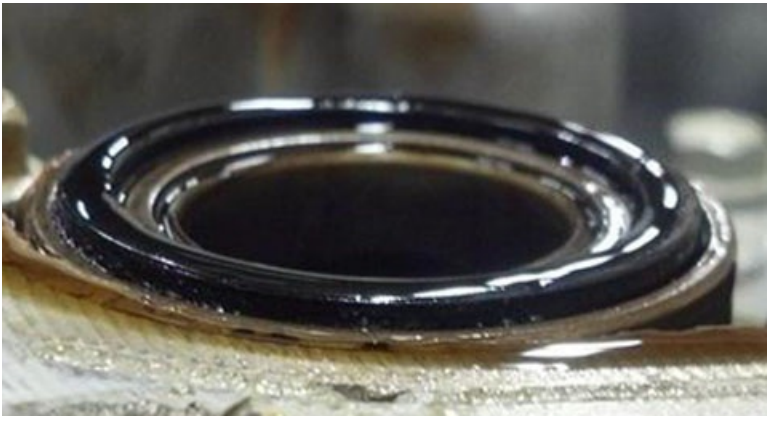
This is an example of a new seal

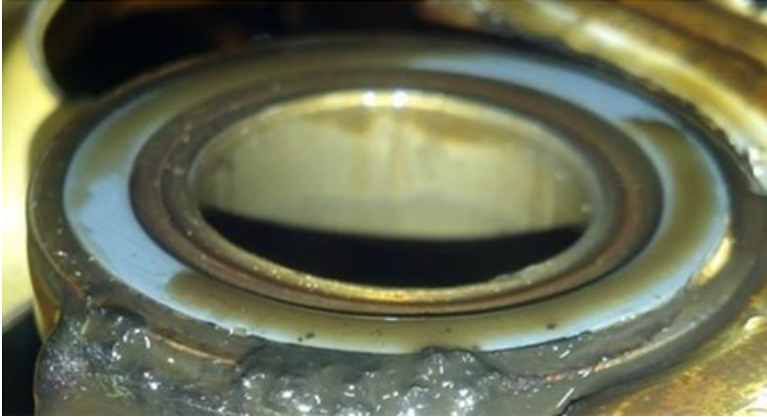
We have identified a possible concern with the oil pump pick-up tube to block seal being compressed.

When this occurs there is the potential to draw in air when first started before the pump picks up oil to seal the gap, Or to continue to pull some air causing oil pressure fluctuation.

This is an example of a compressed (worn out) seal

If this seal is compressed within the cutout of the pick-up tube, then replace the seal and reevaluate the concern.
