Technical Service Bulletin

19 Thermostat, electric fault (DTC P0599, P0597, P2181)

19 16 68 2042328/2 March 9, 2016. Supersedes Technical Service Bulletin Group 19 number 15-63 dated October 29, 2015 for reasons listed below.

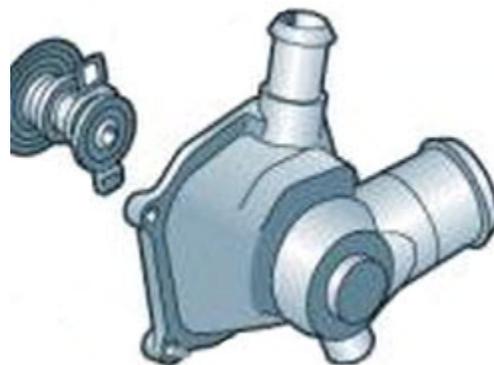
Tolerances of opening spring in thermostat cause the condition.

Figure 2. Coolant thermostat housing for map-controlled engine cooling.

If one of the DTCs listed in the *Condition* is stored, replace the coolant thermostat housing for map-controlled engine cooling (Figure 2).

It is not necessary to replace the complete coolant pump.
