Technical Service Bulletin

19 Coolant temperature control implausible signal

19 16 69 2043770/1 March 31, 2016.

Model(s)	Year	VIN Range	Vehicle-Specific Equipment
R8	2007 - 2015	All	Not Applicable

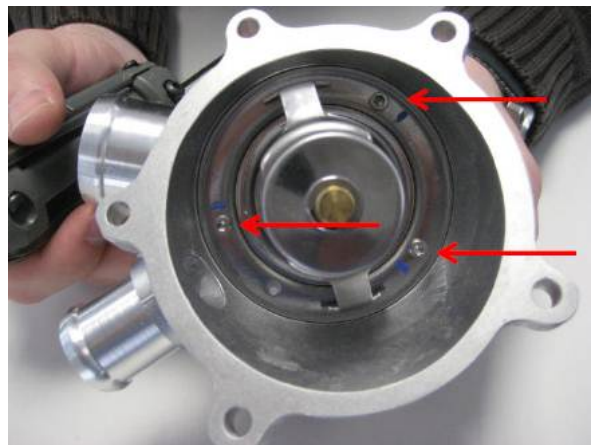
Figure 1. Remove the three Allen screws (red arrows) to remove the thermostat.

1. Remove the coolant thermostat housing according the instructions in Elsa.
2. Note the position of the thermostat element within the housing. Remove the thermostat element by removing the three Allen screws (Figure 1).

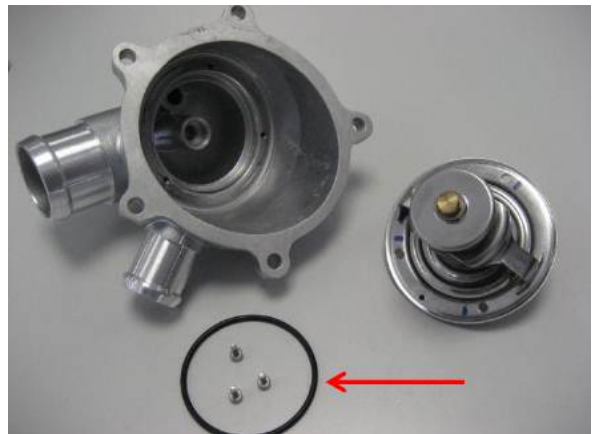
Figure 2. Thermostat housing seal (red arrow).

3. Take the seal out of the thermostat housing and replace it with the new seal (Figure 2).

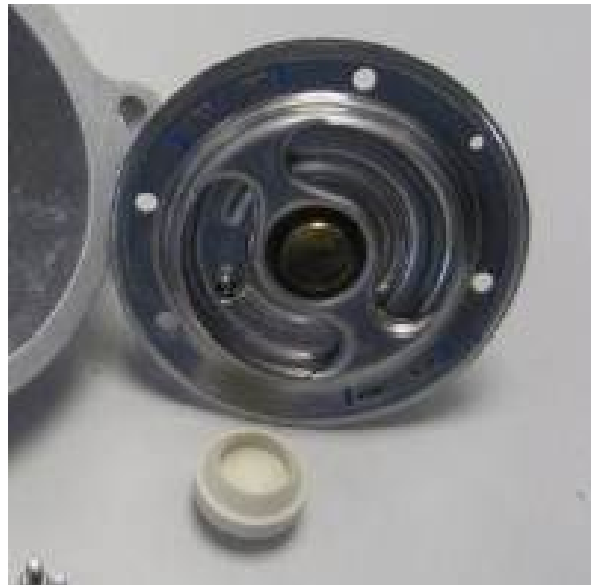
Figure 3. *Insulation sleeve.*

4. Ensure that the insulation sleeve is fitted on the underside of the thermostat element (Figure 3). Before fitting the insulation sleeve and O-ring, lightly coat them with coolant.

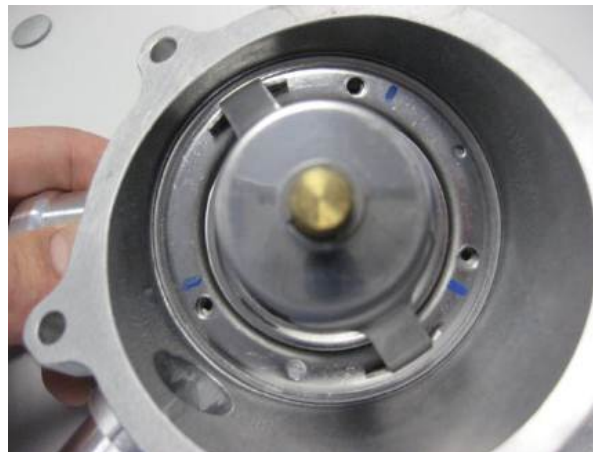
Figure 4. *New thermostat installed.*

5. Insert the new thermostat element (including insulation sleeve) into the housing (Figure 4).

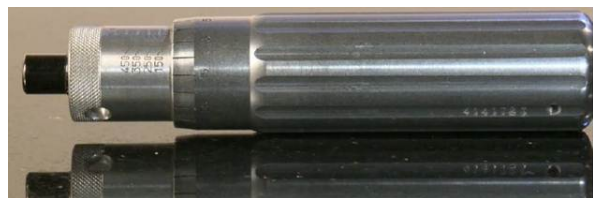
Figure 5. *Torque wrench.*

6. Secure the thermostat element with the three new Allen screws. Use special tool V.A.G 1624 or VAS6494, or equivalent torque wrench (Figure 5). Tighten to 2 Nm (+1 / - 0 Nm).
