# Technical Service Bulletin

## 19 Heating output insufficient

19 17 78 2046971/1 February 24, 2017.

Model(s)	Year	VIN Range	Vehicle-Specific Equipment
S8 +	2016 - 2017	All	Not Applicable

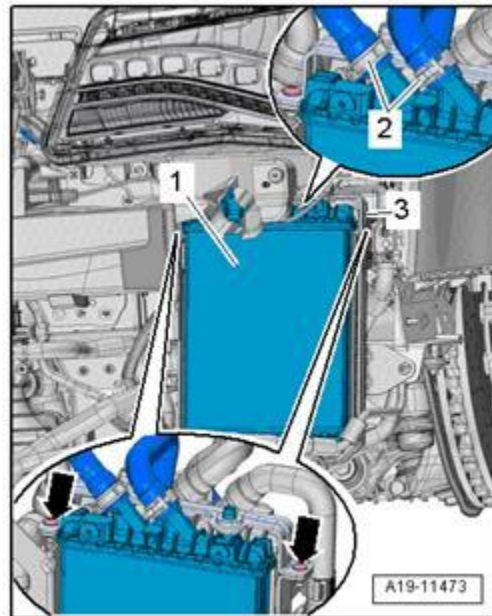
Air is in cooling system circuit.

Figure 1. Hose with check valve.

Improved lower coolant hose with check valve.

4. Replace hose with check valve.
