Technical Service Bulletin

20 Problems fueling vehicle and/or MIL on (DTC P044100 or P045100)

20 17 87 2044667/3 February 8, 2017. Supersedes Technical Service Bulletin Group 20 number 17-86 dated January 27, 2017 for reasons listed below.

Model(s)	Year	VIN Range	Vehicle-Specific Equipment
RS 5, RS 5 cabriolet	2013 - 2015	All	Not Applicable

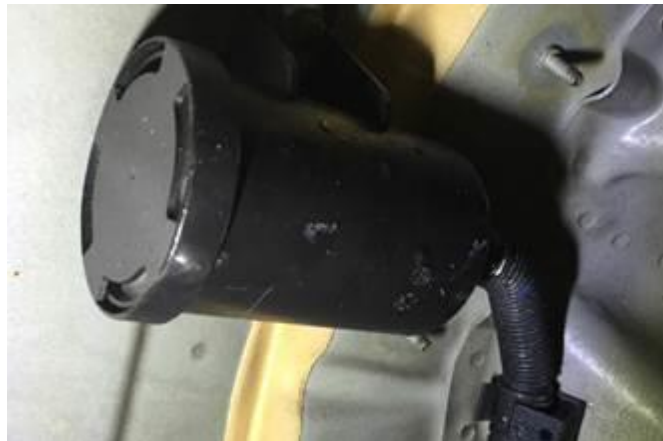
Water enters through the tank ventilation system. The water can flow through the NVLD pressure switch into the activated charcoal filter and freeze in cold temperatures.

Figure 1. Ventilation tube of the activated charcoal filter.

1. Remove activated charcoal filter, ventilation tube, and NVLD pressure switch. Cap off opening to prevent any liquid from escaping.
2. Weigh activated charcoal filter:
 - If it weighs more than 2600 grams, replace the activated charcoal filter, ventilation tube (Figure 1), and NVLD pressure switch.
 - If it weighs less than 2600 grams, replace the ventilation tube (Figure 1) and the NVLD pressure switch.
