Service Bulletin No. 399

<i>MODEL</i>	J4500 Series	<i>TYPE</i>	Field Change Program	<i>SECTION/GROUP</i>	7-Electrical	<i>DATE</i>	Oct. 2, 2013
<i>SUBJECT</i>	WABCO ESC/ ABS ECU						
<i>CONDITIONS</i>

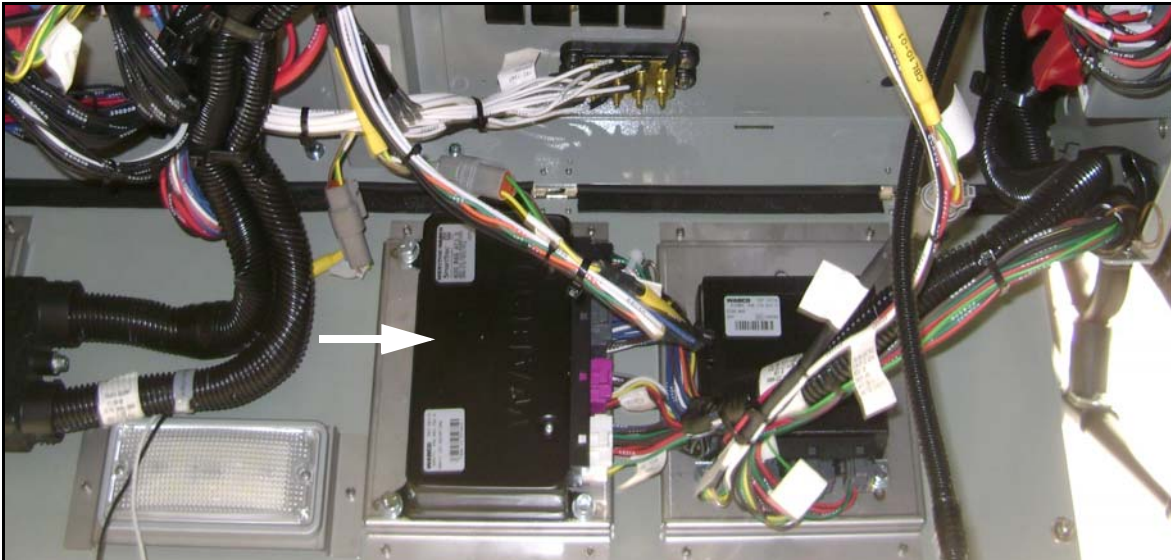
Figure 1.

1. Position the main disconnect rotary switch to the DOWN (OFF) position.
2. Chock both sides of the tires.
3. Open the curbside and roadside doors of baggage bay compartment #3.
4. Locate the rear electrical junction box mounted to the ceiling of baggage bay compartment #3. Release the rubber T-straps on the electrical junction box closing panel.
5. Locate the ECU on the hinged electrical junction box closing panel (refer to Figure 1.).

6. Carefully disconnect the four (4) harnesses from the ECU.
7. Remove and retain the mounting hardware from the ECU. Remove and retain the ECU for submittal back to MCI.
