SERVICE BULLETIN

EC12-012k

December 1, 2016

MIL ON WITH DTC P0101

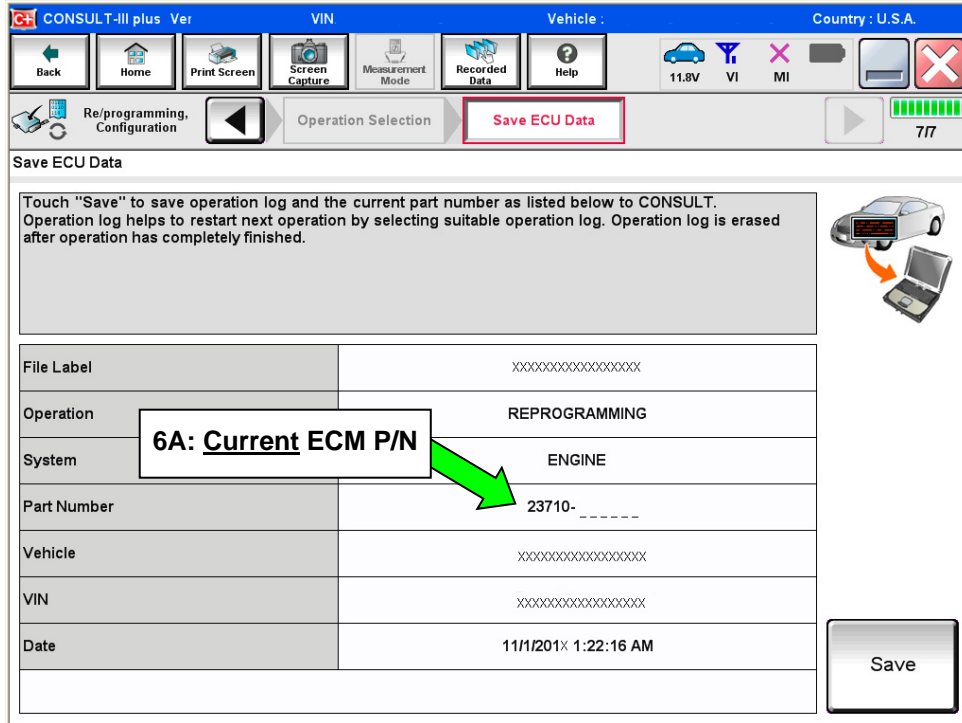
Figure 2

6. When you get to the screen shown in Figure 2, confirm this bulletin applies as follows.
- A. Find the ECM **Part Number** and write it on the repair order.

NOTE: This is the current ECM Part Number (P/N).

- B. Compare the P/N you wrote down to the numbers in the **Current ECM Part Number** column in **Table A** on the next two pages.
- If there is a match, this bulletin applies. Continue with the reprogramming procedure.
 - If there is not a match, this bulletin does not apply. Close C-III plus and refer to ASIST for further diagnostic information.

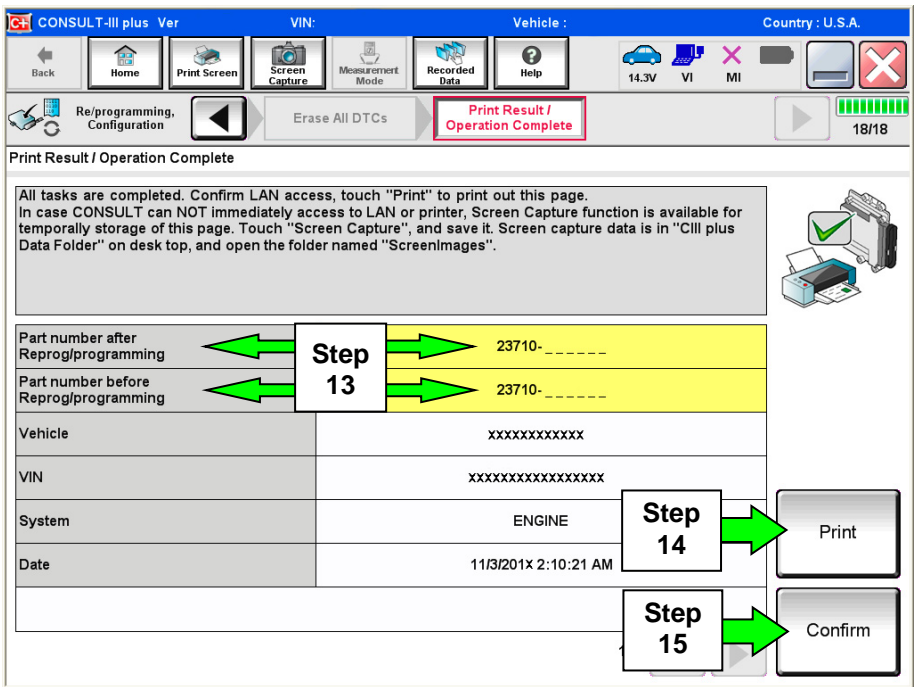
- 12. When the entire reprogramming process is complete, the screen in Figure 7 will display.
- 13. Verify the before and after part numbers are different.
- 14. Print a copy of this screen (Figure 7) and attach it to the repair order for warranty documentation.
- 15. Select **Confirm**.
