EC16-035

INFINITI; DTC P0456 CAUSED BY EVAP LEAK AT VENT CONTROL VALVE O-RING

APPLIED VEHICLES: 2017-2018 QX30 (H15)
2014-2017 QX50 (J50)
2016-2017 QX60 and QX60 Hybrid (L50)

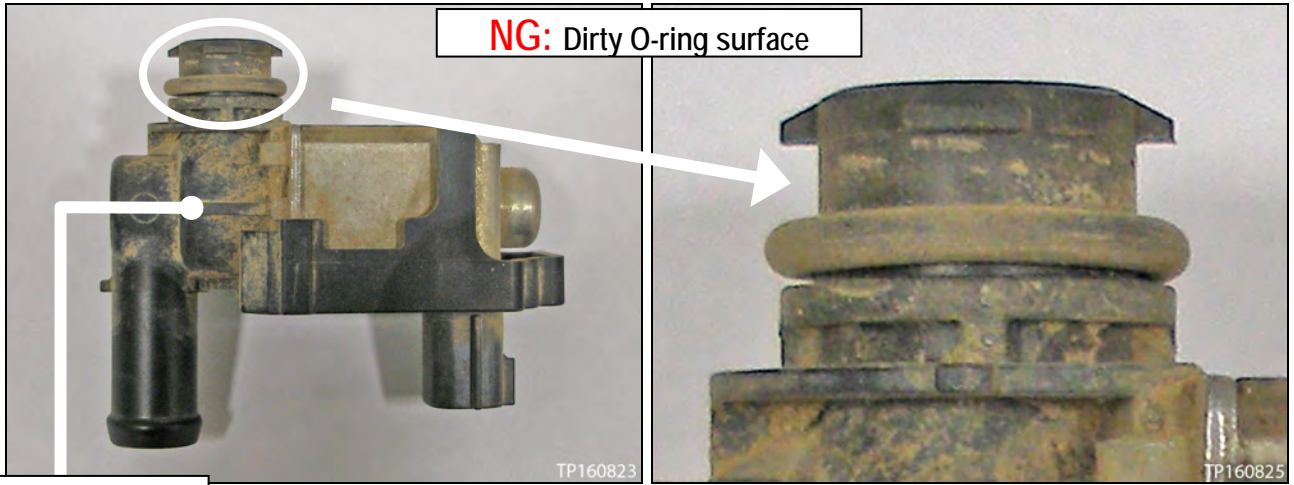
Vent control valve

- Make sure the surfaces that the O-ring comes in contact with are clean.
- When installed, make sure the O-ring is not twisted or rolled over.
- Verify the repair is complete by checking for leaks with a “smoke” leak detection machine or CONSULT-III plus (C-III plus).
 - If a “smoke” leak detection machine is used, follow the manufacturer’s operating instructions.
 - If C-III plus is used:
 1. Confirm the fuel filler cap is secure.
 2. Connect Essential Tool J-42909 to the EVAP service port.
 3. Using Active Test, close the vent control valve.
 4. Apply pressure using J-42909 until the bar graph reaches about halfway.
 5. Monitor the bar graph for 10 minutes.

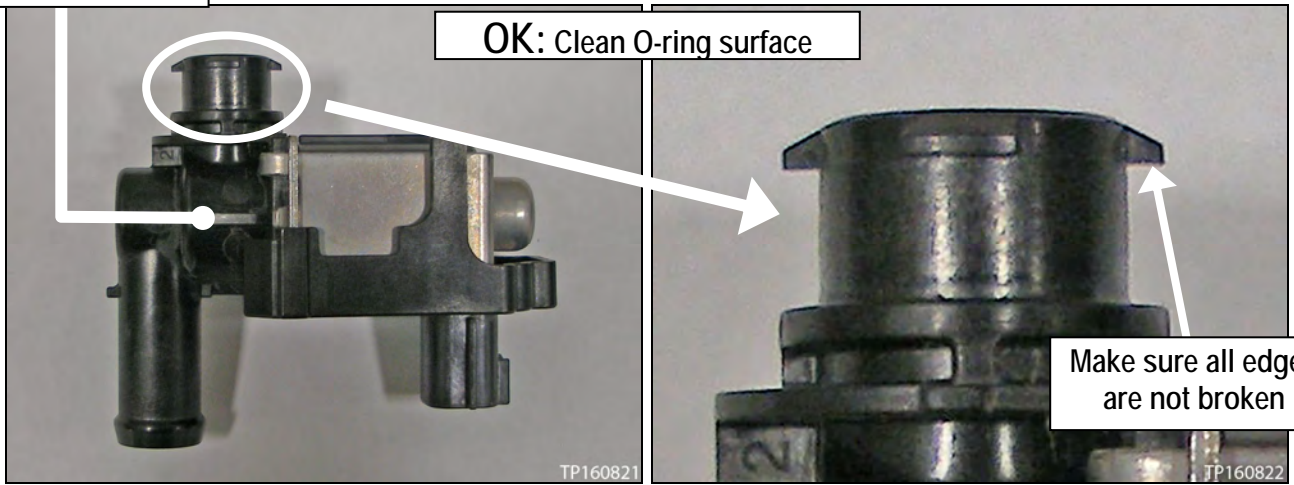
Where vent control valve mounts in canister

Canister

This surface must be clean all around
