Fault P029900 Stored In The DME Due To Loose Vacuum Line

Vehicle Type: **Panamera 4S/Turbo (971)**

Model Year: **2017 built before 12.22.16**

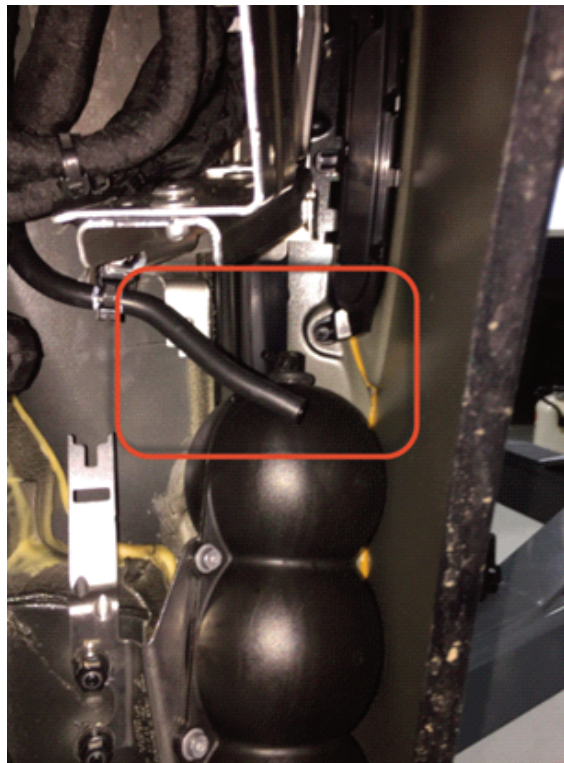
Issue: Fault **P029900-Turbo/Super Charger Underboost** stored in the DME.

Information: A vacuum line at the vacuum reservoir in the left front wheel well was not connected properly during production and may become disconnected (see the picture below). The repair is to simply reconnect the line and make sure it is not under tension.
