WC18 - Reworking Motor for Rear Side Section Flaps (Workshop Campaign)

Vehicle Type: **911 Carrera (991)/911 Carrera S (991)**

Model Year: **2012**

Concerns: **Motor for rear side section flaps**

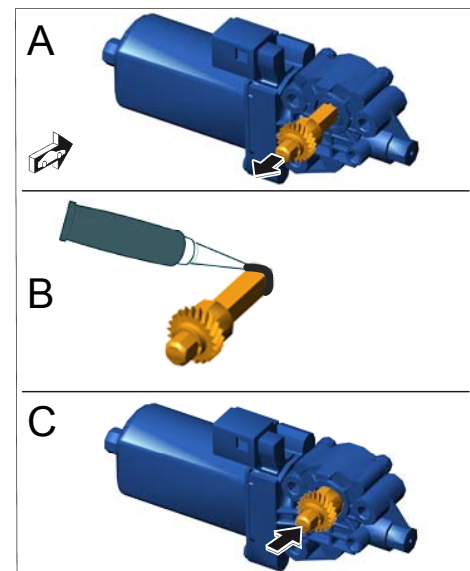
Figure 1

Information: This is to inform you of a voluntary Workshop Campaign on the above-mentioned vehicles. There is the possibility that motors for controlling the rear side section flaps, on which the pinion shaft is not connected properly to the motor due to a manufacturing defect, were installed in the affected vehicles.

In the event of emergency operation, the convertible top cannot therefore be closed manually as described in the Owner's Manual.

2.1 Pull pinion shaft out of the guide for the motor ⇒ *Figure 1 -A-*.

2.2 Clean contact surfaces on the pinion shaft and motor.

2.3 Coat the end of the pinion shaft with **Loctite 480 adhesive** all the way around ⇒ *Figure 1 -B-*.

2.4 Insert the coated pinion shaft into the motor immediately (adhesion time: 10 to 150 sec.) and slide it in as far as it will go ⇒ *Figure 1 -C-*.

The glued pinion shaft must stick securely to the motor. Check that the pinion shaft is adhered correctly (glue it on again if necessary).
