Misfiring at High RPM (59/15)

Vehicle Type: **911 GT3 (991)**

Concerns: **Engine malfunction (Misfiring at high rpm)**

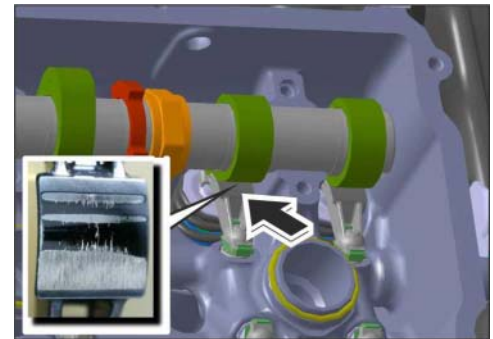
Wear on valve lever

The following problems indicate a worn valve lever:

- Rough surface on the cams of the cylinder in question. If there is a significant amount of wear, the contour of the tip of the cam will be "square" and will show significant tempering colors (blue/brown discoloration of the material caused by high temperatures).
- The valve lever shows significant signs of linear wear on the contact surface to the cam ⇒ *Wear on valve lever -arrow-* at the edge of the hydraulic valve clearance compensating element ⇒ *Wear on valve lever -inset-*. The black coating is worn down and the silver base material can be seen.

3 Take a photo of the relevant damaged areas of the valve lever ⇒ *Wear on valve lever -arrow-* for documentation purposes. Make sure that the photos clearly show the installation position of the valve levers in question.

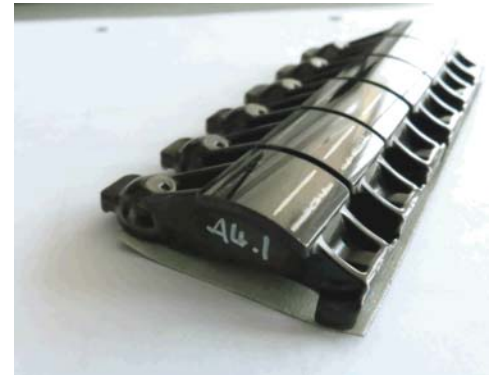
Marking valve levers

Also indicate the installation position of the valve levers in question (e.g. cylinder 6 – intake) or identify the components by labelling them ⇒ *Marking valve levers*.
