# Technical Service Bulletin

## 20 Problems fueling vehicle and/or MIL on (DTC P044100 or P045100)

20 17 86 2044667/2 January 27, 2017. Supersedes Technical Service Bulletin Group 20 number 16-72 dated June 27, 2016 for reasons listed below.

Model(s)	Year	VIN Range	Vehicle-Specific Equipment
RS 5, RS 5 cabriolet	2013 - 2015	All	Not Applicable

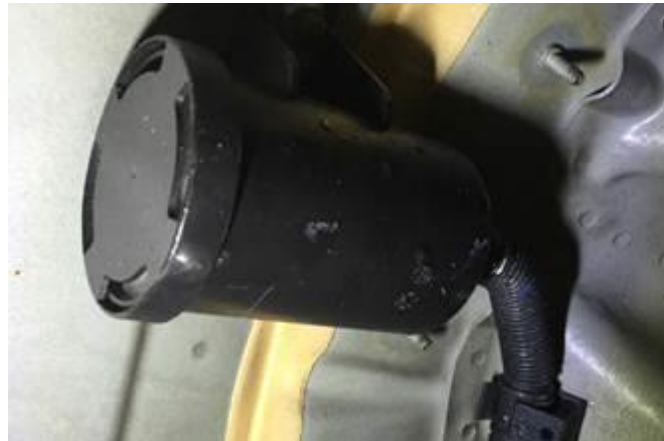
Water enters through the tank ventilation system. The water can flow through the NVLD pressure switch into the activated charcoal filter and freeze in cold temperatures.

**Figure 1.** Ventilation tube of the activated charcoal filter.

1. Remove activated charcoal filter, ventilation tube, and NVLD pressure switch. Cap off opening to prevent any liquid from escaping.
2. Weigh activated charcoal filter:
  - If it weighs more than 2600 grams, replace the activated charcoal filter, ventilation tube (Figure 1), and NVLD pressure switch.
  - If it weighs less than 2600 grams, replace the ventilation tube (Figure 1) and the NVLD pressure switch.
