Technical Service Bulletin

91 Complaints about GPS or satellite radio reception, repair coaxial cable

91 17 04 2045106/2 January 26, 2017. Supersedes Technical Service Bulletin Group 91 number 16-75 dated September 20, 2016 for reasons listed below.

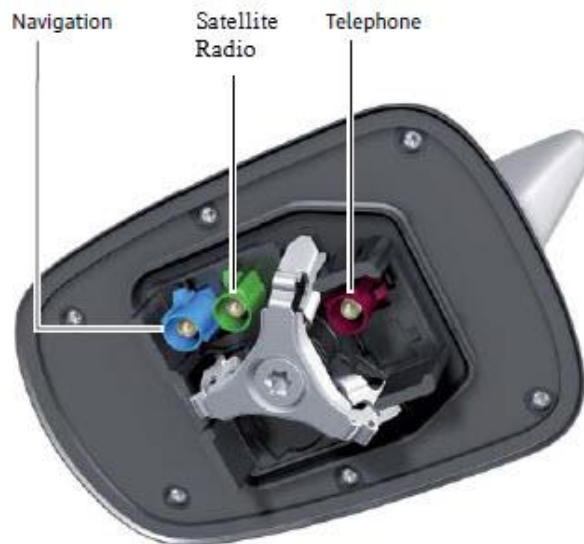
The correct circuit can be identified by the color on the antenna connector. See Figure 1. Not all antenna connectors are laid out the same.

Figure 1. Identify the correct circuit by the color of the antenna connector. Blue: Navigation. Green: Satellite Radio. Connector placement on antenna will change by vehicle options, reference the wiring diagram for your specific vehicle.
