YEAR(S)	MODEL(S)	ADDITIONAL INFORMATION
2014 - 2017	Tundra

TOYOTA T-SB-0277-17 September 6, 2017 Page 2 of 6

Clearance Warning Sonar Sensor False Detection

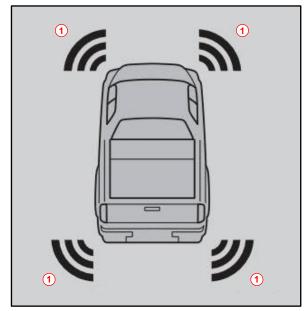
Figure 1.

- Does the clearance warning sonar display indicate there is an object in a detection area when no objects are present in the detection areas?
 - YES Continue to step 2.
 - NO This bulletin does NOT apply.
 Continue diagnosis using the applicable Repair Manual.

1 Detection Area and Sensor Location

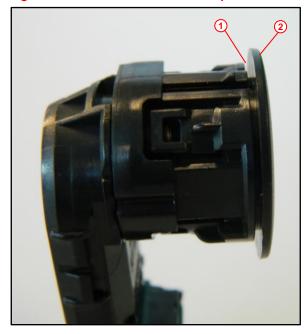
Figure 3. Ultrasonic Sensor Without Spacer

1	Groove
2	Sensor

2. Clean any debris from the sensor assembly groove and bumper surface.

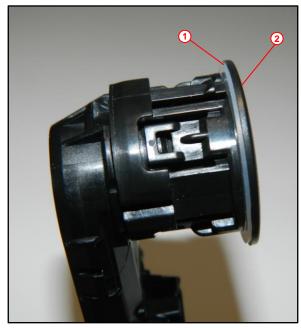
Figure 4. Ultrasonic Sensor With Spacer Installed*

1	Silicon Rubber Spacer
2	Sensor

3. Install a spacer in the groove on the ultrasonic sensor.
