H037NAS2

TECHNICAL BULLETIN

211-03: Steering Linkage

Service Action: Steering Gear Tie-Rod End Ball Joints

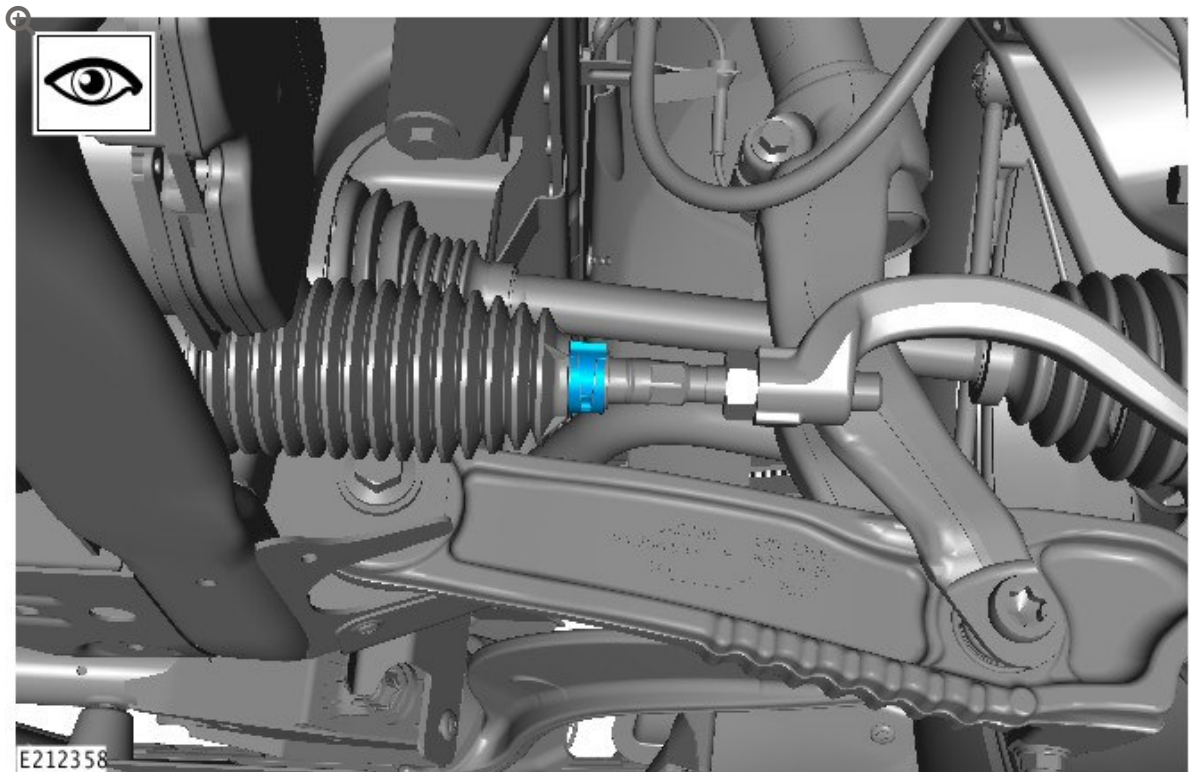
2

Right tie-rod shown; left tie-rod similar.

Inspect the tie-rod bellow clamp for a yellow paint mark indicating that the repair has previously been completed.

- If the identification mark is present, **go to Step 6.**
- If the identification mark is not present, **go to Step 3.**

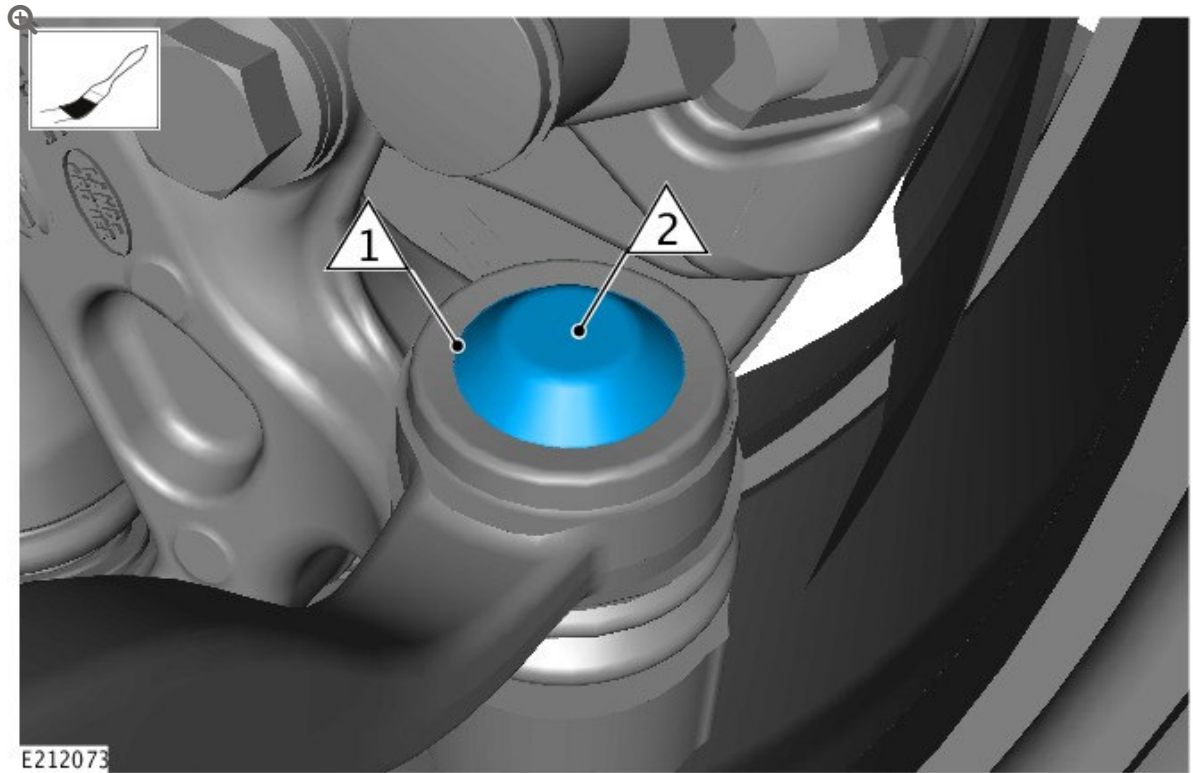
4

The area must be dry before application of the sealing wax.

Apply the sealing wax to the tie-rod end retaining cap.

- 1 Make sure there is sufficient wax applied to seal the retaining joint cap.
- 2 Make sure the wax coats all of the retaining cap surface.
