JTB00578NAS1

TECHNICAL BULLETIN

501-14: Handles, Locks, Latches and Entry Systems

Keyless Entry System Lock Function May Not Operate and/or Operates Intermittently

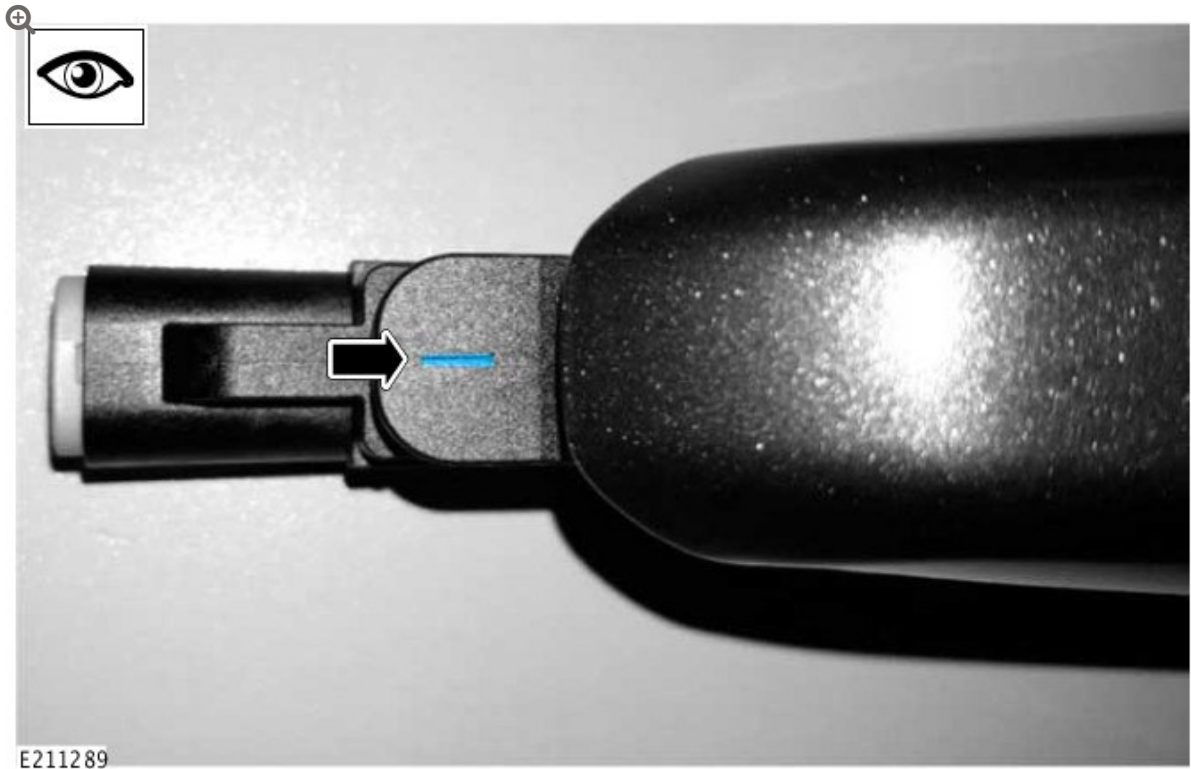
Inspect the new door exterior handle(s) for the identification mark.
