Reference	SSM73095
Models	F-PACE / X761 XE / X760 XF / X260
Title	DTC P026A -77 and P023B-11 Logged Within PCM
Category	Engine
Last modified	25-Sep-2017 00:00:00
Symptom	402000 Cooling System Concerns
Attachments	1SSM73095 Attachment v2.pdf (1SSM73095 Attachment v2.pdf)

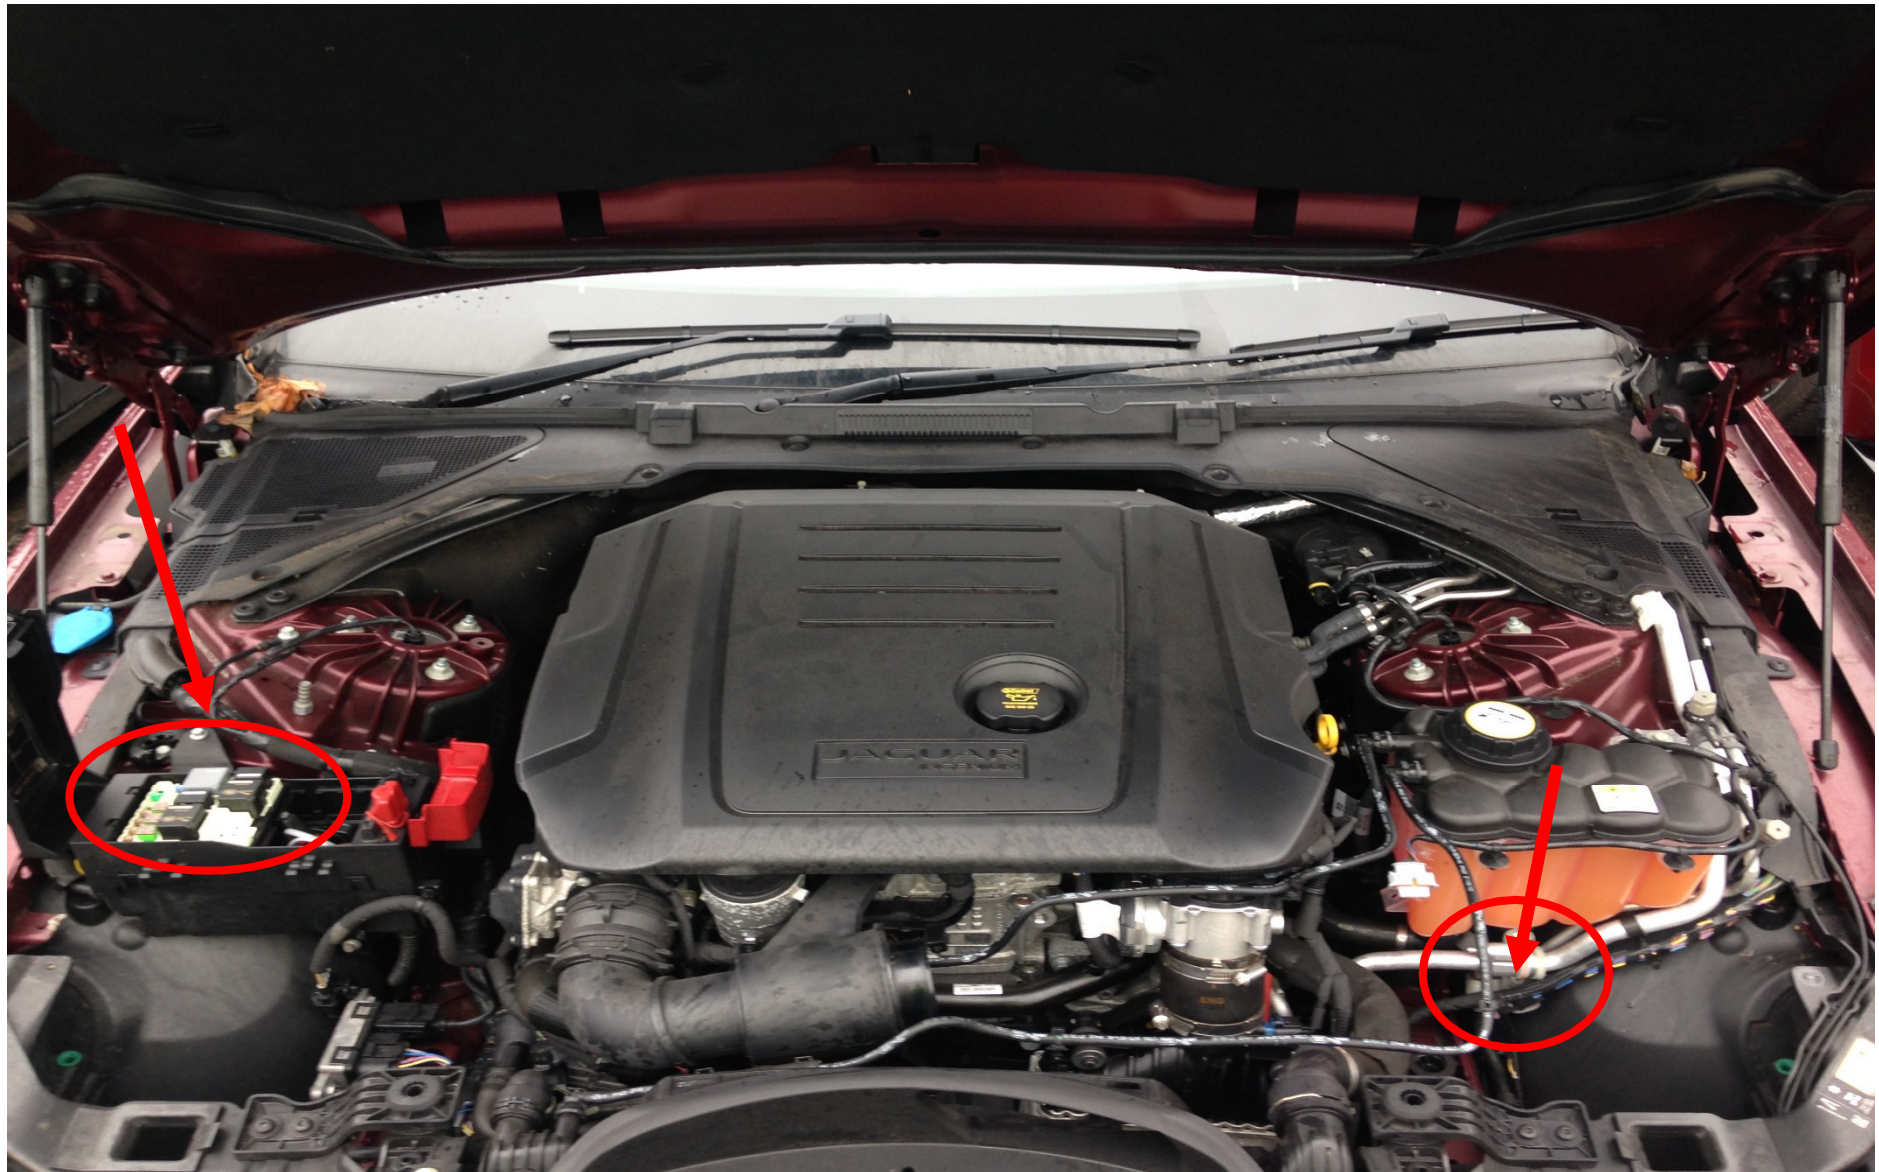
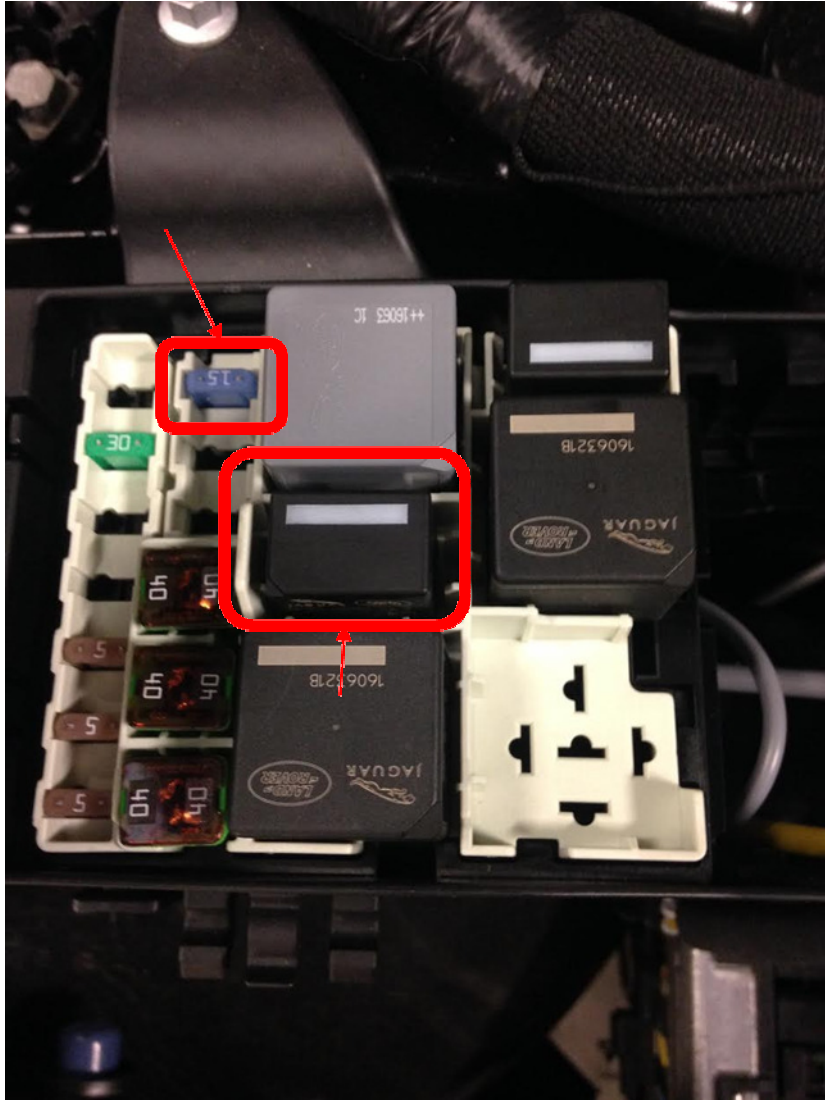
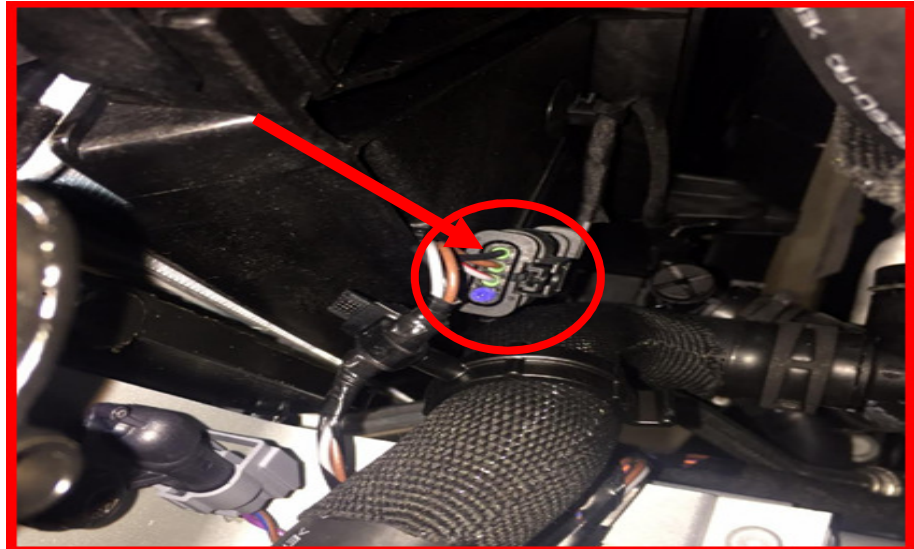
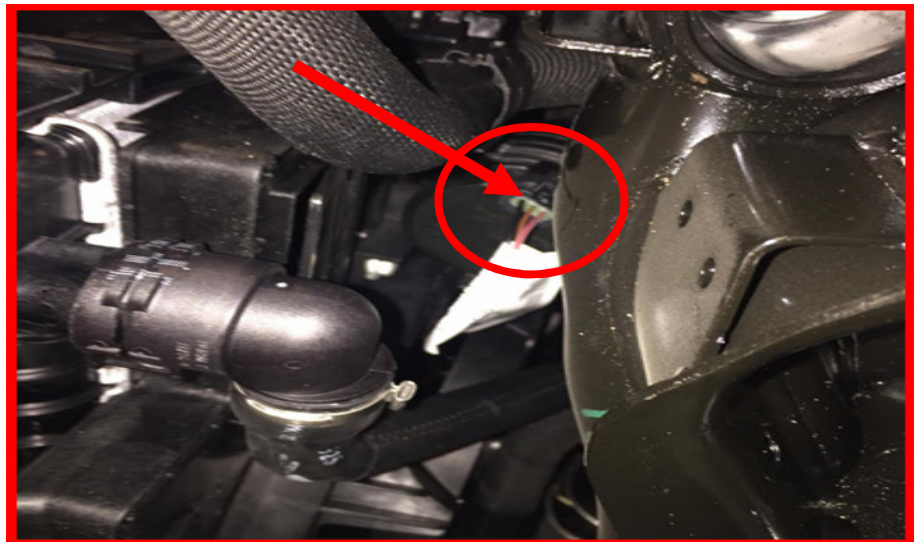
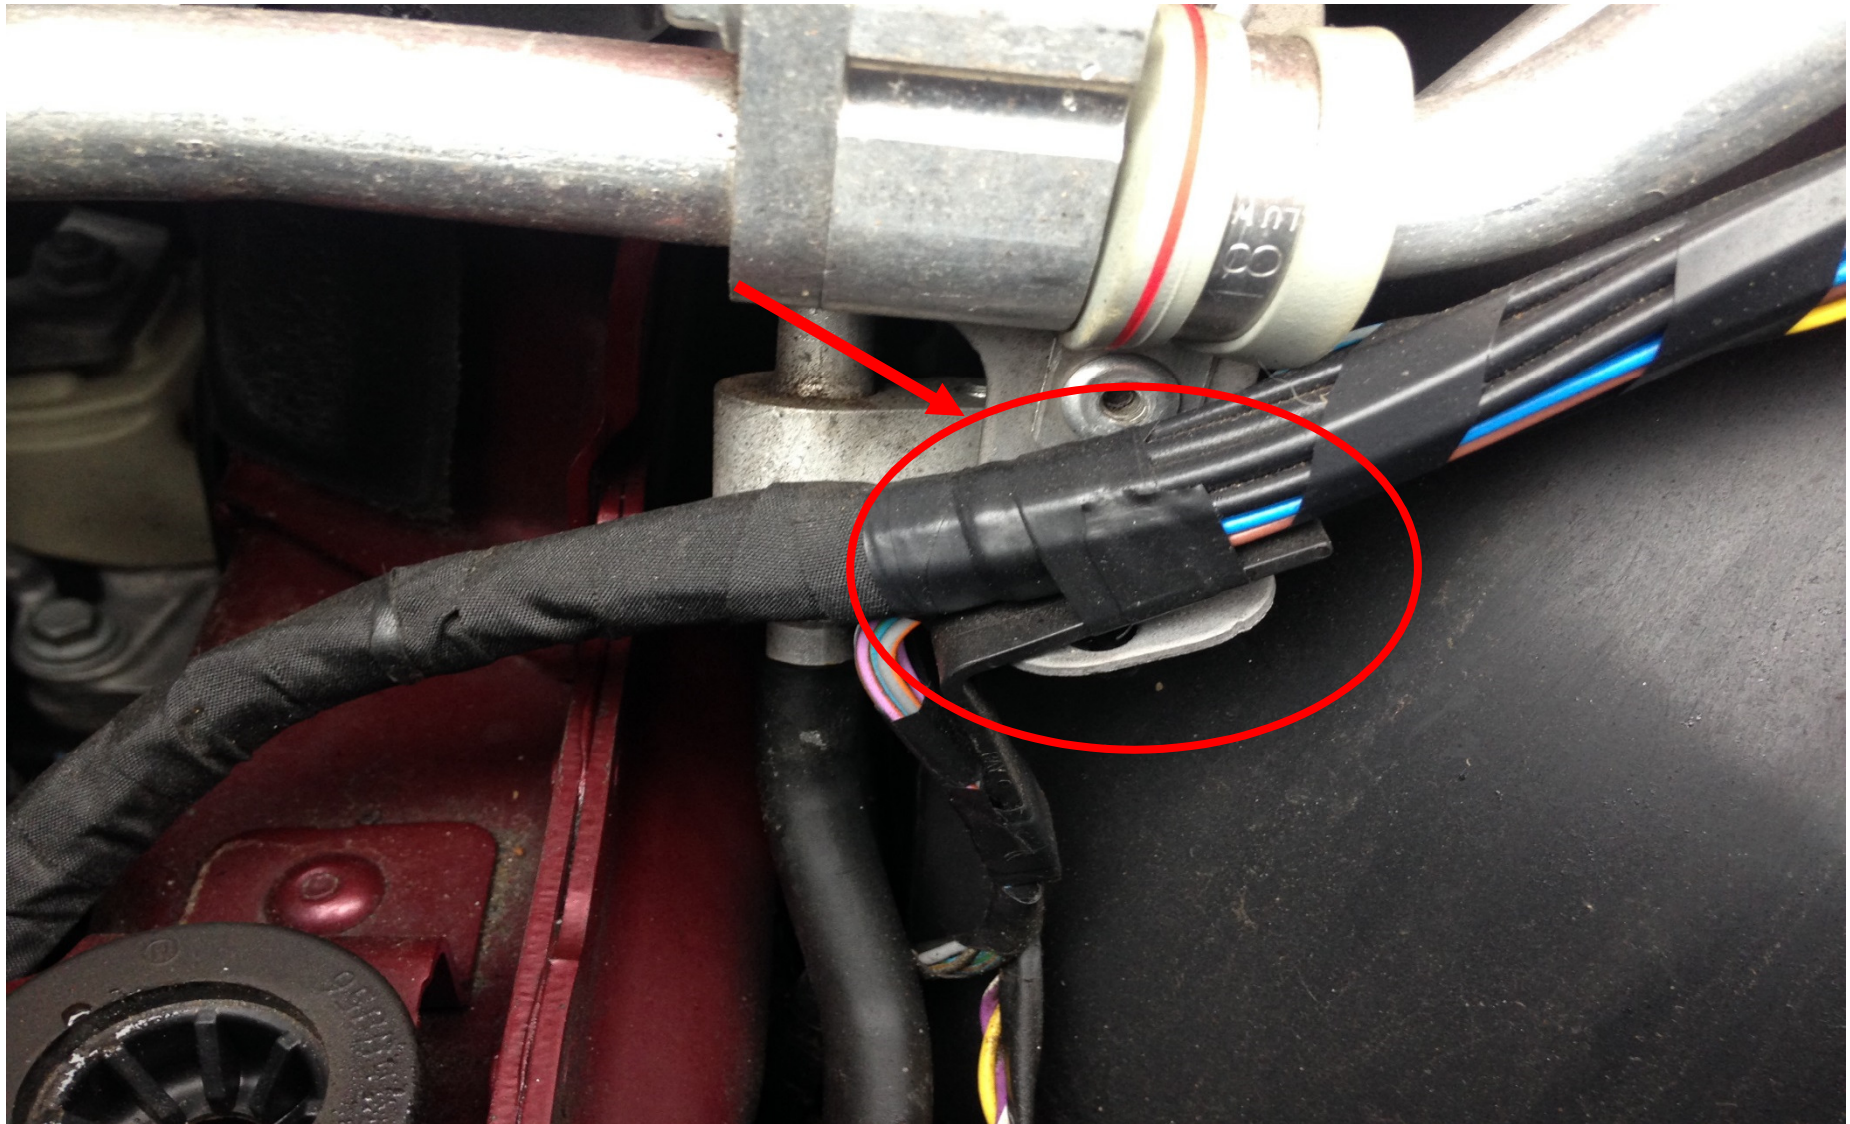
Upon investigation, a number of different root causes have been identified which should be addressed before the Charge Air Cooler Coolant Pump is replaced, these are listed below:

- Potential of air locks in the cooling system
- Harness chafe on the 12+
- Poor earth connection
- Poor fuse connection in the front engine junction box

- Complete the coolant system bleeding process as per Topix section 303-03A
- Please check ground point G1D132D
- Please view the attached PDF which contains images of the potential electrical connection issues and potential harness chafe points which could cause these DTC's.
