Technical Service Bulletin

01 MIL on (DTC P1545, P0121, P0123, P0221 or P0222)

01 15 15 2018260/9 March 10, 2015. Supersedes Technical Service Bulletin Group 01 number 14-96 dated September 26, 2014 for reasons listed below.

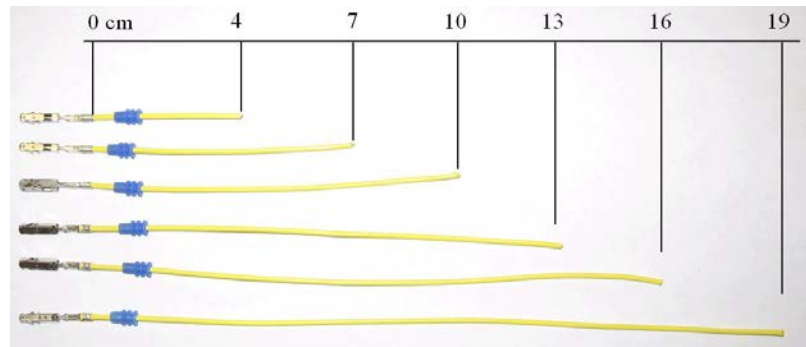
Figure 1. Correctly preassembled wires and seals.

3. Lengthen wires and preassemble seals as shown (Figure 1).

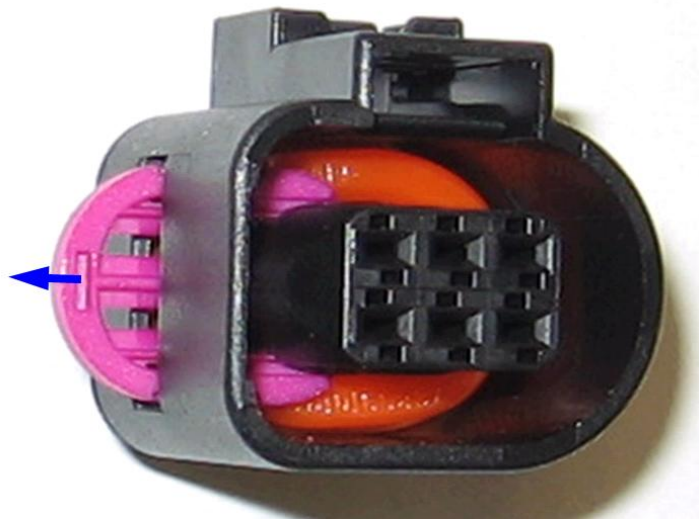
Figure 2. The slot to be used to remove the pink lock.

4. On the new housing, remove pink lock with small flathead screwdriver, using the slot on the pink lock (Figure 2).

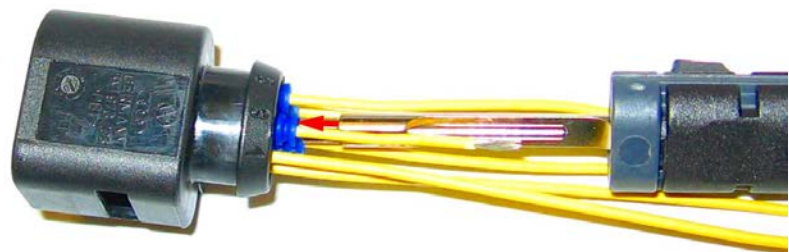
Figure 3. The single wire seal, slid as far as the stop.

5. Insert all terminals into housing until they audibly click.
6. Reinstall pink lock.
7. Using the appropriate assembly tool, slide the single wire seal up the repair wire until it contacts the housing. Continue to slide the single wire seal into the housing as far as the stop (Figure 3).
