Technical Service Bulletin

01 MIL on (DTC P310B, P129F, P008B, P129E, P008A, P2540, P0087)

01 15 17 2027417/4 March 12, 2015. Supersedes Technical Service Bulletin Group 01 number 12-45 dated March 16, 2012 for reasons listed below.

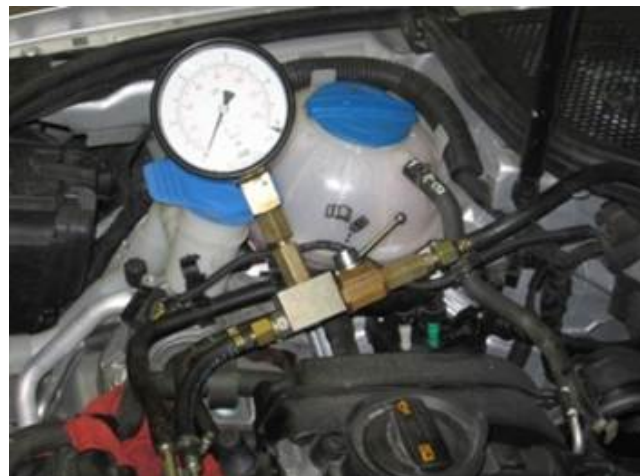
A false signal may be sent to the controller due to fuel intrusion into the low-pressure system fuel pressure sensor, G410. The result is a reading that is out of tolerance.

Figure 1. VAG 1318 gauge installed on an A3 2.0L TFSI.

1. Verify that *24T4 UPDATE - Fuel Pressure Sender (Warr_Ext)* was performed (if applicable).
2. Verify the customer did not run out of fuel at the time the DTCs were stored.
3. Follow indication of GFF for applicable DTCs.
4. To check the low-side fuel pressure sensor G410, measure the fuel pressure with a mechanical gauge using the following method:
 - a. Start engine and allow it to idle for at least one minute.
 - b. Stop the engine.
 - c. Keep the ignition on.
 - d. Measure actual low-side fuel pressure via mechanical gauge (VAG 1318) on the low pressure supply line in the engine compartment (Figure 1).

5. Add 1 bar to the value obtained from the mechanical gauge to calculate the adjusted gauge measurement value.
6. Compare the adjusted gauge measurement value to the actual value stored in MVB 103 field 1.
7. If the MVB 103 field 1 value deviates more than ± 1.0 bar from the adjusted gauge measurement value, then the DTC was likely triggered by a faulty G410 low-side fuel pressure sensor. In this case, document the adjusted gauge measurement value and MVB value on the repair order and perform the *Sensor replacement procedure* below.

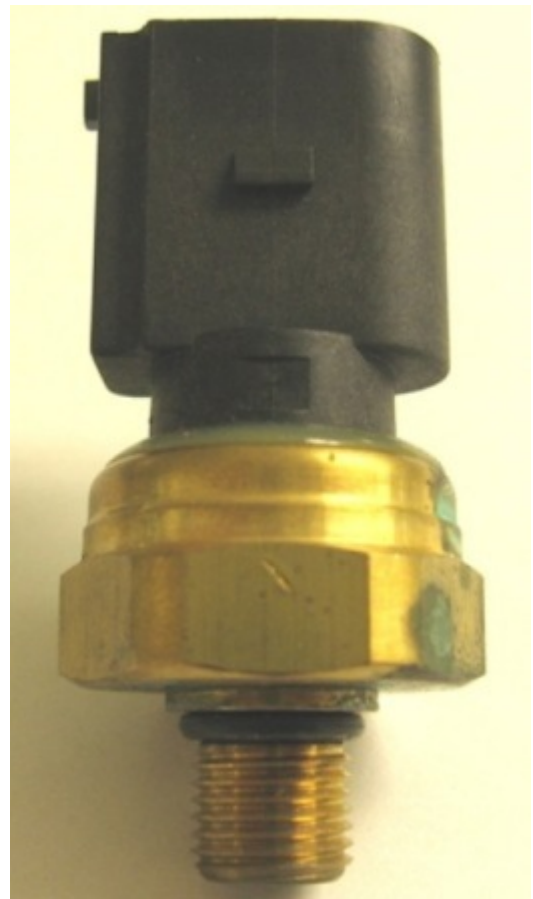
Figure 2. G410 sensor.

1. Replace the low-pressure system fuel pressure sensor, G410 (Figure 2).

2. Clear DTCs and verify that the problem was eliminated.
3. Run Basic Settings 103 to adapt system.
4. Do not replace the high pressure fuel pump, electrical fuel pump, fuel pump control module, or fuel filter unless problem persists and further diagnosis indicates a malfunction of any of these components.
