Technical Service Bulletin

66 Wind noise from exterior rear view mirror

66 15 52 2035673/5 April 30, 2015. Supersedes Technical Service Bulletin Group 66 number 15-50 dated April 10, 2015 for reasons listed below.

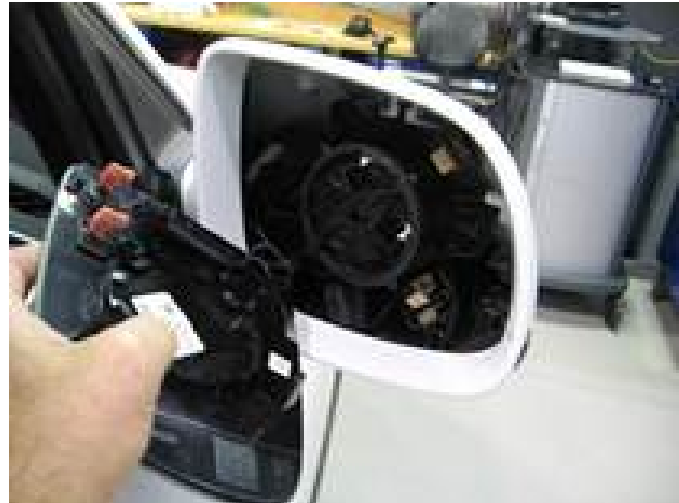
Figure 1. Exterior rear view mirror glass removed.

1. Begin by removing the exterior rear view mirror glass (Figure 1). Disconnect the electrical connectors carefully and set the glass aside.

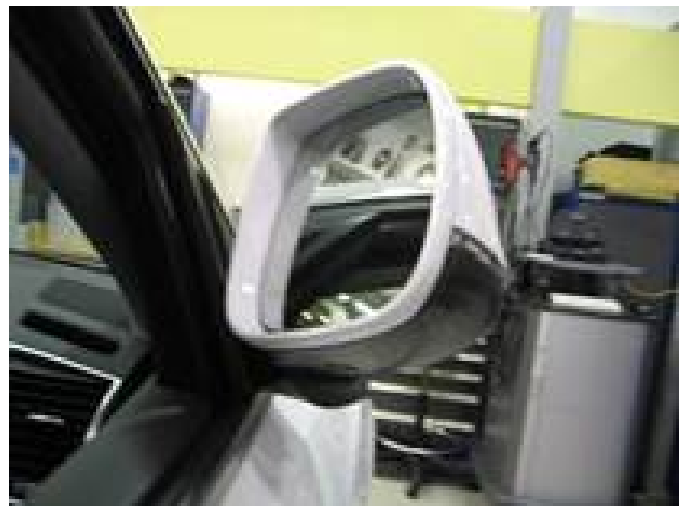
Figure 2. Exterior rear view mirror manually folded.

2. Remove the exterior rear view mirror cover. Manually folding the mirror body up will aid in the removal process (Figure 2).

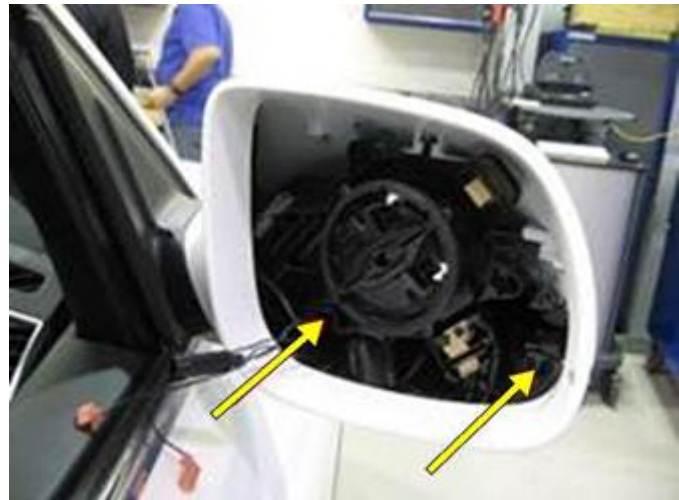
Figure 3. Location of the retaining clips.

- Carefully pull the lower rim of the cover away from the mirror base. Release the two retaining clips for the cover inside the mirror base (Figure 3).

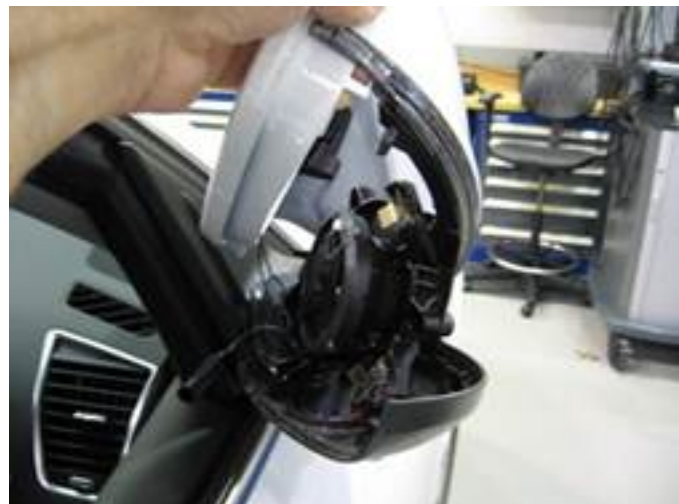
Figure 4. Removing the mirror cover.

- Unsnap the cover and set it aside (Figure 4).

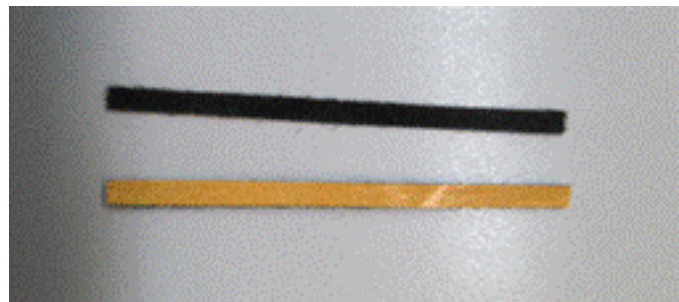
Figure 5. Strips cut from felt tape.

- Cut two 60mm x 3mm strips of felt tape (part number: **533863288A**) (Figure 5).

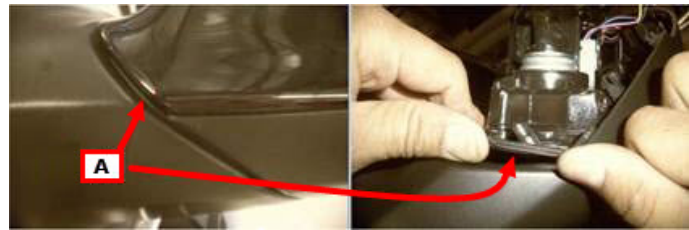
The two main sources of wind noise from the exterior rear view mirrors are: the seam surrounding the turn signal lamp and the seam at the mirror base. The modifications explained in the *Service* section of this bulletin will effectively mitigate the wind noise symptom for the customer.

Figure 6. Area where felt tape is to be applied (A).

6. Apply the felt tape strips to the area of the mirror base between the mirror base and the seal, as shown at right (Figure 6). This will provide tension to the seal limiting the possibility of seal vibration at high speeds.

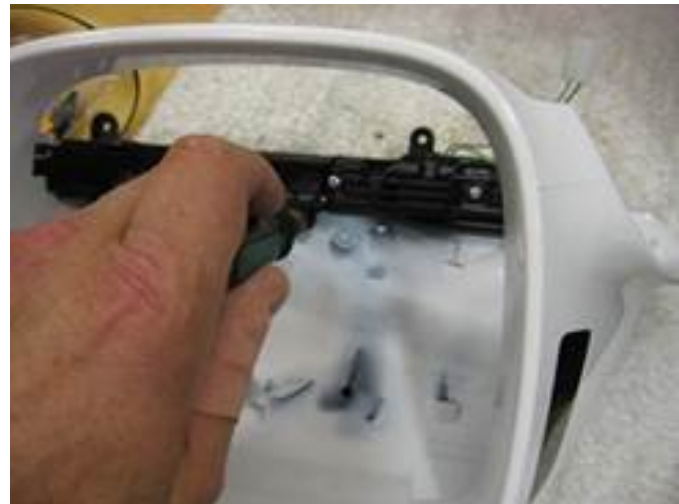
Figure 7. Removing the turn signal lamp.

7. Remove the turn signal lamp from the mirror cover (Figure 7).

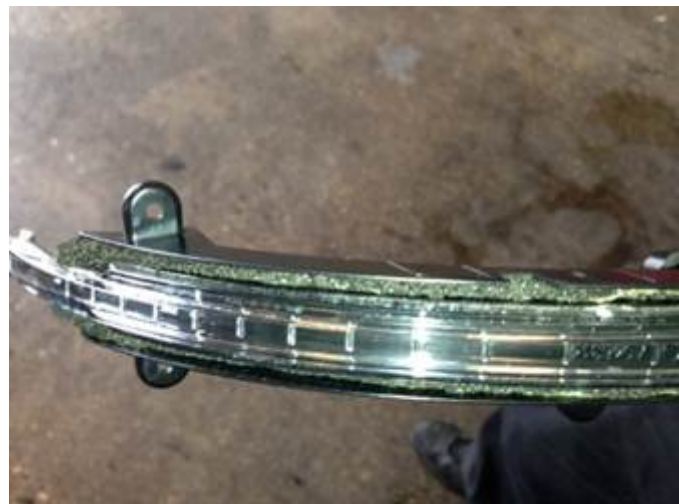
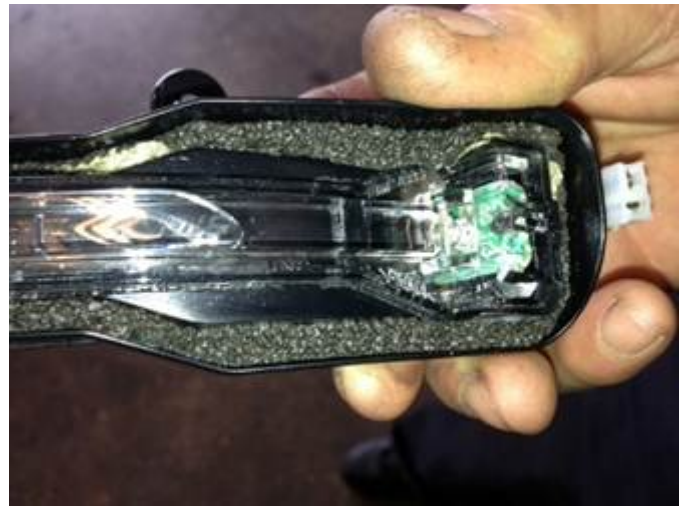
Figure 8. Turn signal lamp with sealing foam tape installed.

Figure 9. Turn signal lamp with sealing foam tape installed.

8. Apply strips of foam material (part number **8F0857869**) into the entire channel that surrounds the turn signal lamp, as shown at right (Figure 8 and Figure 9).

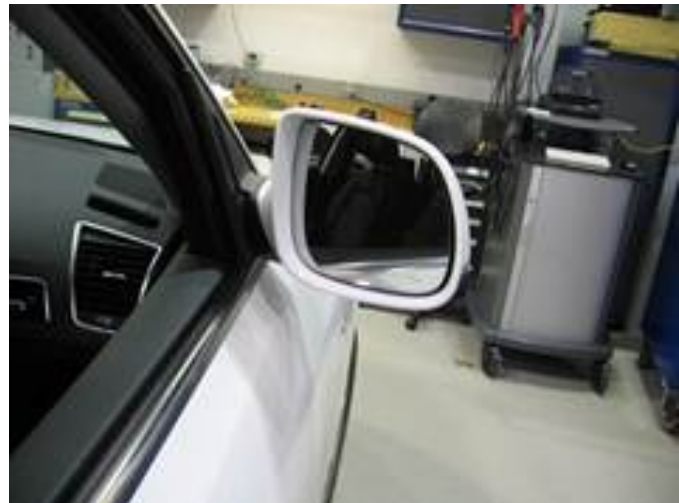
Figure 10. Mirror reassembled.

9. Reinstall the turn signal lamp into the mirror cover. Reinstall the mirror cover onto the mirror base (Figure 10).

Tip: Exercise care in the reassembly process. Incorrect or incomplete reassembly will cause recurrence or additional wind noise from the mirror assembly.
