# Technical Service Bulletin

## 94 Headlight switch pressed in

94 15 66 2017566/5 April 17, 2015. Supersedes Technical Service Bulletin Group 94 number 13-12 dated March 29, 2013 for reasons listed below.

Model(s)	Year	VIN Range	Vehicle-Specific Equipment
A3, A4, A5, A5 Cabriolet, A6, A7, A8, Q5	2012 - 2017	All	Not Applicable

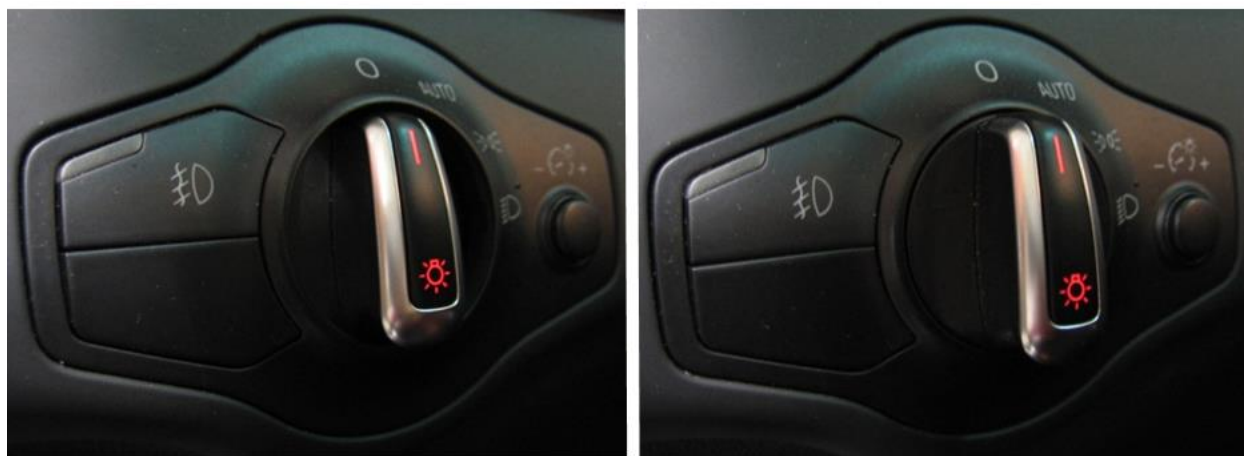
The headlight switch knob is pressed in, but the switch functions correctly.

The headlight switch knob was designed with a normal position and a pushed-in position (Figure 1, Figure 2, and Figure 3). This feature was designed to avoid injuries during a collision.

**Figure 1.** B8 headlight switch knob pushed in (left) and in normal position (right).

1. Pull out the knob and return it to the original position.
2. Explain the *Technical Background* to the customer.

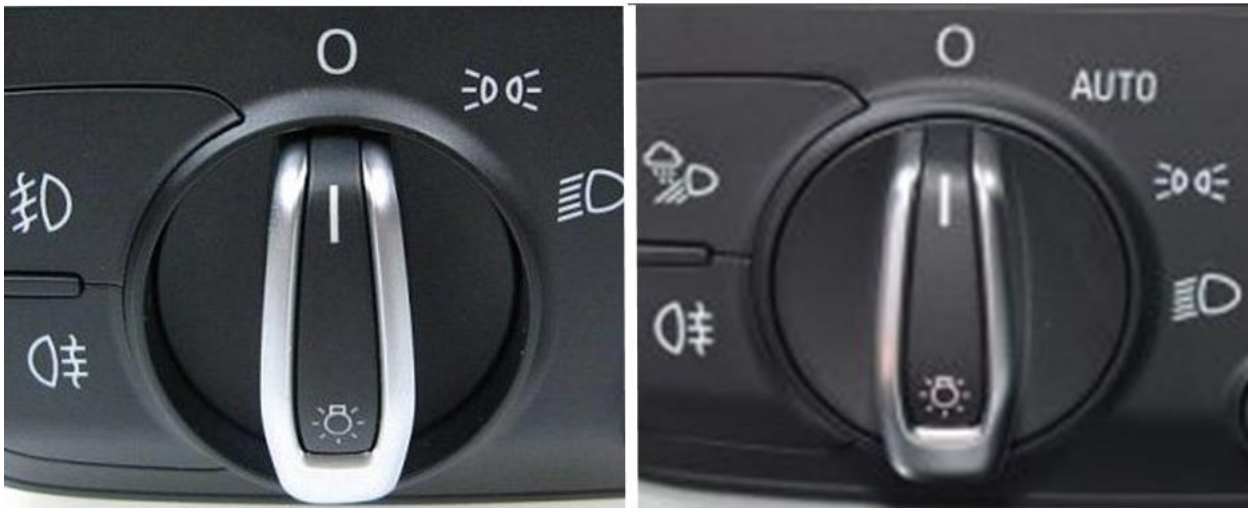
**Figure 2.** A3 headlight switch knob pushed in (left) and in normal position (right).

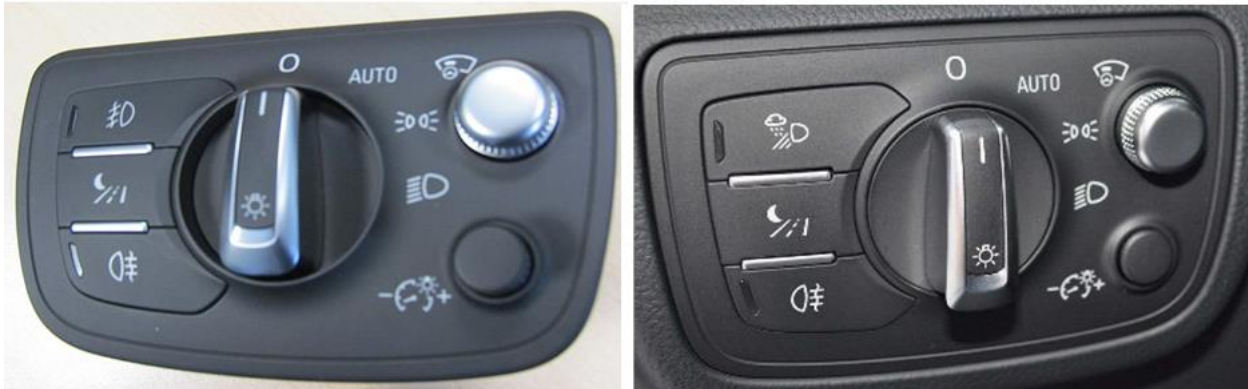
**Figure 3.** A6 and A7 headlight switch knob pushed in (left) and in normal position (right).
