EC16-041

## 2017 QX80; MIL IS ON WITH DTC P2080 AND/OR P2082

**APPLIED VEHICLES:** 2017 QX80 (Z62)

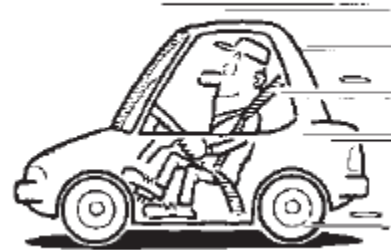
Figure A

- Most instructions for reprogramming with CONSULT-III plus (C-III plus) are displayed on the CONSULT PC screen.
- If you are not familiar with the reprogramming procedure, click here. This will link you to the "CONSULT- III plus (C-III plus) Reprogramming" general procedure.
- Take the vehicle for a 10 minute drive in order to meet the following Idle Air Volume Learn (IAVL) conditions:
  - Engine coolant temperature: 70 - 105°C (158 - 221°F)
  - Battery voltage: More than 12.9V (at idle)
  - Transmission: Warmed up

**NOTE:** After reprogramming is complete, you will be required to perform Throttle Valve Closed Position, Idle Air Volume Learn, Accelerator Closed Position, and DTC erase. The above conditions are required for IAVL to complete.

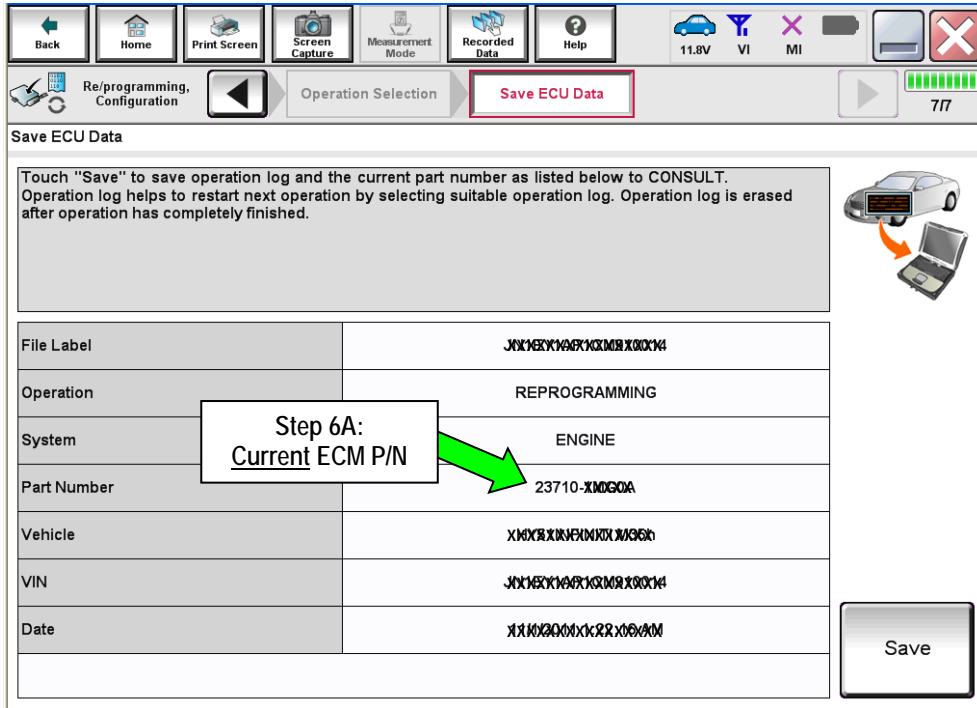
Figure 2

6. When you get to the screen shown in Figure 2, confirm this bulletin applies as follows.

A. Find the ECM Part Number and write it on the repair order.

B. Compare the P/N you wrote down to the numbers in the **Current ECM Part Number** column in **Table A** below.

- If there is a match, this bulletin applies. Continue with the reprogramming procedure.
- If there is not a match, this bulletin does not apply. Close C-III plus and refer to ASIST for further diagnostic information.

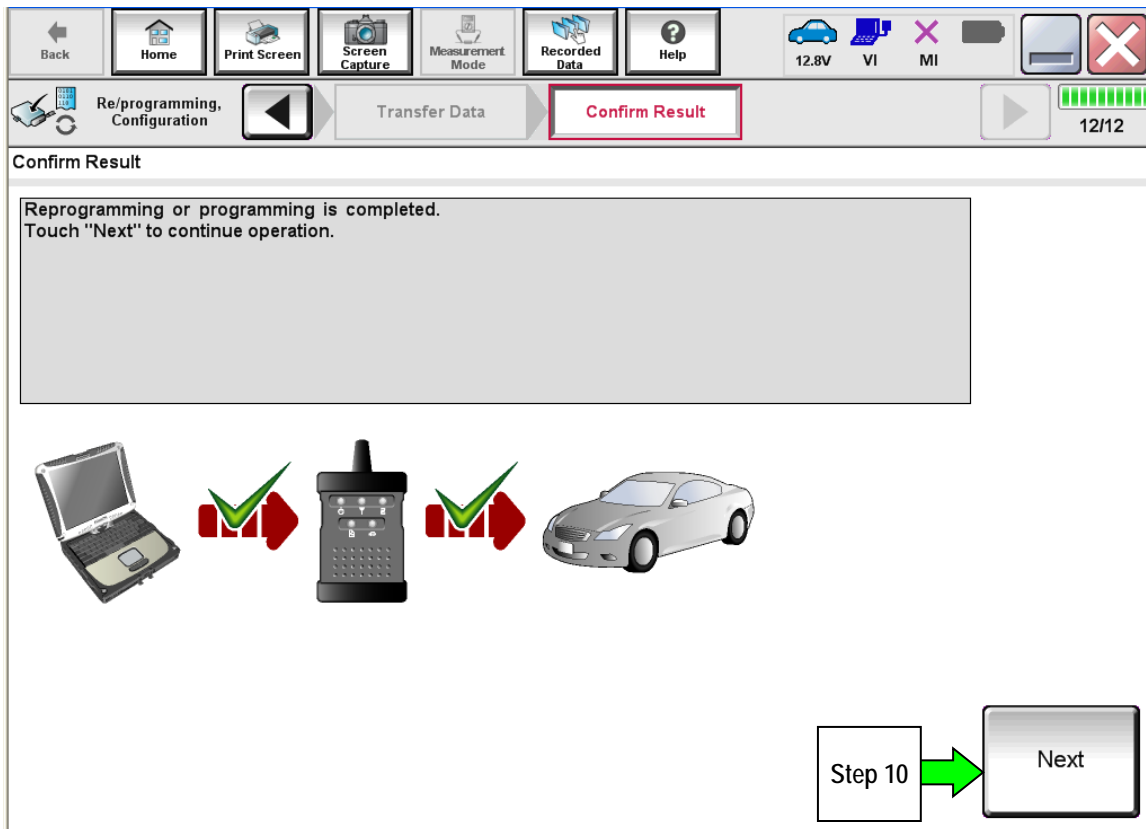
8. When the screen in Figure 4 displays, reprogramming is complete.

**NOTE:** If the screen in Figure 4 does not display (reprogramming does not complete), refer to ECM recovery on the next page.

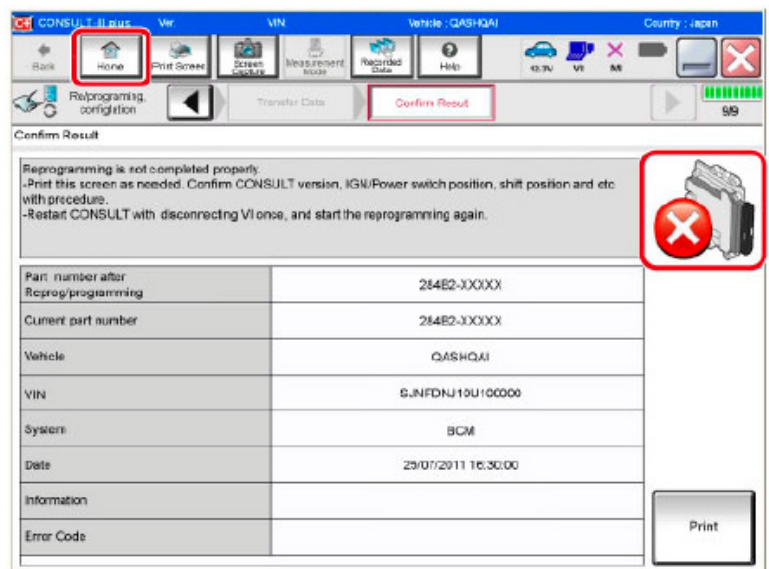
Figure 6

If reprogramming does not complete and the “X” icon displays as shown in Figure 6:

- Check battery voltage (12.0 - 15.5 V).
- CONSULT A/C adapter is plugged in.
- Ignition is ON, engine OFF.
- Transmission is in Park.
- All C-III plus / VI cables are securely connected.
- All C-III plus updates are installed.
- **Select Home, and restart the reprogram procedure from the beginning.**
