SERVICE BULLETIN

Classification: EC17-012	Reference: NTB17-086	Date: July 25, 2017
-----------------------------	-------------------------	------------------------

2016 – 2017 TITAN AND TITAN XD IGNITION WILL NOT TURN OFF

APPLIED VEHICLES: 2016 Titan XD (A61) **not** equipped with remote start
2017 Titan and Titan XD (A61) **not** equipped with remote start

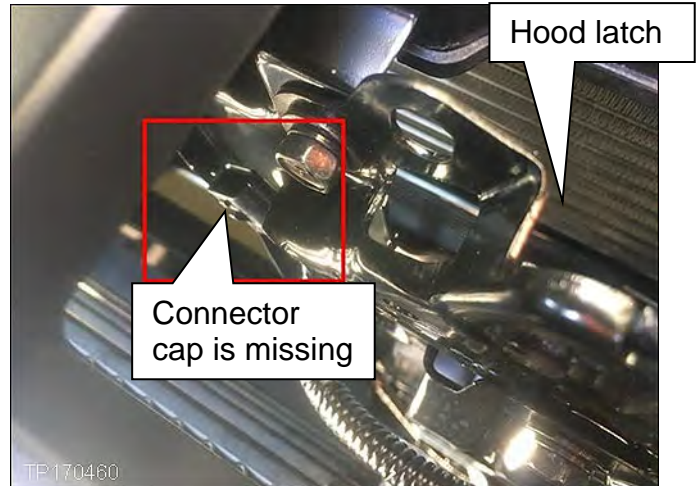
Figure A

The connector cap for the hood switch harness connector (connector E94) is missing or damaged.

NG – connector cap missing.

Replace the hood switch harness connector (connector E94) with the **new** one (Service Kit) listed in the Parts Information.

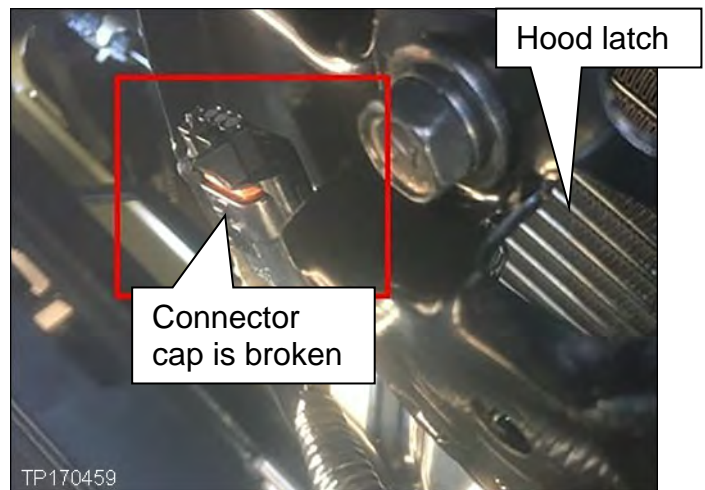
Figure B

NG – connector cap broken and partly missing.

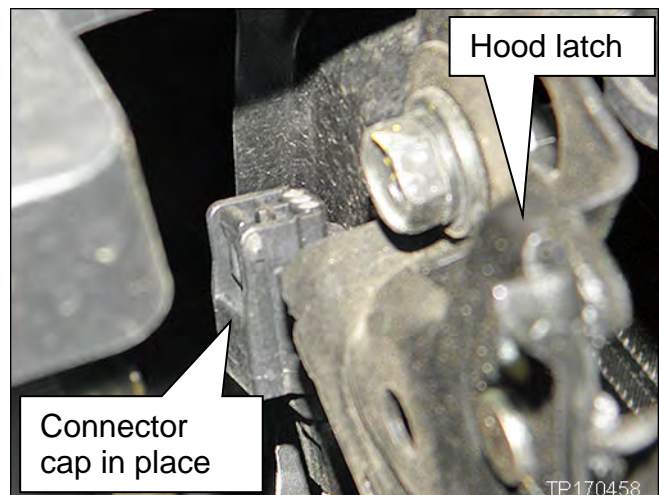
Figure C

OK – connector cap is in place.
