Technical Service Bulletin

91 How to update MMI MIB navigation map - potential customer concerns

91 16 33 2037809/2 March 17, 2016. Supersedes Technical Service Bulletin Group 91 number 14-54 dated July 30, 2014 for reasons listed below.

Model(s)	Year	VIN Range	Vehicle-Specific Equipment
A3	2015 - 2018	All	With navigation
A6, A7, TT	2016 - 2018	All	With navigation
A4, Q7	2017 - 2018	All	With navigation

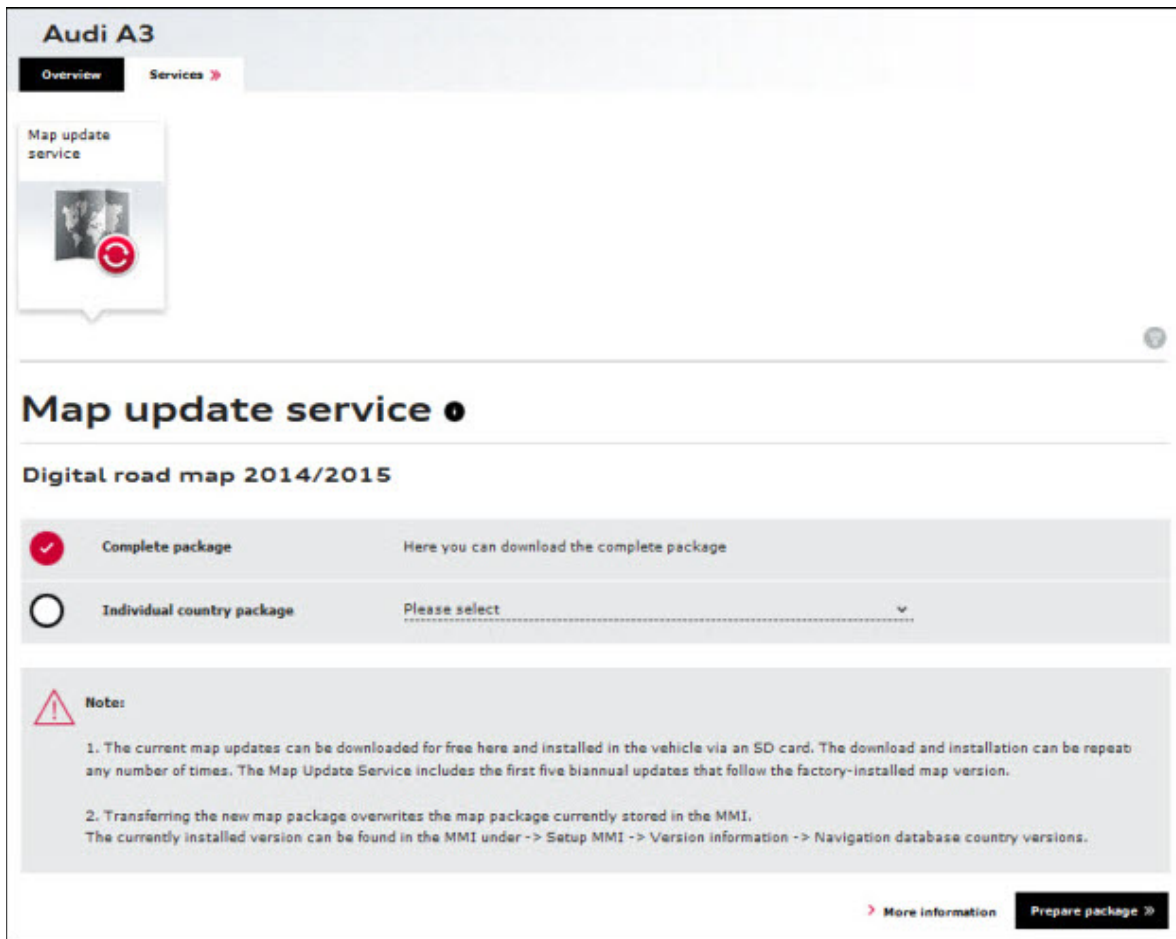
- The customer must register with the myAudi web site (my.audiusa.com).
- The customer will need to add the vehicle VIN that supports MIB navigation to their myAudi profile on the web site in order to access the "Map update service" (Figure 1).

Figure 1. Map update service on the myAudi web site (my.audiusa.com).

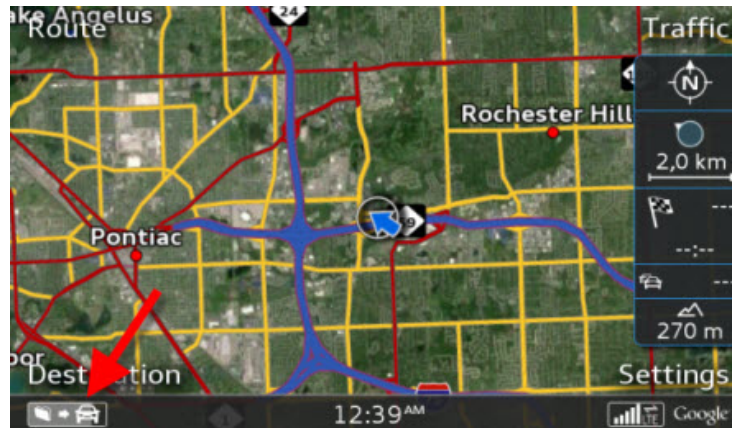
- During the map update process, the performance of the MMI system may be slow, with lagging or freezing during screen transitions or after a selection is made. These performance limitations should only occur during the map update, and no repairs should be made to correct them. A file transfer icon appears when the map update is running the background (Figure 2).

Figure 2. The background map update is indicated by the file transfer icon.

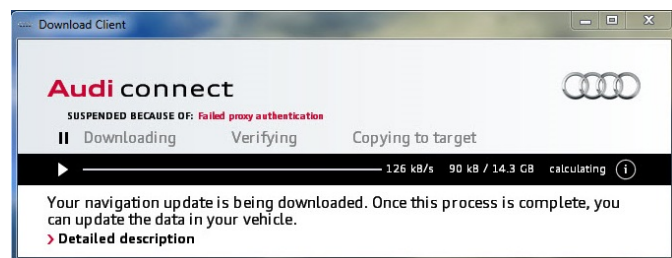
1. The map download is performed with a Java-based download manager (Figure 3). Ask the customer if the latest version of Java is installed on his or her computer. If the latest version of Java is not installed, it is possible that the map update cannot be performed.

Figure 3. Download manager

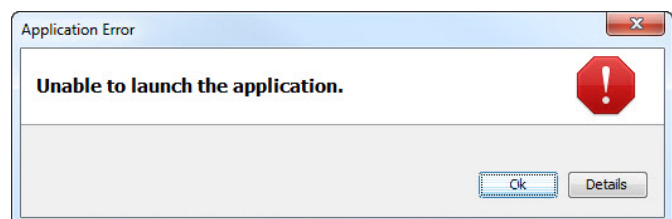
2. If the error message pictured at right (Figure 4) appears, it is because the Java download client cannot initiate a connection to the download site, which is indicative of a local issue with the customer's PC or ISP.

Figure 4. Error message

If this error message appears, ask the customer to do the following:

- Turn off all anti-virus software, which could be blocking the java application. Or, add the program to the exception list for the anti-virus software.
- Turn off any firewalls in the PC or in the router

hardware.

- Try connecting the PC directly to the cable or DSL modem with the Ethernet cable, to bypass the router.
 - Have the customer contact his or her ISP or local IT support.
3. After the map download client is successfully downloaded to the customer's computer, the map download client will start the map download process. The download client will ask where the data should be stored. Advise the customer to save the data to the root directory of the SD card. If the data is saved inside of a folder on the SD card, the update may not be seen by the main unit in the vehicle.
- If the computer loses its internet connection, the customer will be required to reenter his or her myAudi password to restart the download (Figure 5). The map download client automatically saves all progress if the computer loses its internet connection.

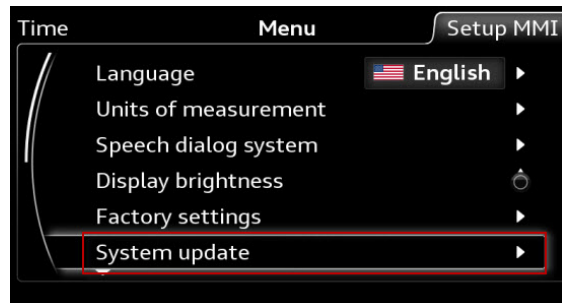
4. After the map data has successfully downloaded to the SD card, the SD card should be inserted into the MMI main unit. Once the SD card is inserted into the MMI main unit, the customer must initiate the download (Figure 6) function in the MMI.

Figure 6. MMI option for customer map update

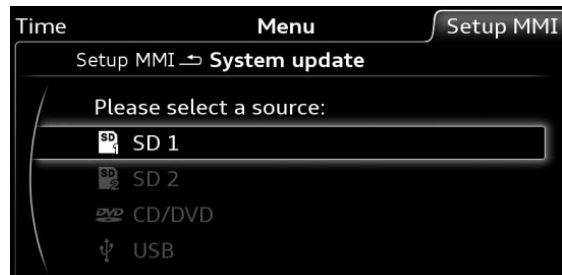
5. If the data was downloaded to the SD card correctly, the SD card will be highlighted in white (Figure 7). If no SD card is highlighted, ask the customer to troubleshoot the issue (Check formatting and verify that all the data is in the root directory of the media).

Figure 7. SD card that contains the map update data

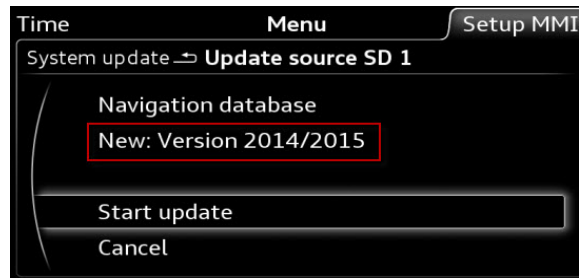
- The new version of the map data will be indicated in the MMI screen. Selecting “Start update” begins the update (Figure 8).

Figure 8. Selecting “Start update”

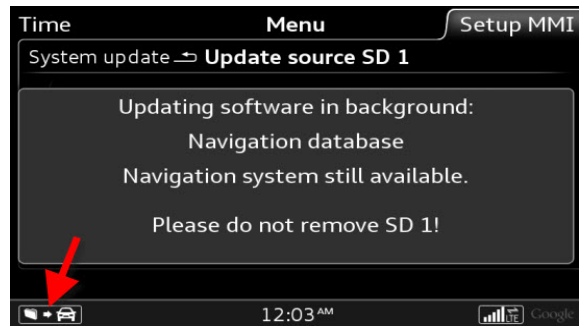
The MMI will automatically perform the update in the background, which is indicated by the file transfer icon in the lower left-hand side of the MMI screen (Figure 9).

Figure 9. The background update is indicated by the file transfer icon

Tell the customer that the vehicle can be shut off during the update process, but the SD card (or other update media) should never be removed from the MMI main unit. If the vehicle is turned off during the update process, the MMI will continue to perform the update in the background for approximately 30 minutes. The update will automatically begin again on the next ignition cycle. The complete process can take about 60-90 minutes with an SD card. If the customer chooses to use a DVD or a USB drive via AMI, then the update may take considerably longer.

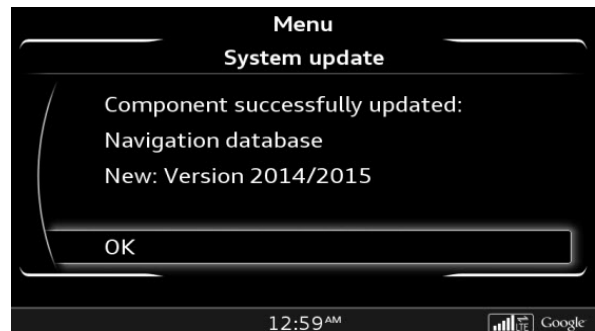
- After the update is complete, the icon in the lower left-hand side of the MMI screen will disappear. Additionally, a confirmation can be seen in the MMI system update screen (Figure 10).

Figure 10. Successful update screen

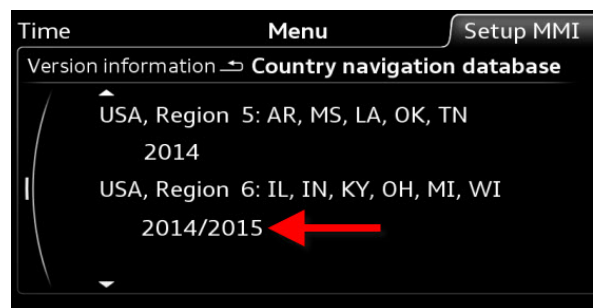
- The update can be verified under the MMI Version Information screen (Figure 11).

The MMI system will allow the same map data to be overwritten at any time, which means that if the customer puts the same SD card with the same map data into the main unit after a successfully-completed map update, the MMI will still indicate that a map update is available. This

Figure 11. The updated map regions will be indicated by the calendar year listing under the region. In this figure, only “USA, Region 6” was updated.

does not directly indicate the map update was incomplete; the customer must review the “Version Information” data and verify that the latest calendar year listing is shown under each region (Figure 11).
