Technical Service Bulletin

94 Headlight switch is loose or falls into dashboard

94 16 75 2024896/2 March 15, 2016. Supersedes Technical Service Bulletin Group 70 number 10-21 dated December 6, 2010 for reasons listed below.

Model(s)	Year	VIN Range	Vehicle-Specific Equipment
Q7	2007 - 2015	All	Not Applicable

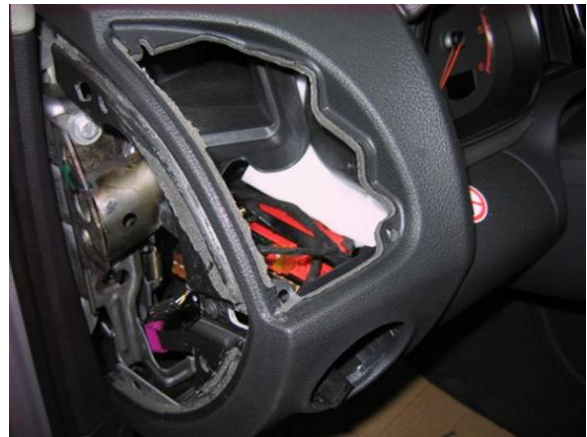
Figure 1. The dashboard, ready for the repair.

3. Disconnect the headlight switch assembly and remove it (Figure 1).

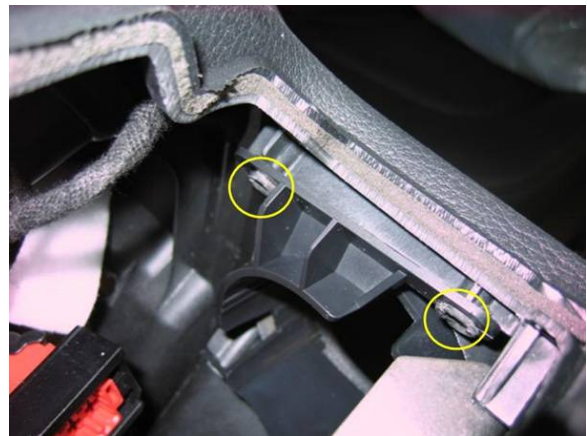
The rivets that hold the headlight switch holder in the dashboard can break if the headlight switch is bumped (by driver entering vehicle).

The broken rivets are shown in the images at right. The damaged areas are circled in yellow (Figure 2 and Figure 3).

Figure 2. The broken plastic rivets, viewed from above.

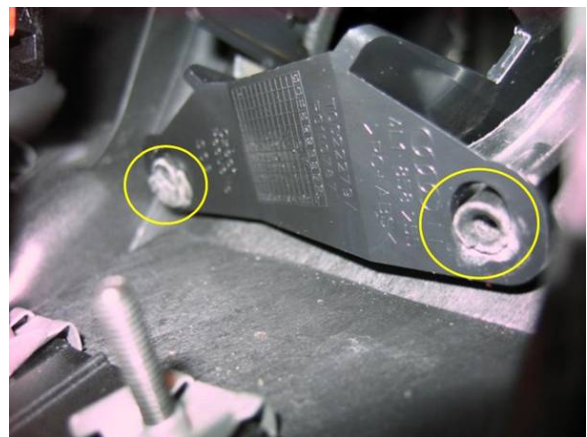
Figure 3. The broken plastic rivets, viewed from below.

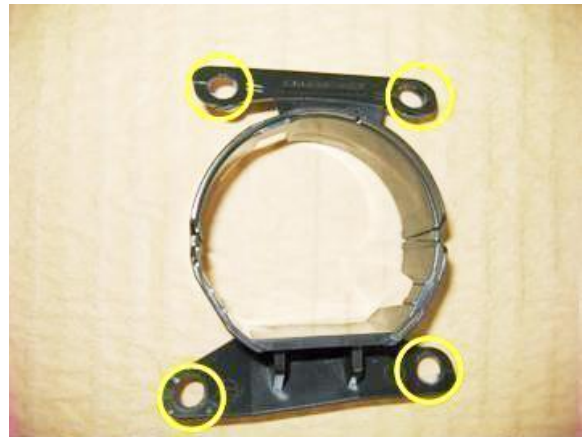
Figure 4. Attachment points.

4. Apply 2K plastic bonder (part number D 180KU1A1) on the fastening points as shown (Figure 4 and Figure 5). The bead should be approximately 5 mm in diameter.

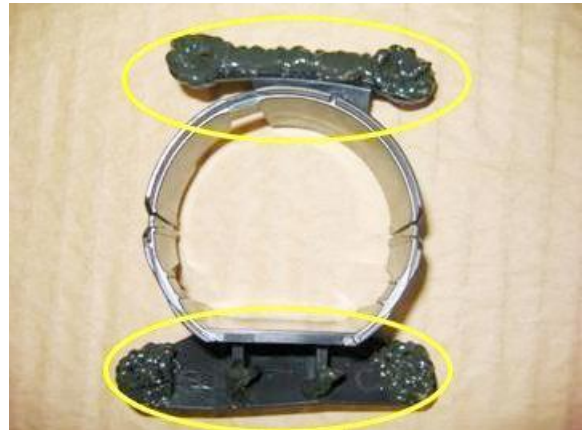
Figure 5. Attachment points after applying bonder.

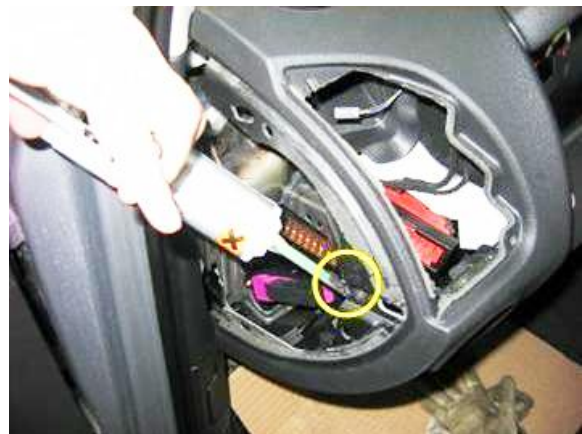
Figure 6. Applying additional bonder to four fastening points on holder.

5. Reattach the holder to its original position in the dashboard.
6. Once installed, apply additional bonder over the four fastening points to thicken the bond (Figure 6).

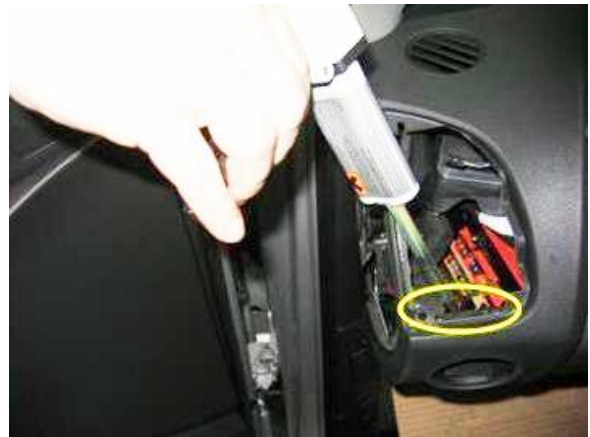
Figure 7. Applying additional bonder to the top of holder.

7. Apply additional bonder to the top of the holder from the panel vent access hole. This will provide additional strength to the repair. (Figure 7 and Figure 8.)

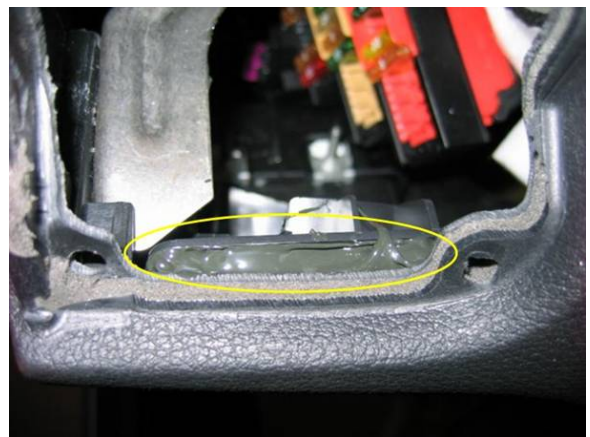
Figure 8. Additional bonder applied to top of holder.

8. Allow bonder to set before reinstalling parts.
