Technical Service Bulletin

48 Creaking or squeaking noises from steering column (sealing boot)

48 16 69 2034351/6 March 18, 2016. Supersedes Technical Service Bulletin Group 48 number 15-66 dated July 30, 2015 for reasons listed below.

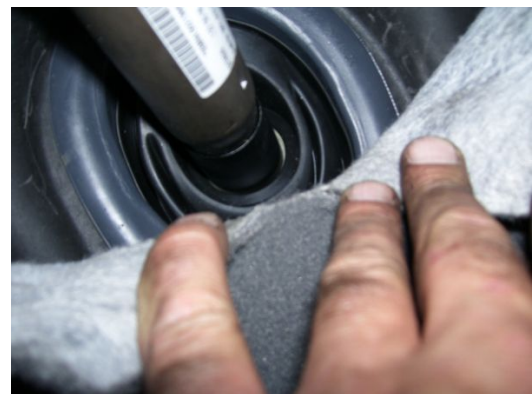
The noise comes from the sealing sleeve/steering column opening on the bulkhead. For an example of the noise, listen to the audio file at <https://audi-external.kzoplatform.com:443/swf/player/304> (Figure 1).

Insufficient lubrication of the intermediate steering shaft in the area of the sealing sleeve.

Figure 1. Sealing sleeve on the bulkhead.

1. Check the sealing sleeve for proper installation and fit (Figure 1).
2. To eliminate the noise, loosen the upper bolted connection of the steering intermediate shaft and the steering column. Pull the intermediate steering shaft out about 4 in (10 cm) and spray the special lubricant spray (**G052172M2**) in the area of the bearing ring and the black plastic sleeve. Push it in and pull it out a few times to distribute the spray on the intermediate steering shaft.

Do not lubricate the u-joints of the steering shaft.

3. Retighten the shaft with a new bolt on the steering column.
4. If the noise persists, replace the intermediate steering shaft.
