Technical Service Bulletin

70 Noises from headliner / sunroof area

70 15 44 2038029/2 February 25, 2015. Supersedes Technical Service Bulletin Group 70 number 14-39 dated August 11, 2014 for reasons listed below.

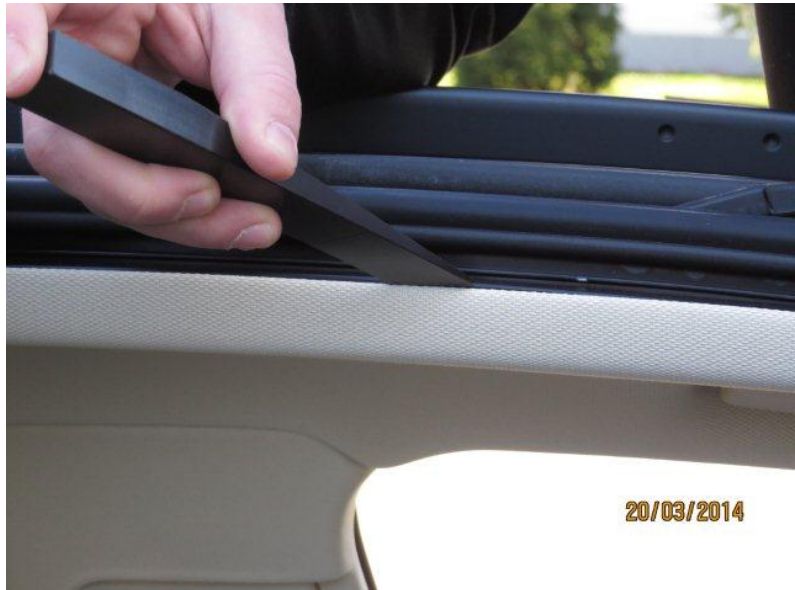
Figure 1: Unclipping the sunroof cover trim frame.

1. Remove the glass sliding roof panel(s). Remove the beam for the sunroof rollershade. Carefully unclip and remove the sunroof cover trim frame (Figure 1).

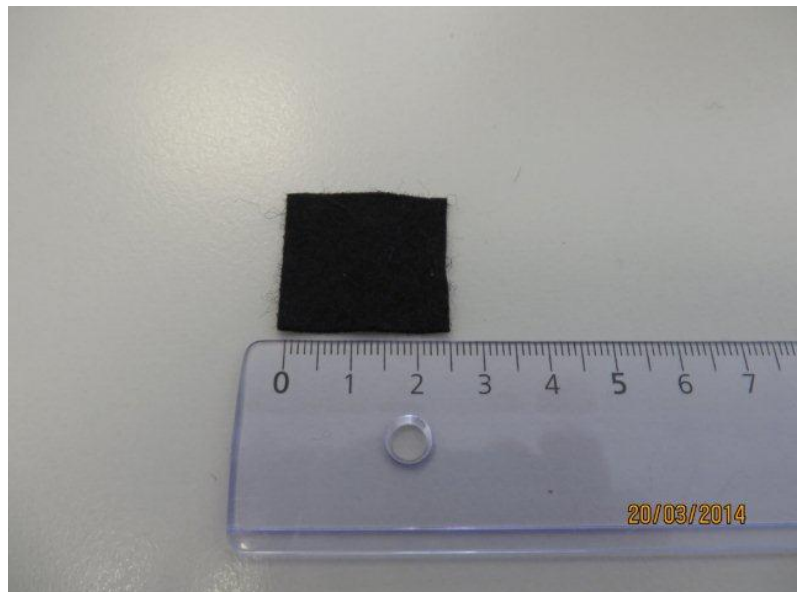
Figure 2: A 25mm section of fleece adhesive tape D 373125A2.

2. The number of retaining clips will vary by model. A piece of dampening tape (fleece adhesive tape D 373125A2) will be applied to each clipping point. Cut pieces of the tape 25mm long (Figure 2).

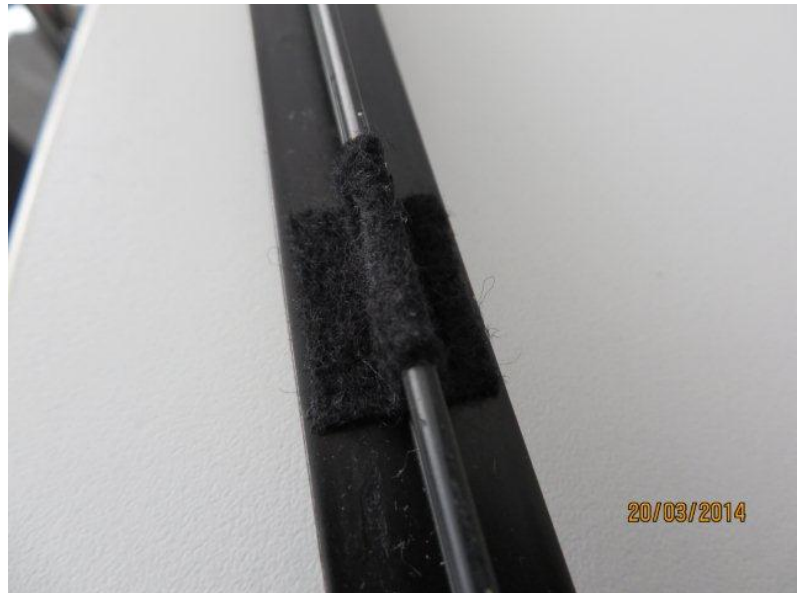
Figure 3: Fleece tape section applied.

3. Apply the sections of fleece tape to the sunroof cover trim frame to each clipping point as shown (Figure 3 and Figure 4).

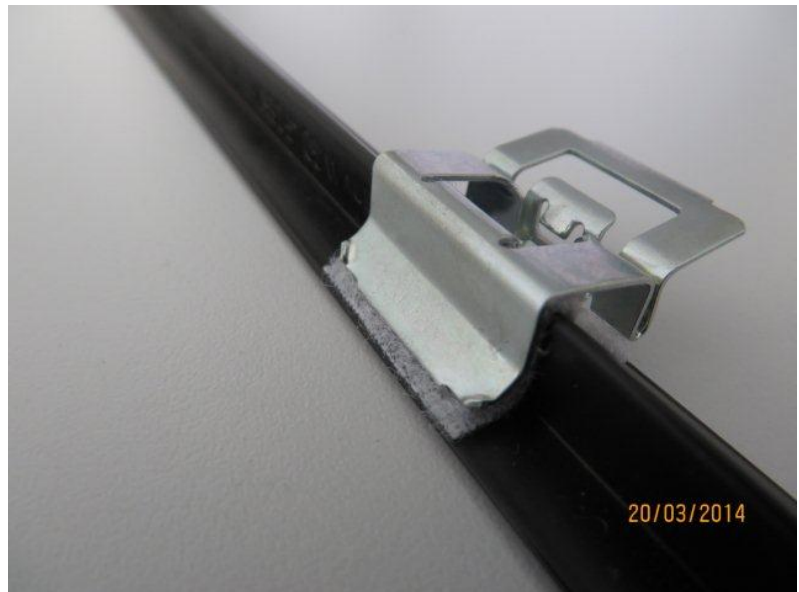
Figure 4: Retaining clip isolated with the fleece tape.

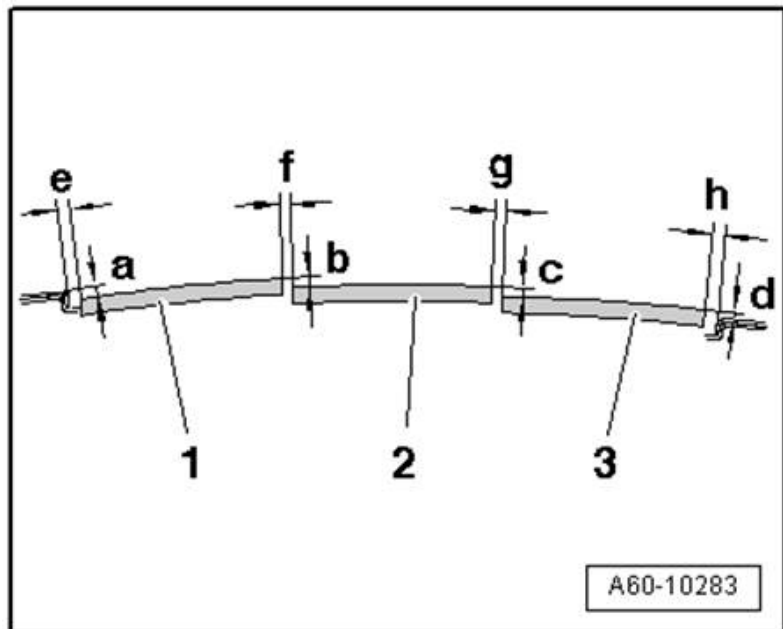
Figure 5: Adjustment of the glass sliding roof panels.

4. Reassemble the components removed for this modification. Ensure that the glass sliding roof panels are adjusted properly according to the repair manual (Figure 5).
