# Technical Service Bulletin

## 94 Vehicle lights malfunction message in instrument cluster display (DTC 03280 or 01800)

94 15 60 2017806/10 February 12, 2015. Supersedes Technical Service Bulletin Group 94 number 14-32 dated January 23, 2014 for reasons listed below.

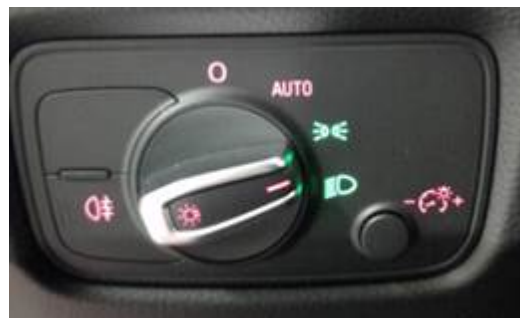
If the headlight switch is moved to an intermediate position and remains there (Figure 1), the light bulb warning light and the error message appear after approximately ten seconds (Figure 2).

**Figure 1.** A headlight switch in an intermediate position.

Determine if the above situation applies to the vehicle, and explain the background to the customer. Replacing parts does not change the behavior.

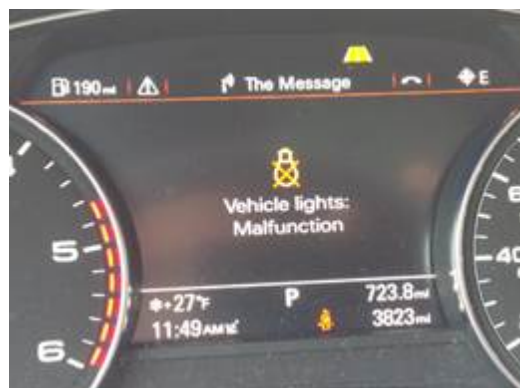
**Figure 2.** The warning light and error message in the instrument cluster display.

Once displayed, the message turns off after approximately five seconds. The light bulb warning light turns off only after the headlight switch is turned to a defined position, and the status of **DTC 03280** or **DTC 01800** are changed to sporadic.
