# Technical Service Bulletin

## 94 LED daytime running light does not work on one side (DTC 02895, 02897)

94 17 85 2032338/3 February 13, 2017. Supersedes Technical Service Bulletin Group 94 number 13-18 dated May 23, 2013 for reasons listed below.

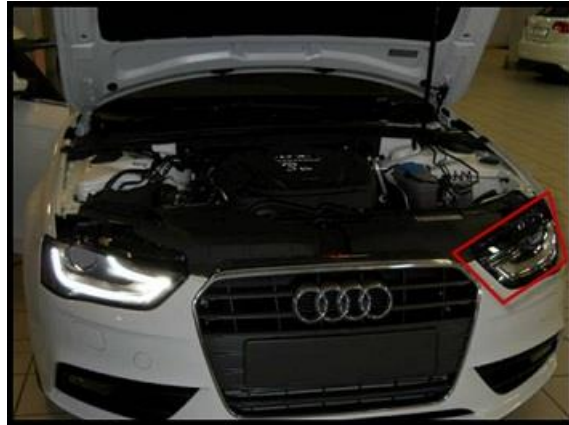
- The LED daytime running light in a single headlight does not work (Figure 1). The issue must be repeatable at the workshop.

*Figure 1. Driver's side LED DRL inoperative.*

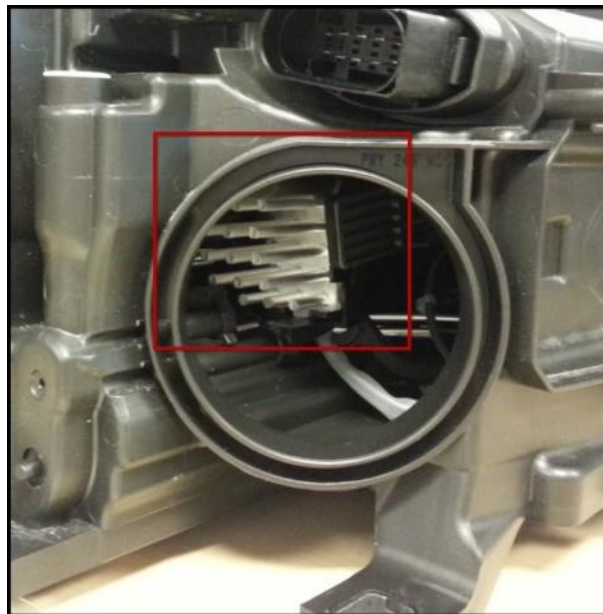
**Figure 2.** LED Parking Lamp/Daytime Running Lamp module (LED module), L176/L177

The LED Parking Lamp/Daytime Running Lamp module (LED module), L176/L177 (Figure 2), or the wiring to the LED module, is damaged during headlight assembly at the supplier.

The holding tool, which is used during the installation of the LEDs into the headlight, was improved. The headlight adjustment screw was optimized to the headlight housing.

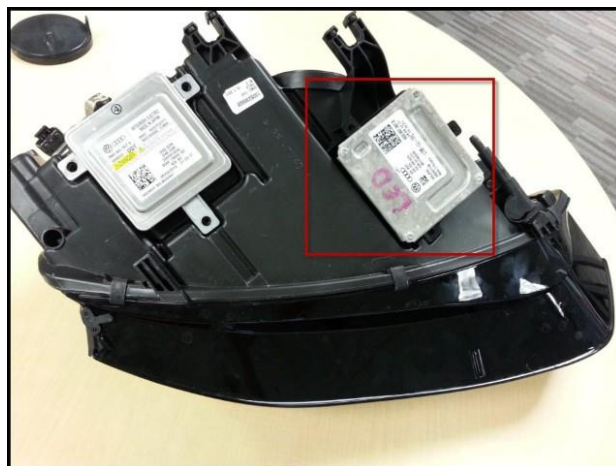
**Figure 3.** Daytime Running Lamp and Parking Lamp control module (DRL control module), J860/J861

Additionally, water can enter through an adjustment screw at the top of the headlight, causing damage to the Daytime Running Lamp and Parking Lamp control module (DRL control module), J860/J861 (Figure 3).

1. Remove the DRL control module of the affected side. Inspect the female connectors located inside of the headlight and inspect the male connectors located on the DRL control module:

If water and/or corrosion *are* found inside of the DRL control module (male connector side):

- Replace the headlight.
- Replace the DRL control module.
- Inspect the HID Gas Discharge Lamp control module, J343/344. Replace the module if water and/or corrosion are found.
- Inspect the Headlamp Power Output State/Adaptive Headlight control module, J667/J668, if equipped. Replace the module if water and/or corrosion are found.
- Proceed to step 2.
