Technical Service Bulletin

91 MMI3G+ GPS navigation location inaccurate or navigation takes a very long time to acquire location

91 15 90 2040406/2 June 5, 2015. Supersedes Technical Service Bulletin Group 91 number 15-87 dated May 18, 2015 for reasons listed below.

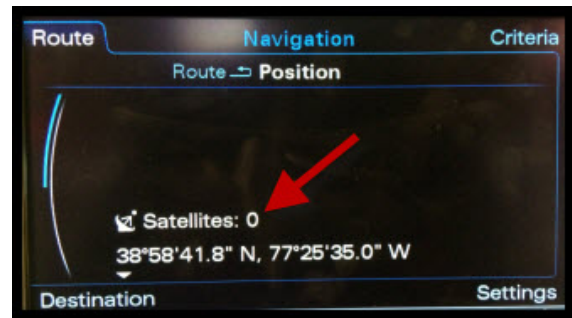
- When the issue occurs, the GPS navigation system satellite reception shows 0 satellites. Due to the infrequency of the issue, this might not be verifiable. (To view the number of satellites being received, go to *Nav >> Route >> Select Current Position* (first item in list) and scroll up (Figure 1)).

Figure 1. No satellite reception.
