SERVICE BULLETIN

APPLICABILITY: 2013-14MY Legacy and Outback Models with 2.5L FB Engines
 2011-14MY Forester Models with 2.5L FB Engines
 2015 MY Forester (Manual Transmissions Only) with 2.5L FB Engines
 2012-13 MY Impreza and XV Crosstrek Models with 2.0 FB Engines
 2014-15 MY Impreza and XV Crosstrek Models (Manual Transmissions Only) with 2.0 FB Engines

NUMBER: 02-157-14R
DATE: 08/28/14
REVISED: 02/24/16

SUBJECT: Surface Treatment Change To Oil Control Piston Rings

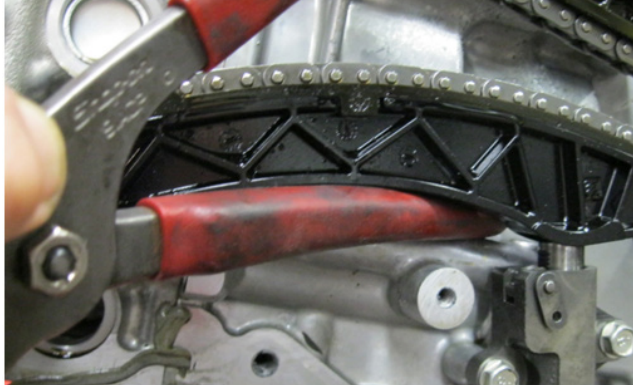
Rubber-coated plier handle inserted between a ledge area on the front of the block and the B1 lower chain guide **VERY CAREFULLY** lifting upward on the lower guide.

- Same as the left side, align the indicator links to the timing marks found on the cam sprocket assemblies. Install the chain guides and tensioner. Once proper positioning has been confirmed, pull the pin to release the tensioner. With your hand, grab and squeeze the upper and lower left side chain / guides together to allow the plunger in the tensioner to extend fully and click into its furthest notch as shown in the previous (right side) photo. If necessary, insert a rubber-coated plier handle between the ledge area on the front of the block and the right side (B1) lower chain guide. Then, **VERY CAREFULLY** lift up on the guide just enough to get the extra “click” on the tensioner as shown in the photo below.
