PRODUCT CAMPAIGN BULLETIN

APPLICABILITY: 2016-2017MY Legacy and Outback
SUBJECT: Inspection and Repair Procedure for Stop Sale / Recall Campaign
 WTD-65: Steering Column

NUMBER: WTD-65
DATE: 06/08/16
NHTSA ID: 16V-292

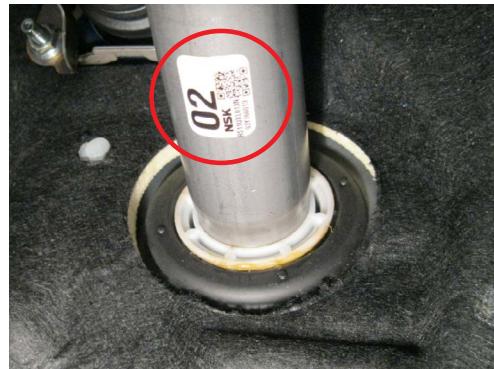
- Locate the lot number label at the base of the steering column located just above the toe board grommet as shown in the photo below.

For KEY START models, the label will have a large "02" as shown in the photo. For PUSH START models, the label will have a large "03".

The steering columns are **NOT** interchangeable.

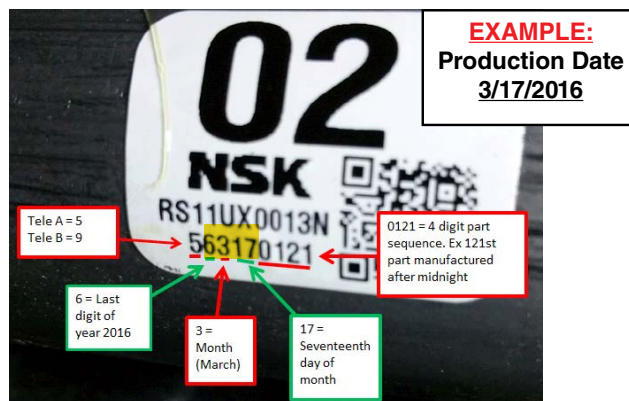
- Decode the lot number of the steering column using the illustration below.
- Affected steering columns will have a lot number label indicating the column was produced **on or between** 6228 (February 28, 2016) and 6416 (April 16, 2016), the steering column assembly must be replaced.
- If the lot number is illegible or otherwise cannot be determined, it must be noted on the repair order and the steering column assembly must be replaced.

- **IMPORTANT:** Always record the original lot number on the Repair Order even if it is outside the affected range. The **ORIGINAL** 4-digit lot number must also be entered in the Miscellaneous Detail field when submitting for claim reimbursement. If illegible, enter “**ILLEGIBLE**” in that field.

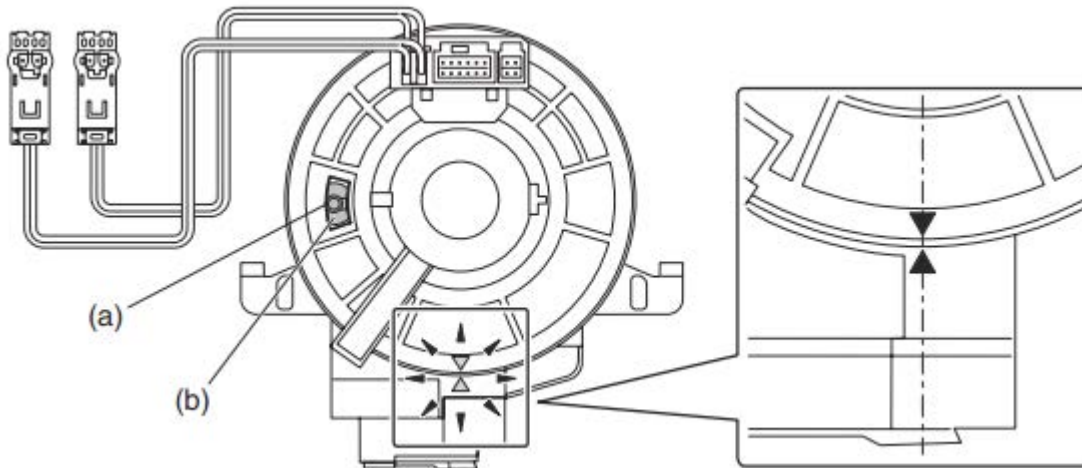
NOTE: When the roll connector comes to the center position, the orange roller (b) can be seen from the sight glass (a) as shown below.

- 1) Confirm the front wheels are positioned in straight ahead direction.
- 2) Rotate the roll connector counter-clockwise until it stops.
- 3) Rotate the roll connector clockwise approximately 2.5 turns until the “Δ” marks are aligned.
