SERVICE BULLETIN

APPLICABILITY: 2014-16MY Forester
 2008-14MY WRX and STI
 2012-16MY Impreza 2.0L
 2013-16MY XV Crosstrek (EXCEPT Hybrid Model)

NUMBER: 06-55-16R
DATE: 06/15/16
REVISED: 06/24/16

SUBJECT: Design Change to Stop Light Switch

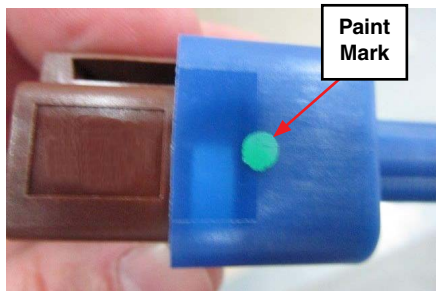
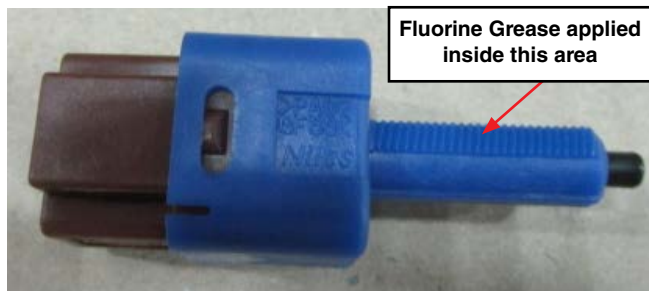
- The previous switch body was Gray in color while the new version is Blue and also has a greenish paint mark / dot applied to help identify it as the latest version.
- Fluorine grease is now used to lubricate the plunger and prevent silicone from potentially contaminating the switch contacts.

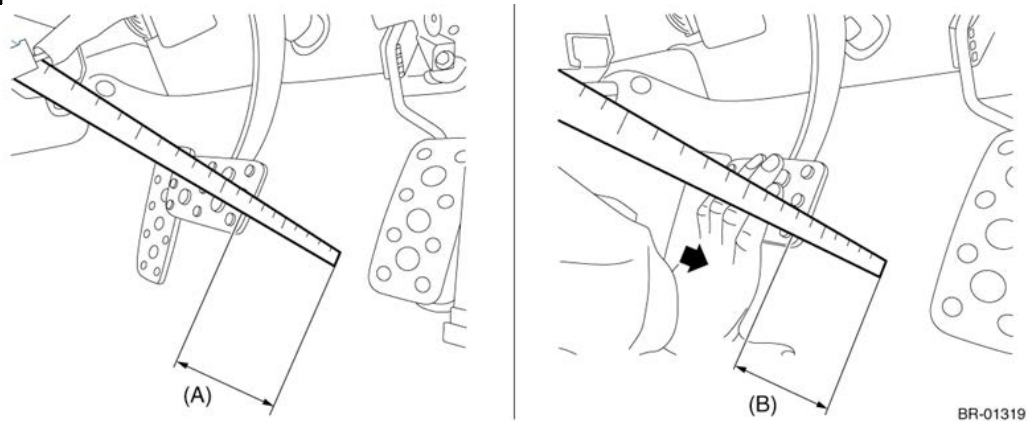
The minimum brake pedal travel specification (amount of pedal travel before the brake lamps come on) also varies between models. Using the illustrations below, measure the brake pedal stroke by first measuring the distance “A” between the floor mat and the pedal. Depress the brake pedal slowly until the brake lights come on “B” then record the second measurement. Subtract “B” from “A” to obtain the pedal stroke measurement.

The pedal stroke specification to activate the stop light switch is 5.5mm +/- 2.5mm (>3mm but <8mm).

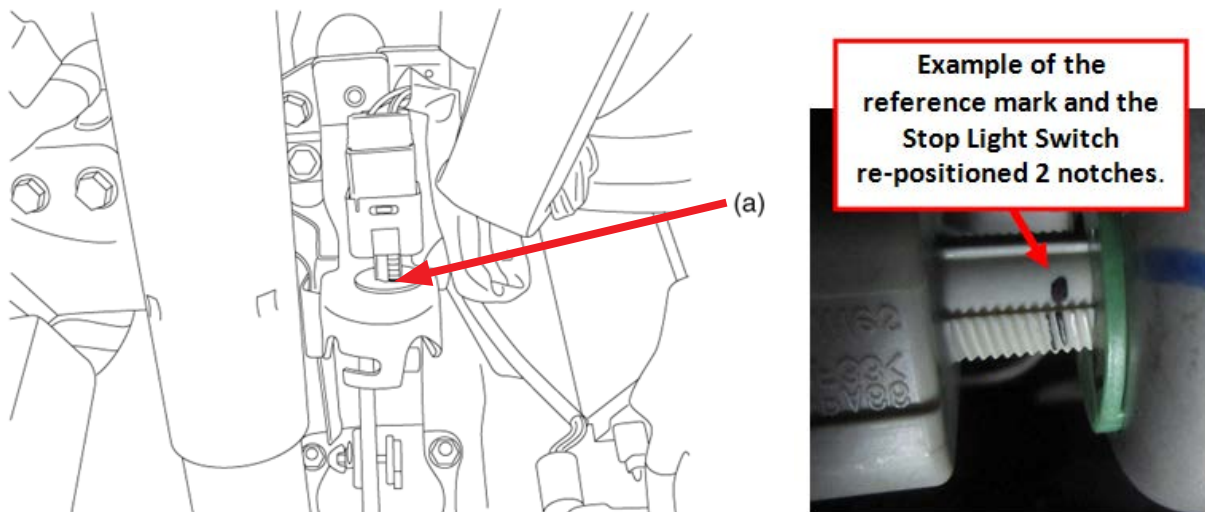
If the measurement (switch activation) is out of specification, the stop light switch will need to be adjusted. When the brake lights come on too soon (not enough pedal stroke), the switch needs to be adjusted “inward” toward the bulkhead. If the pedal stroke is excessive before the brake lights come on, the switch will need to be adjusted outward toward the steering wheel. The switch adjustment is sensitive and in most cases, moving it just one should bring the operation into specification since one notch is equivalent to approximately 4mm of movement. Using a sharp-tipped permanent marker, put a reference mark on the switch (a) as shown below.
