SERVICE BULLETIN

APPLICABILITY: 2015-2016MY Legacy and Outback
 2015-2016MY Impreza and XV Crosstrek
 2016MY Forester
 2016MY WRX

NUMBER: 15-198-16R
DATE: 05/02/16
REVISED: 06/22/16

SUBJECT: Reprogramming File Availability to Address Operational Concerns with “Gen 2” Fujitsu-TEN (F10) Navigation and 7” Display Audio Units

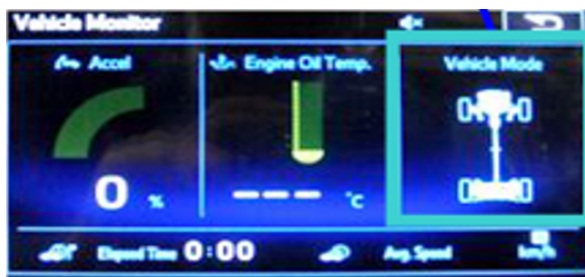
VDC “Inactive”

- Logic change to provide a “_” (underscore) character on the keyboard.
- Logic change to match the engine oil maintenance remaining mileage on the maintenance reminder screen to the odometer meter value on the combination meter when mileage unit is set to read in “KM”.
- Logic change to insure the Vehicle Mode indicator on the Vehicle Monitor screen matches the actual vehicle status. Example: The wheel indicators on the vehicle monitor screen no longer stay illuminated indicating VDC is “active” after VDC activation is complete.

This bulletin announces reprogramming file availability and the software installation procedure to address a group of operational concerns received from the field listed below involving “Gen 2” F10 Navigation and Display Audio units with 7” display. The procedure will involve downloading the applicable software update files from Subarunet then loading them onto a flash drive for audio unit installation. It is important to read through and understand this information **completely** before proceeding.
