Technical Bulletin

Model(s)	Year	Eng. Code	Trans. Code	VIN Range From	VIN Range To
Passat Wagon	1998 – 2010	All	All	All	All

55 16 01 January 19, 2016 2038993 Supersedes Technical Bulletin V551407 dated December 19, 2014 to update model year applicability.

Corrosion on Rear Lid at Rear Window Area

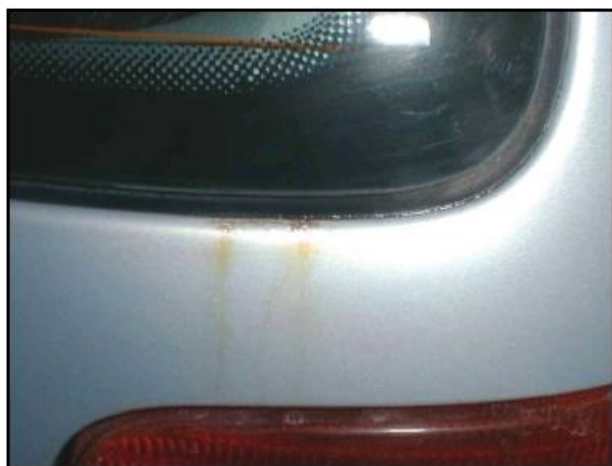
Figure 1

When the rear window heater is switched ON, power is transmitted to the outer sealing lip of the rear window. In some places the window sealer makes contact with the bus bar of the rear window heater.

1a. Repair rear lid and replace rear window Only perform this operation if the total repair cost is 80% or less of the total replacement cost.

1b. replace rear lid and replace rear window

Install a new rear glass in every case, since the complete removal of the sealer from the bus bar cannot be guaranteed. Use sealer part number DH 009 100 03 or DA 004 600 A2 - for sealing the window.

To avoid repeat cases make sure that no sealer gets on the bus bar of the rear window. Cover the bus bar with masking tape during installation and remove the tape after sealing.
