# Technical Bulletin

**46 16 03** March 8, 2016 **2015173** Supersedes Technical Bulletin V461506 dated September 25, 2015 to include model year 2016 Passat.

### Brake Disc Pulsation or Vibration (U.S. Only)

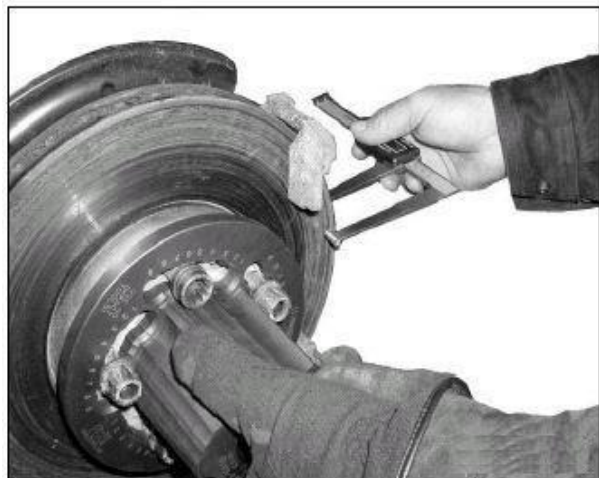
- Inspect brake disc friction surfaces on both sides of the brake disc for:
- Severe discoloration (bluing)
- High heat surface damage (raised hard spots)
- Visible cracks

Brake discs showing any of the above described conditions are **NOT** serviceable. Parts must be replaced in accordance with the Volkswagen Warranty Policy and Procedure Manual.

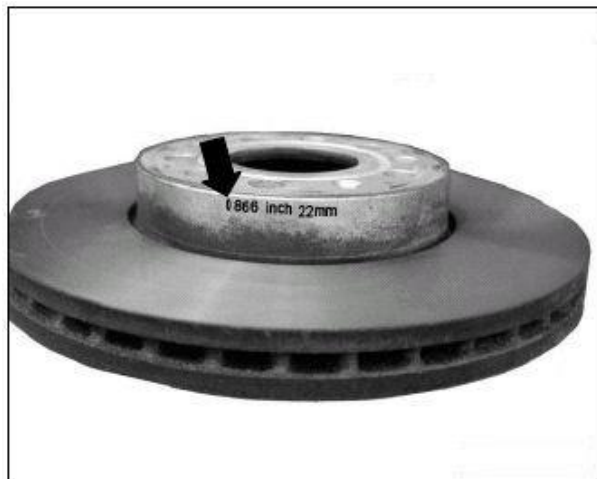
- Measure the brake disc thickness in 4 locations using either the Pro Cut International™ disc thickness measuring tool Part No. 50-902 or the Hunter Engineering Company disc thickness measuring tool Part No. 25-99-2. Measurements **MUST** be taken at the same distance from the brake disc outer circumference to ensure consistency.

The brake disc thickness measurement must exceed the minimum specification after the machining process is completed in order to be re-used. If the brake disc thickness measurement does not meet this requirement, then replace the brake disc.

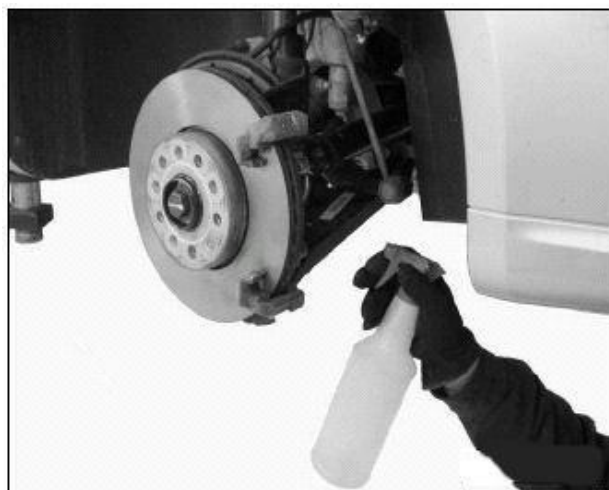
Recommended on-car brake lathes are either the PRO-CUT International™ PFM 9.0, or the Hunter Engineering Company model OCL 400. This design of brake lathe will produce a surface quality which will provide proper brake performance without a brake pad to brake disc break-in period.

To ensure that a high quality brake disc finish is produced, brake lathe cutting tools must be maintained as directed by the lathe or tool manufacturer.

- Follow the brake lathe manufacturer's instructions for set-up and machining.
- Wash the brake disc with a soap and water solution upon completion of resurfacing to remove all machining particles.

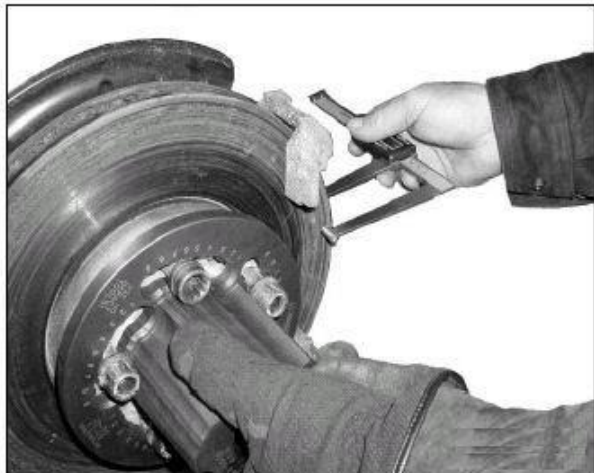
- Re-measure brake disc thickness in 4 locations using either the Pro Cut International™ disc thickness measuring tool Part No. 50-902 or the Hunter Engineering Company disc thickness measuring tool Part No. 25-99-2. If recorded brake disc measurement is less than the minimum thickness, the brake disc **MUST** be replaced.

Always replace brake discs in pairs (front axle or rear axle). Do not replace all 4 brake discs unless it is required.

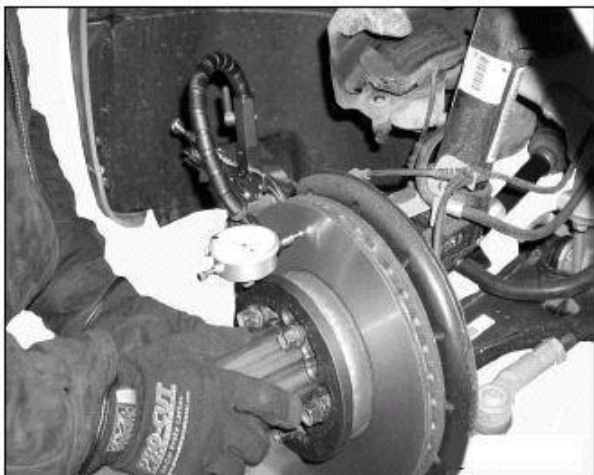
- Measure brake disc lateral run out using Pro Cut Disc Lateral run out measuring kit Part No. 50-700FC or the Hunter Disc Lateral run out measuring kit Part No. 25-128-2 with a dial indicator.
- Run out must not exceed 0.1mm.
- If brake disc exceed the 0.1mm specification replace the applicable brake discs.
