Tech Tips

TT 61-12-04

2007-2015 Eos – Convertible Top Inoperative With Faults
03053, 03055, and/or 03057 Stored

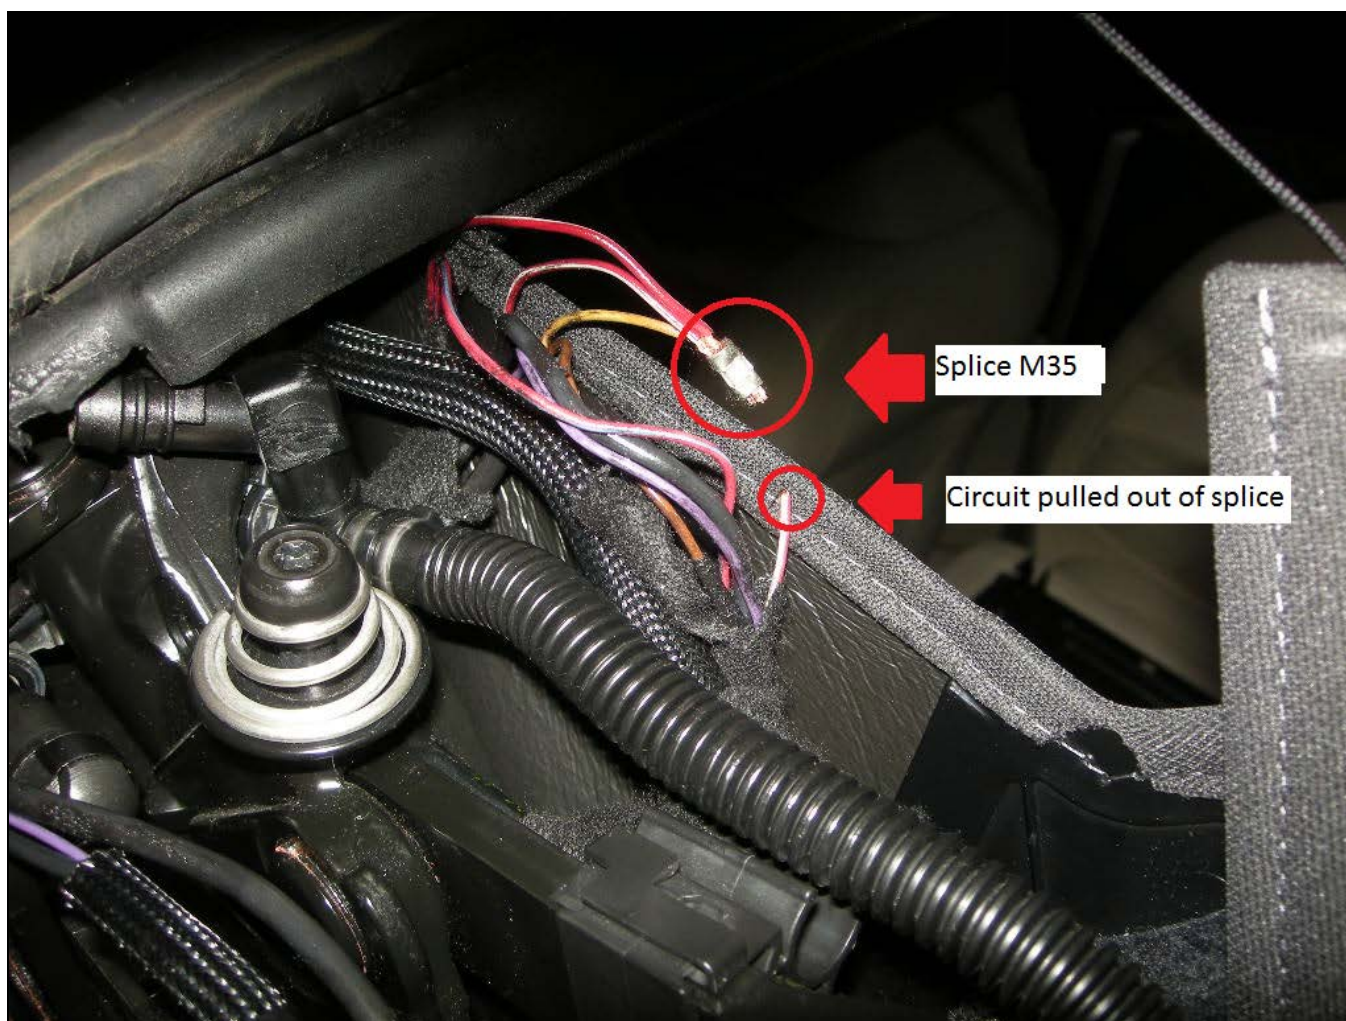
When diagnosing a customer concern of convertible top inoperative with faults 03053-008 “Left Roof Pillar Lock Sensor G558 implausible signal”, 03055-008 “Rear Window Frame Left Lock Sensor G560 implausible signal”, and/or 03057-008 “Rear Window Frame Opening Sensor G562 implausible signal” stored in convertible top, start by inspecting M35 splice in convertible top harness. Splice is located near left rear convertible top drain, as shown below.
