# Technical Service Bulletin

## 01 MIL on (DTC P2006(00) or P2007(00))

01 13 34 2033919/11 October 8, 2013. Supersedes Technical Service Bulletin Group 01 number 13-26 dated August 29, 2013 for reasons listed below.

Model(s)	Year	VIN Range	Vehicle-Specific Equipment
A6, A7, S4, S5, S5 Cab, Q7, Q5	2013	All	3.0 FSI Engine

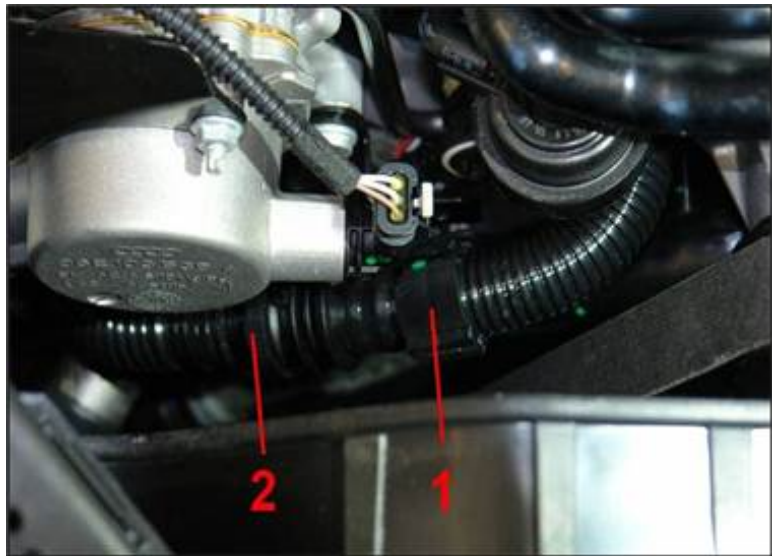
**Figure 2.** Bracket (1) and coupling (2) to disconnect from the secondary air injection line

1. Unclip the secondary air injection line from the bracket (Figure 2, 1) and disconnect the coupling (Figure 2, 2) by pushing both release tabs at the same time (one in the front one in the back).

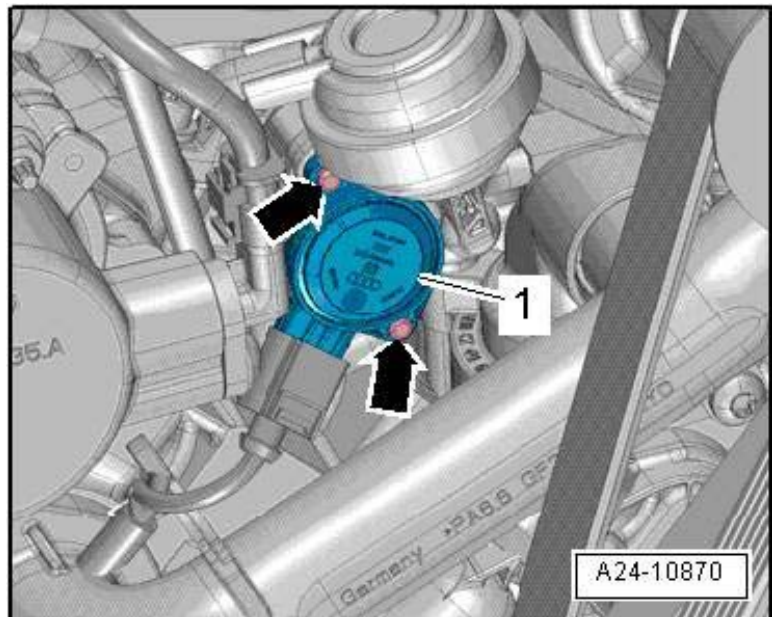
**Figure 3.** Intake manifold sensor (1) and bolts (arrows)

2. Remove the intake manifold runner position sensor by using a ball head torx bit to remove the screws (Figure 3, arrows).

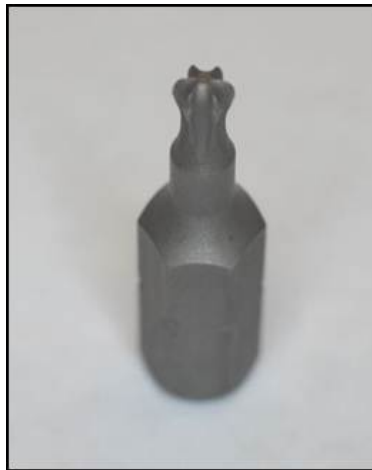
**Figure 4.** T10 ball head torx bit.

**Tip:** The T10 ball head torx bit is sourced locally (Figure 4). Examples include: Snap-on Tools SDM32KT or SDMBT10, or VIM Tools VIS108 or VIS112.

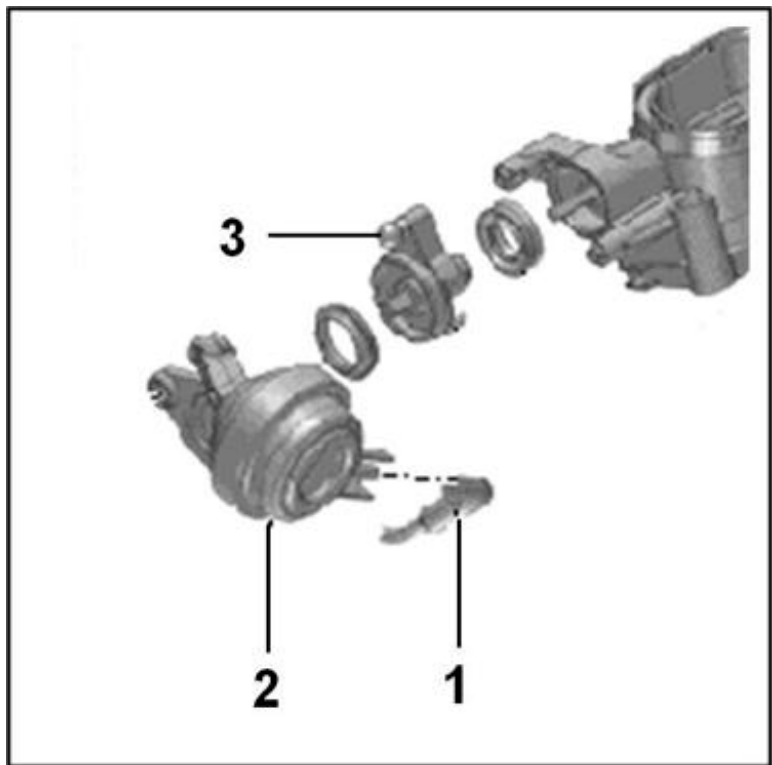
**Figure 5.** Vacuum hose (1), vacuum actuator (2), and ball head (3)

3. Disconnect the vacuum hose (Figure 5, 1), then pry the vacuum actuator (Figure 5, 2) off of the ball head (Figure 5, 3).

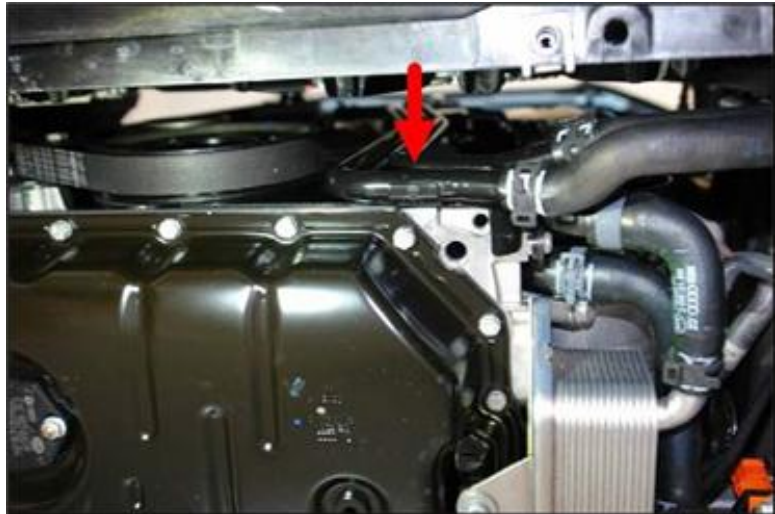
**Figure 6.** Screw to be removed from coolant line and upper section of oil pan (arrow)

2. Remove the screw (Figure 6, arrow) from the coolant line and upper section of oil pan. This will allow the coolant lines to be moved out of the way when removing the sensor.

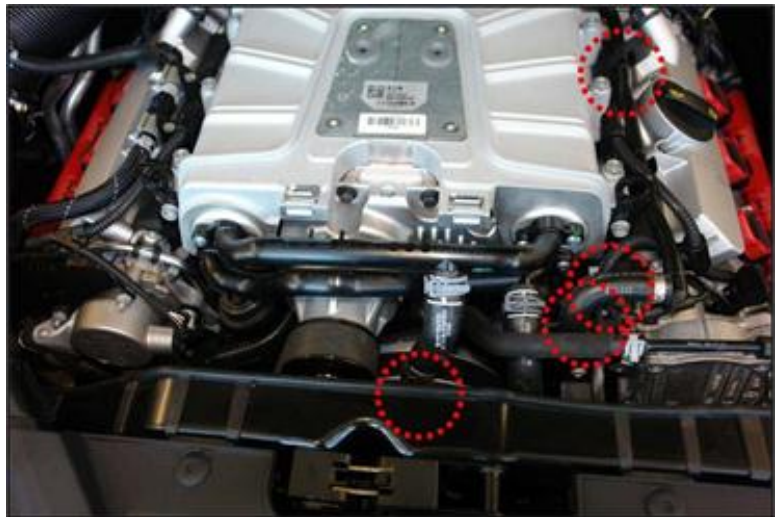
**Figure 7.** Sensors and valve that need to be disconnected are circled in red.

4. Disconnect the following (Figure 7):

- Charge air pressure sensor
- Engine coolant temperature sensor
- Camshaft position sensor
- Solenoid valve

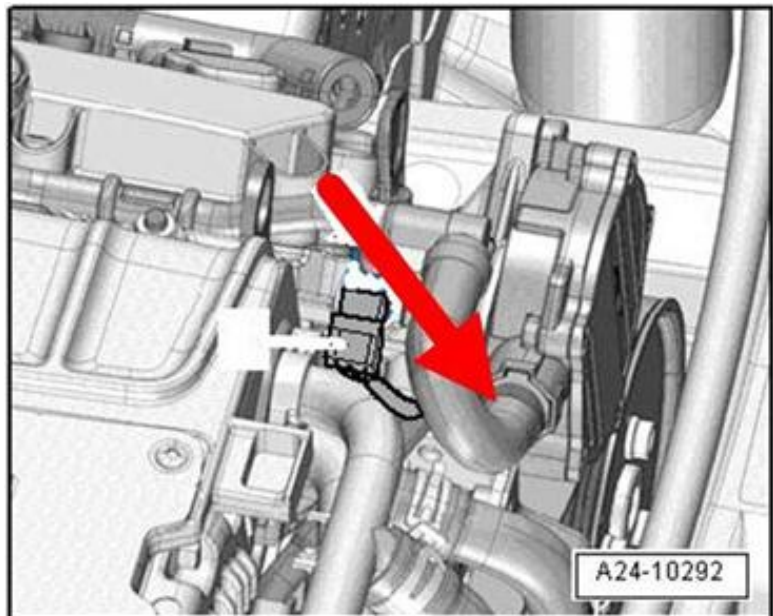
**Figure 8.** Vacuum hose (arrow)

6. Disconnect the vacuum hose (Figure 8, arrow) from the vacuum pump and lay it aside.

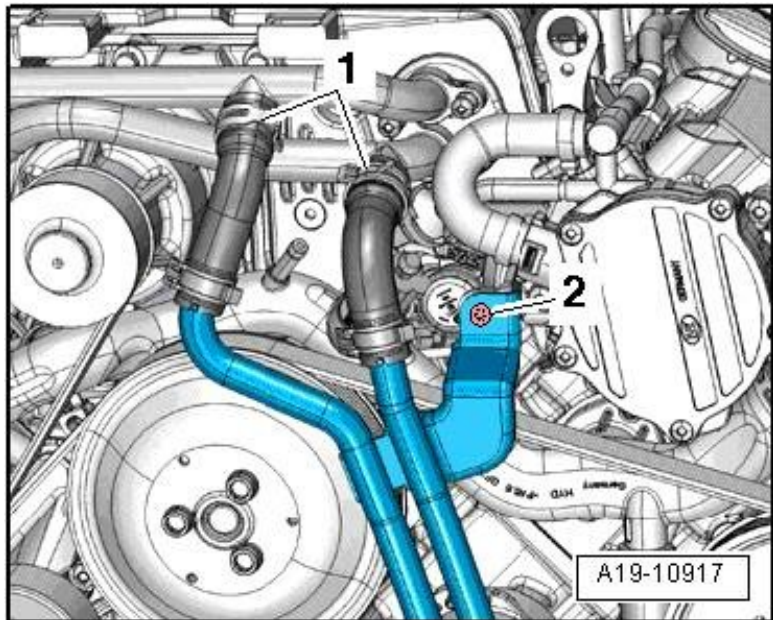
**Figure 9.** Bolt to be removed (2)

7. Remove the bolt as shown in the image at right (Figure 9, 2)

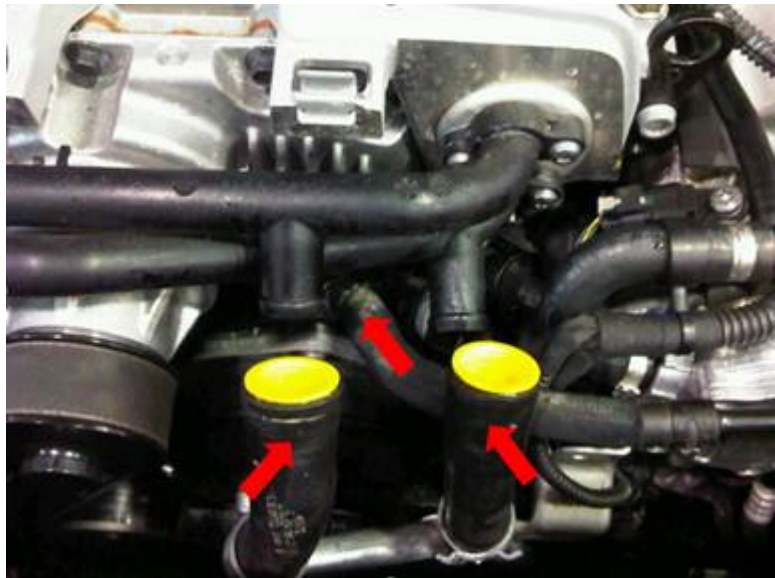
*Figure 10. Coolant hoses (arrows)*

8. Remove coolant hoses (Figure 10, arrows) and close them off with fitting caps (yellow caps from VAS 6122). Move the coolant hoses to the side for access to the intake runner position sensor.

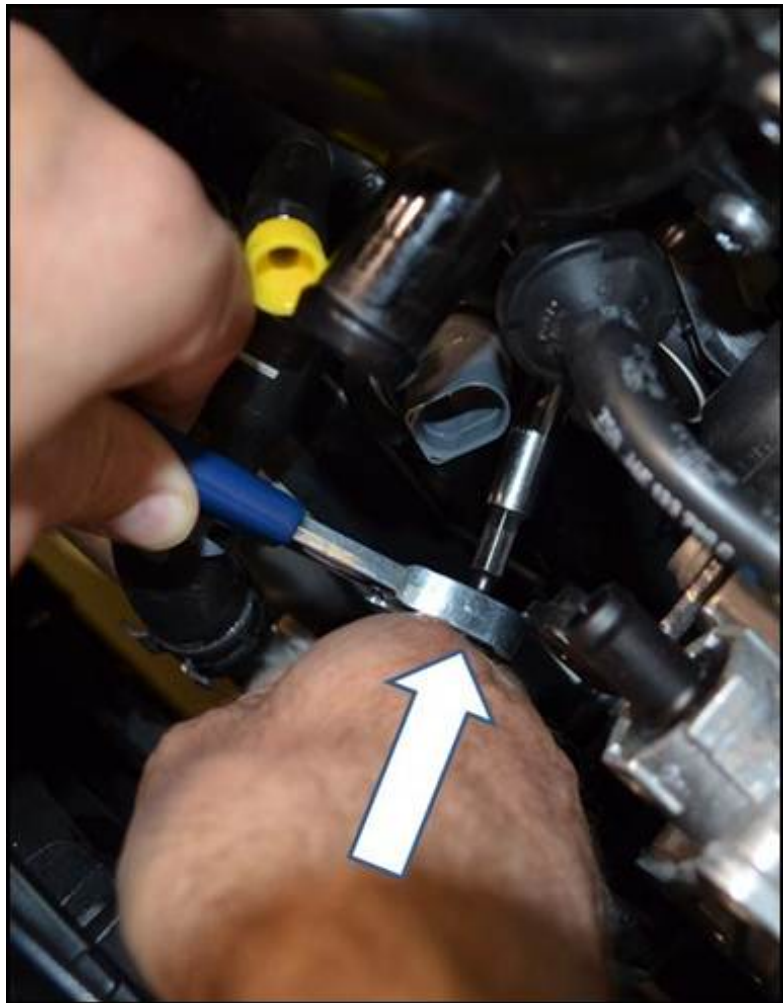
*Figure 11. Apply force in the direction of the arrow.*

10. Remove the intake manifold runner position sensor by using a ball head torx bit to remove the bolts. To ensure good torx bit to bolt head contact, apply force in the direction of the arrow (Figure 11, arrow).

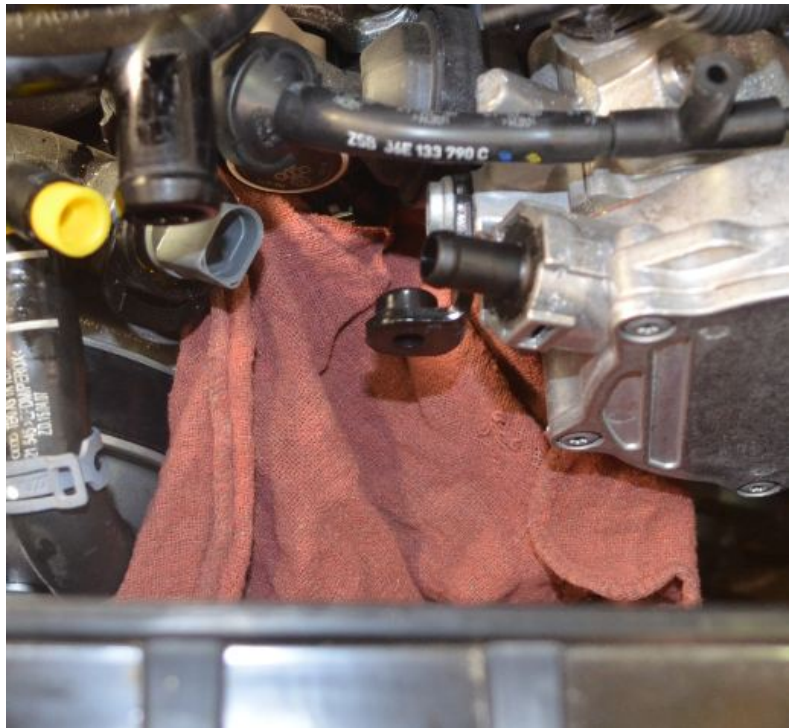
*Figure 12. Place a shop rag under the screws.*

**Tip:** Place a shop rag under the screws to catch any screws that drop (Figure 12).

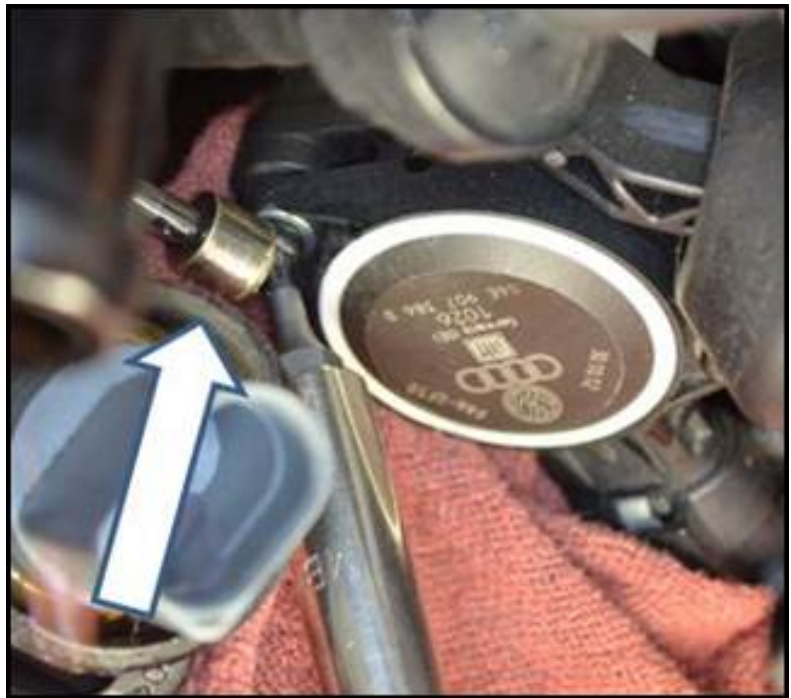
*Figure 13. Use a magnet (arrow) to hold the screws during removal.*

**Tip:** To prevent losing the screws, use a non-bonding adhesive on the tip of the ball torx bit and use a magnet to hold them during removal (Figure 13).

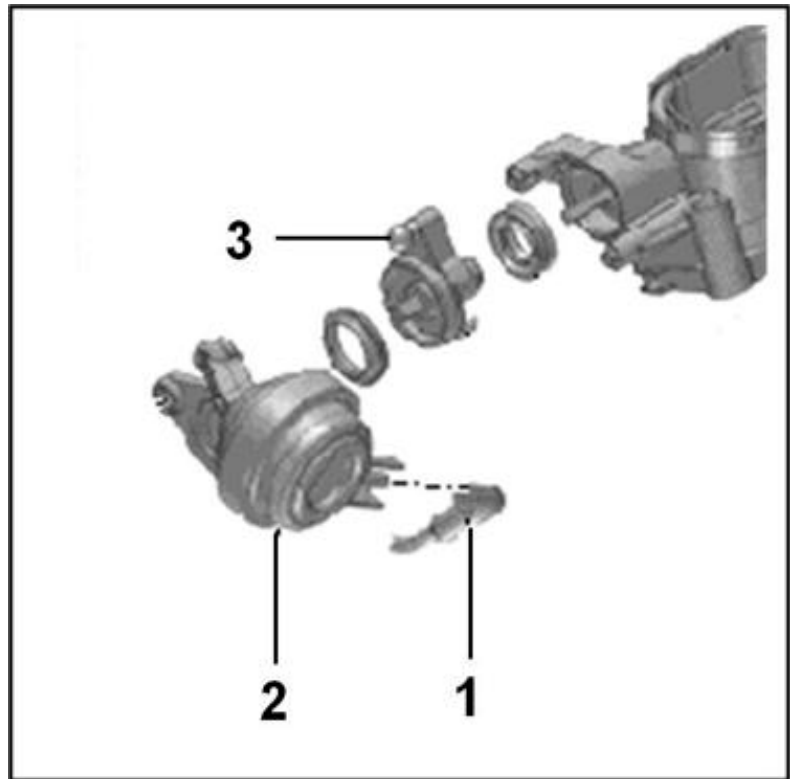
**Figure 14.** Vacuum hose (1), vacuum actuator (2), and ball head (3)

11. Pry the vacuum actuator (Figure 14, 2) off of the ball head (Figure 14, 3), then disconnect the vacuum hose (Figure 14, 1).
