Technical Service Bulletin

69 Replaced airbag control unit cannot be coded

69 13 26 2023323/11 October 21, 2013. Supersedes Technical Service Bulletin Group 69 number 12-25 dated April 25, 2012 for reasons listed below.

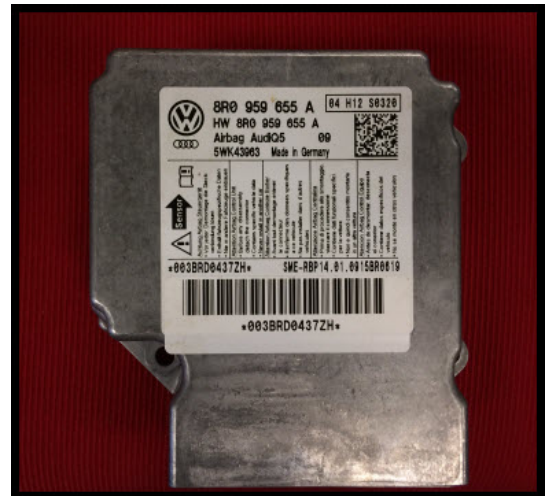
Tip: The color code indicates the ECU software that the control module must be programmed with to operate correctly in the North American Market. Only control modules to be used for service will have a color code. In addition, service parts will have a secondary label placed over the original supplier label after the part has been programmed for the North American market (Figure 3 and Figure 4).

Figure 3. Production Control Unit

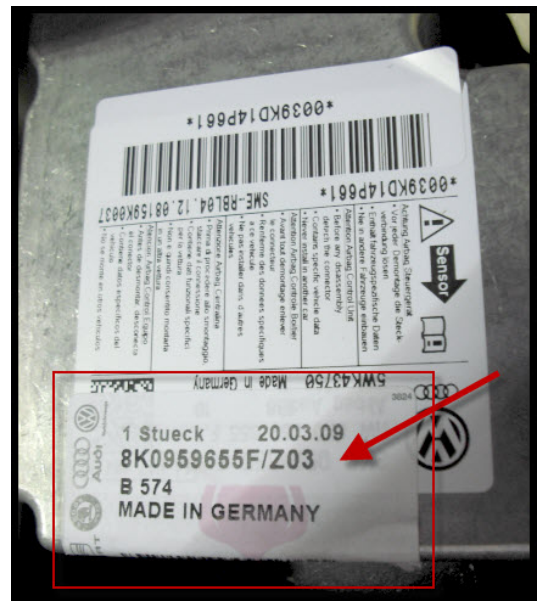
Figure 4. Service Part Control Unit

4. If no parameterization and/or coding is suggested, check the color code on the service part label of the control module. Compare this color code to the suggestion given by ETKA by using the FI search function.
 - If the color codes *do not* match, or if the service part has no color code, re-order the correct part listed in ETKA with the appropriate color code.
 - If the color codes *do* match, contact TAC.
